Manhole Inspection Report

Date:	04/21/2018	Weather:		Coding:	RZMACP
MH#:	M-907-016	Owner:	NA	Len. Surveyed:	7.4
P.O.#:		Surveyor:	Jen Costello	Rim to Invert:	7.6
Customer:		Cert. #:	U-907-5518	Wall Material:	Concrete (reinforced)

Street:	10th St. and Union St. Hobart High S	Project:	Hobart, IN
City:	Hobart, IN	GPS Northing:	0.0
Location:		GPS Easting:	0.0
Drain Area:	Southeast	GPS Accuracy:	Nearest Meter
Cover Shape:	Circular	Evidence of Surcharge:	No
Cover Size:	22.5	Potential for Runoff:	None
Comments:

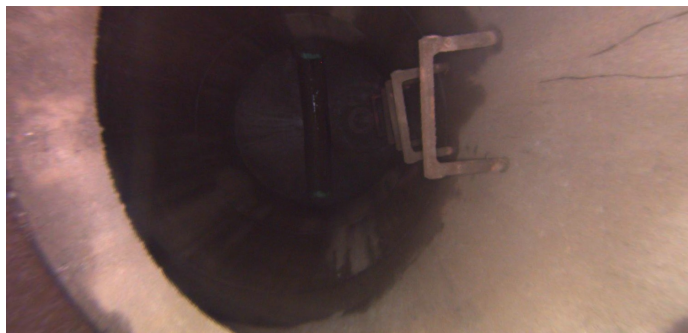
Code: **MGO**
Description: **General Observation**

Distance (ft): **.0**
Structural Grade: **0**
O&M Grade: **0**
Clock Start/From:
Clock To:
1st Value:
2nd Value:
Value Percent:
Step: **NO**
Remarks: **ACCESS MH**

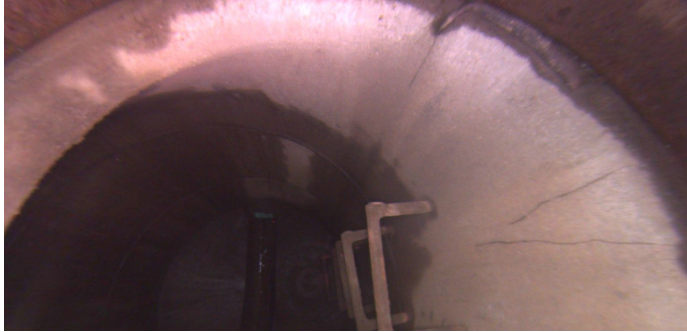
Code: **CM**
Description: **Crack Multiple**

Distance (ft): **.0**
Structural Grade: **3**
O&M Grade: **0**
Clock Start/From: **1**
Clock To: **3**
1st Value:
2nd Value:
Value Percent:
Step: **NO**
Remarks:

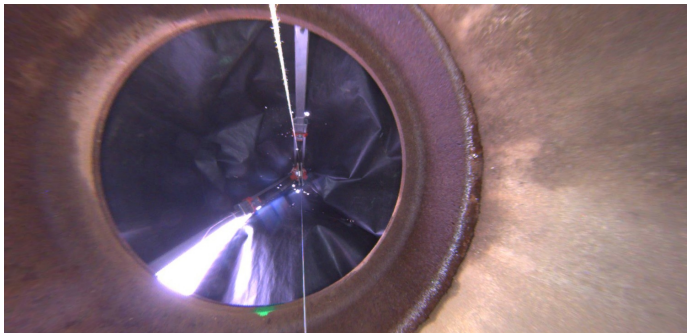
Code: **MGO**
Description: **General Observation**

Distance (ft): **1.8**
Structural Grade: **0**
O&M Grade: **0**
Clock Start/From:
Clock To:
1st Value:
2nd Value:
Value Percent:
Step: **NO**
Remarks: **UNDERSIDE OF FRAME**

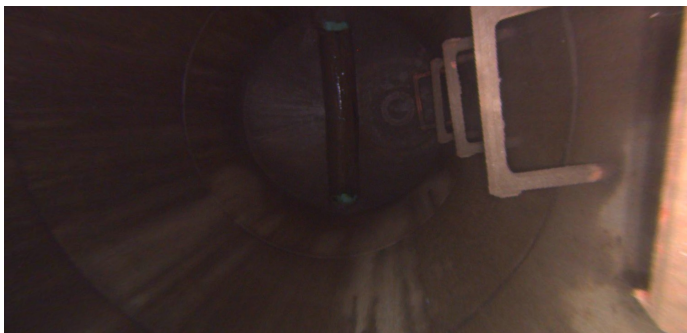
Code: **IW**
Description: **Infil Weeper**

Distance (ft): **1.8**
Structural Grade: **0**
O&M Grade: **2**
Clock Start/From: **12**
Clock To: **12**
1st Value:
2nd Value:
Value Percent:
Step: **NO**
Remarks:

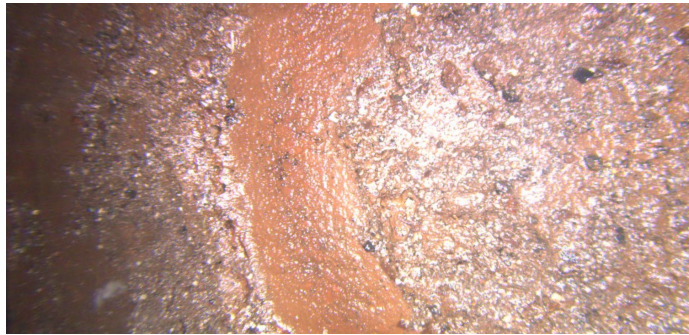
Code:	MGO
Description:	General Observation
Distance (ft):	7.4
Structural Grade:	0
O&M Grade:	0
Clock Start/From:	
Clock To:	
1st Value:	
2nd Value:	
Value Percent:	
Step:	NO
Remarks:	END SURVEY

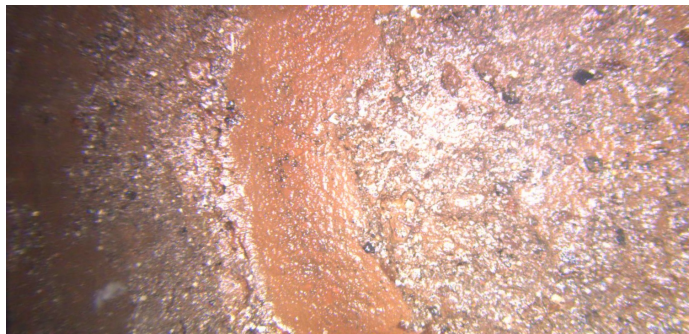
Code:	DSF
Description:	Deposits Settled Fine
Distance (ft):	7.4
Structural Grade:	0
O&M Grade:	2
Clock Start/From:	12
Clock To:	12
1st Value:	
2nd Value:	
Value Percent:	5.000
Step:	NO
Remarks:
