# Manhole Inspection Report

Date:	<b>04/22/2018</b>	Weather:		Coding:	<b>RZMACP</b>
MH#:	<b>M-907-019A</b>	Owner:	<b>NA</b>	Len. Surveyed:	<b>14.5</b>
P.O.#:		Surveyor:	<b>John Kuglmaier</b>	Rim to Invert:	<b>14.6</b>
Customer:	<b>8.7</b>	Cert. #:	<b>U-1215-07002349</b>	Wall Material:	<b>Concrete (reinforced)</b>

Street:	<b>10th St. and Union St. Hobart High S</b>	Project:	<b>Hobart, IN</b>
City:	<b>Hobart, IN</b>	GPS Northing:	<b>0.0</b>
Location:		GPS Easting:	<b>0.0</b>
Drain Area:	<b>Southeast</b>	GPS Accuracy:	<b>Nearest Meter</b>
Cover Shape:	<b>Circular</b>	Evidence of Surcharge:	<b>No</b>
Cover Size:	<b>22.5</b>	Potential for Runoff:	<b>None</b>
Comments:

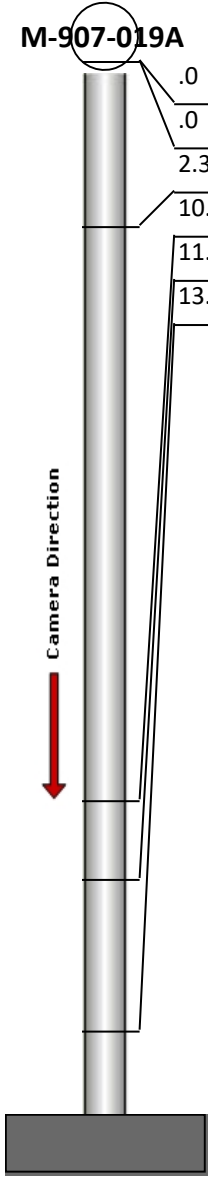
.0	MGP	General Photo	10	NA
	.0	RFJ	Roots Fine Joint	22	M 1
	2.3	MGP	General Photo	40	NA
	10.3	IS	Infil Stain	70	NA
	11.4	DAZ	Deposits Attached Other	84	M 2
	13.5	MGO	General Observation	100	NA

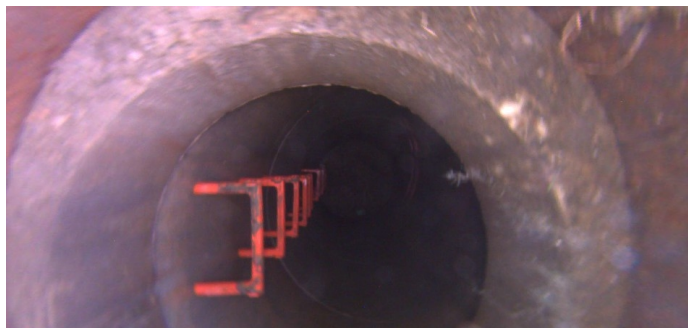
Code: **MGP**  
Description: **General Photo**

Distance (ft): **.0**  
Structural Grade: **0**  
O&M Grade: **0**  
Clock Start/From:  
Clock To:  
1st Value:  
2nd Value:  
Value Percent:  
Step: **NO**  
Remarks:

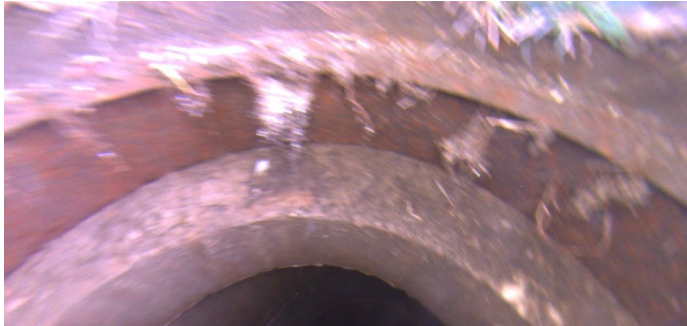
Code: **RFJ**  
Description: **Roots Fine Joint**

Distance (ft): **.0**  
Structural Grade: **0**  
O&M Grade: **1**  
Clock Start/From: **12**  
Clock To: **12**  
1st Value:  
2nd Value:  
Value Percent:  
Step: **NO**  
Remarks:

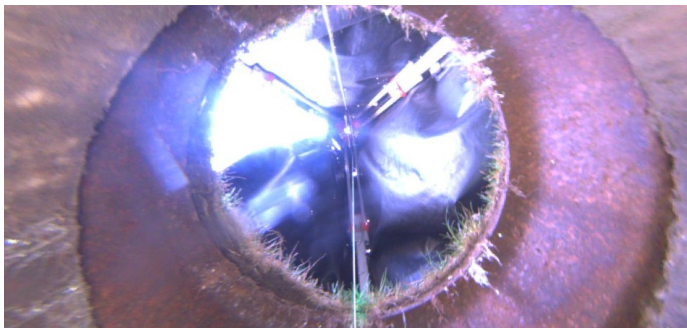
Code: **MGP**  
Description: **General Photo**

Distance (ft): **2.3**  
Structural Grade: **0**  
O&M Grade: **0**  
Clock Start/From:  
Clock To:  
1st Value:  
2nd Value:  
Value Percent:  
Step: **NO**  
Remarks:

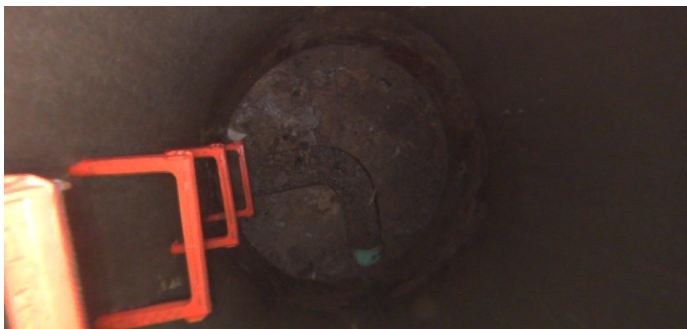
Code: **IS**  
Description: **Infil Stain**

Distance (ft): **10.3**  
Structural Grade: **0**  
O&M Grade: **0**  
Clock Start/From: **12**  
Clock To: **12**  
1st Value:  
2nd Value:  
Value Percent:  
Step: **NO**  
Remarks:

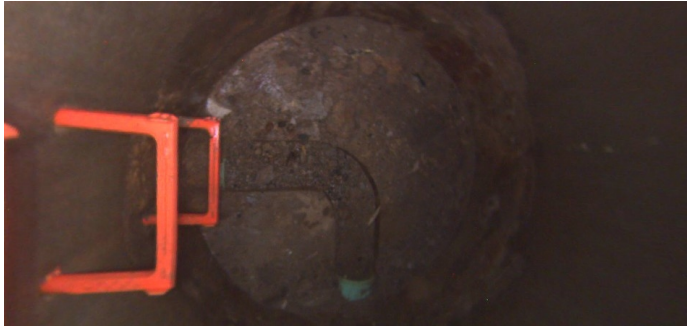
Code:	<b>DAZ</b>
Description:	<b>Deposits Attached Other</b>
Distance (ft):	<b>11.4</b>
Structural Grade:	<b>0</b>
O&M Grade:	<b>2</b>
Clock Start/From:	<b>12</b>
Clock To:	<b>12</b>
1st Value:	
2nd Value:	
Value Percent:	<b>10.000</b>
Step:	<b>NO</b>
Remarks:	<b>Mixed materials</b>

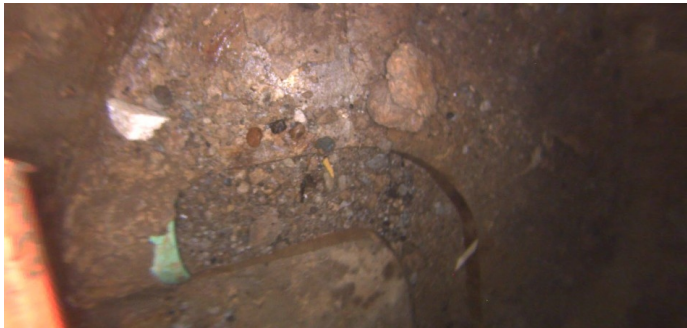
Code:	<b>MGO</b>
Description:	<b>General Observation</b>
Distance (ft):	<b>13.5</b>
Structural Grade:	<b>0</b>
O&M Grade:	<b>0</b>
Clock Start/From:	
Clock To:	
1st Value:	
2nd Value:	
Value Percent:	
Step:	<b>NO</b>
Remarks:	<b>Ins. Comp.</b>
