Manhole Inspection Report

Date:	04/16/2018	Weather:		Coding:	RZMACP
MH#:	M-910-002	Owner:	NA	Len. Surveyed:	13.6
P.O.#:		Surveyor:	Jen Costello	Rim to Invert:	14.0
Customer:		Cert. #:	U-907-5518	Wall Material:	Concrete (reinforced)

Street:	Norris Dr. 282' East of Randolph St.	Project:	Hobart, IN
City:	Hobart, IN	GPS Northing:	2910298.902
Location:		GPS Easting:	2910298.902
Drain Area:	Southeast	GPS Accuracy:	Sub-Meter
Cover Shape:	Circular	Evidence of Surcharge:	No
Cover Size:	29.0	Potential for Runoff:	None
Comments:

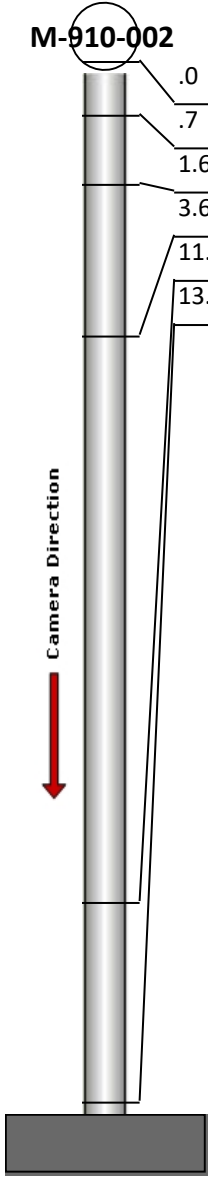
.0	MGO	General Observation	10	NA
	.7	RFJ	Roots Fine Joint	23	M 1
	1.6	MGP	General Photo	38	NA
	3.6	IW	Infil Weeper	55	M 2
	11.0	IW	Infil Weeper	81	M 2
	13.6	MGO	General Observation	98	NA

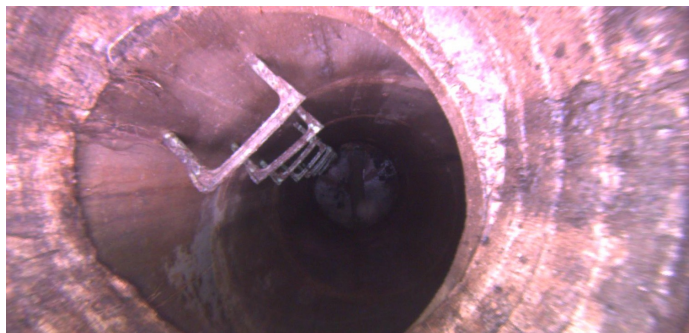
Code: **MGO**
Description: **General Observation**

Distance (ft): **.0**
Structural Grade: **0**
O&M Grade: **0**
Clock Start/From:
Clock To:
1st Value:
2nd Value:
Value Percent:
Step: **NO**
Remarks: **ACCESS MH**

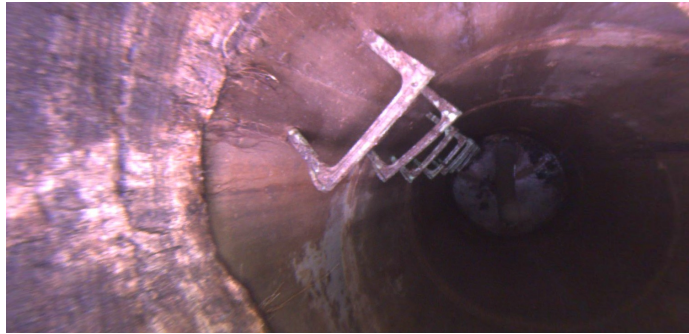
Code:	RFJ
Description:	Roots Fine Joint
Distance (ft):	.7
Structural Grade:	0
O&M Grade:	1
Clock Start/From:	8
Clock To:	10
1st Value:	
2nd Value:	
Value Percent:	
Step:	NO
Remarks:

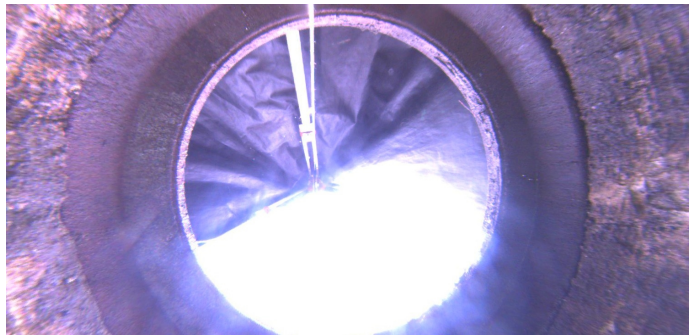
Code:	MGP
Description:	General Photo
Distance (ft):	1.6
Structural Grade:	0
O&M Grade:	0
Clock Start/From:	
Clock To:	
1st Value:	
2nd Value:	
Value Percent:	
Step:	NO
Remarks:	UNDERSIDE OF FRAME

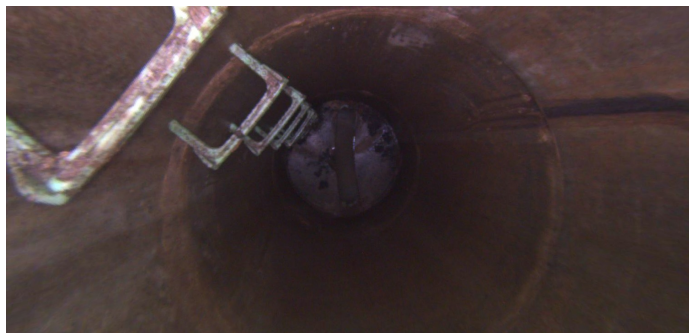
Code:	IW
Description:	Infil Weeper
Distance (ft):	3.6
Structural Grade:	0
O&M Grade:	2
Clock Start/From:	3
Clock To:	
1st Value:	
2nd Value:	
Value Percent:	
Step:	NO
Remarks:

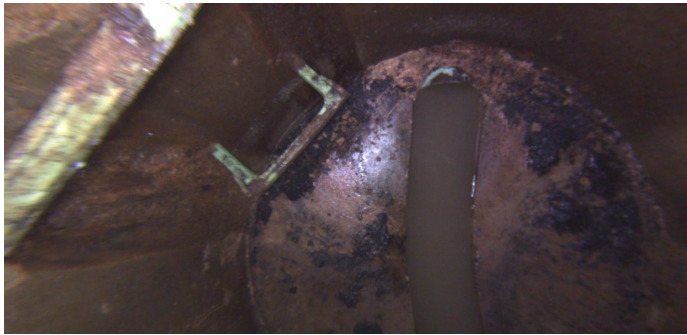
Code: **IW**
Description: **Infil Weeper**

Distance (ft): **11.0**
Structural Grade: **0**
O&M Grade: **2**
Clock Start/From: **9**
Clock To: **11**
1st Value:
2nd Value:
Value Percent:
Step: **NO**
Remarks:

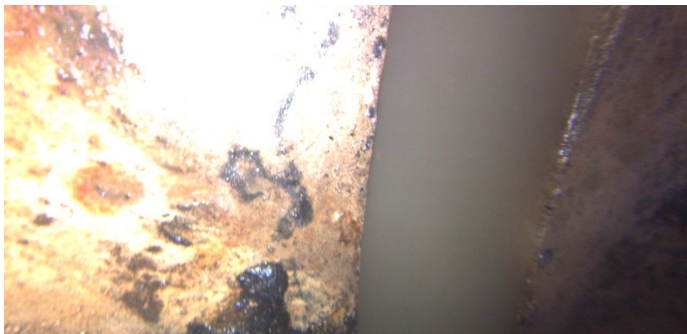
Code: **MGO**
Description: **General Observation**

Distance (ft): **13.6**
Structural Grade: **0**
O&M Grade: **0**
Clock Start/From:
Clock To:
1st Value:
2nd Value:
Value Percent:
Step: **NO**
Remarks: **END SURVEY**
