Manhole Inspection Report

Date:	04/16/2018	Weather:		Coding:	RZMACP
MH#:	M-910-003	Owner:	NA	Len. Surveyed:	12.6
P.O.#:		Surveyor:	Jen Costello	Rim to Invert:	12.9
Customer:		Cert. #:	U-907-5518	Wall Material:	Concrete (reinforced)

Street:	Norris Dr. 469' East of Randolph St.	Project:	Hobart, IN
City:	Hobart, IN	GPS Northing:	2910496.141
Location:		GPS Easting:	2910496.141
Drain Area:	Southeast	GPS Accuracy:	Sub-Meter
Cover Shape:	Circular	Evidence of Surcharge:	No
Cover Size:	29.0	Potential for Runoff:	None
Comments:

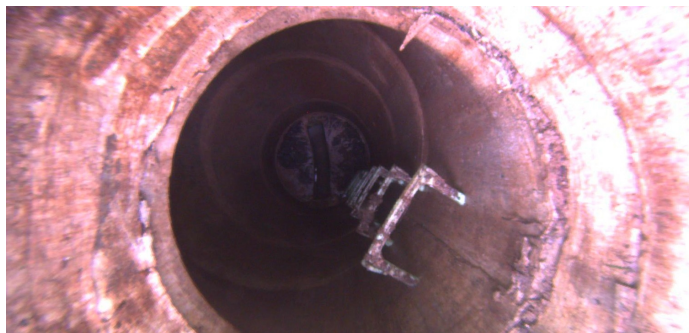
Code: **MGO**
Description: **General Observation**

Distance (ft): **.0**
Structural Grade: **0**
O&M Grade: **0**
Clock Start/From:
Clock To:
1st Value:
2nd Value:
Value Percent:
Step: **NO**
Remarks: **ACCESS MH**

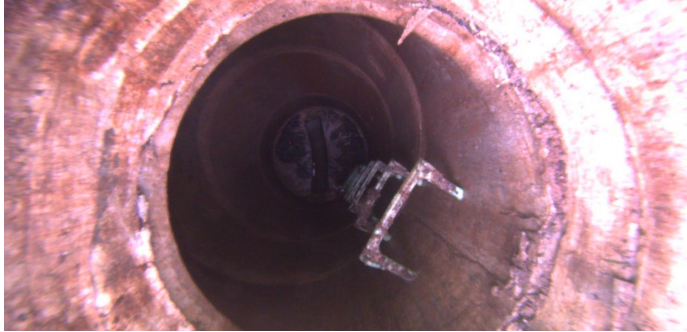
Code: **RFJ**
Description: **Roots Fine Joint**

Distance (ft): **.0**
Structural Grade: **0**
O&M Grade: **1**
Clock Start/From: **12**
Clock To: **12**
1st Value:
2nd Value:
Value Percent:
Step: **NO**
Remarks:

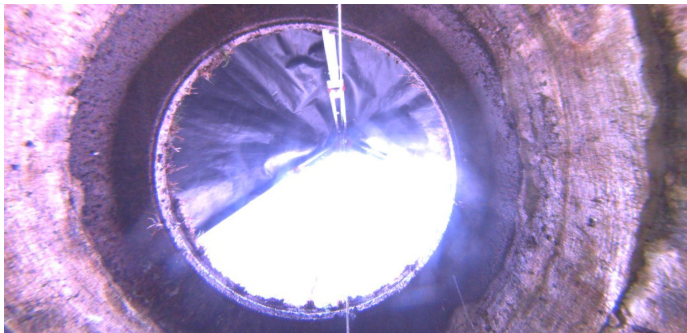
Code: **MGP**
Description: **General Photo**

Distance (ft): **1.7**
Structural Grade: **0**
O&M Grade: **0**
Clock Start/From:
Clock To:
1st Value:
2nd Value:
Value Percent:
Step: **NO**
Remarks: **UNDERSIDE OF FRAME**

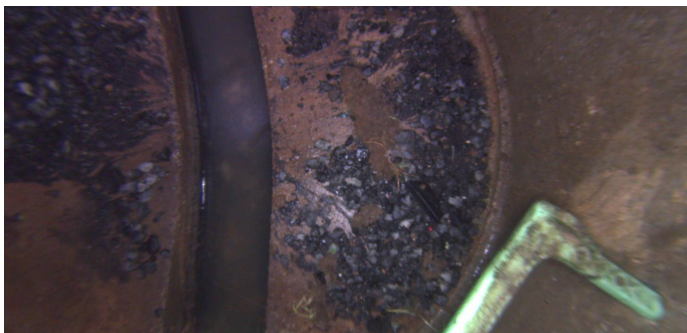
Code: **DSGV**
Description: **Deposits Settled Gravel**

Distance (ft): **10.7**
Structural Grade: **0**
O&M Grade: **2**
Clock Start/From: **12**
Clock To: **6**
1st Value:
2nd Value:
Value Percent: **5.000**
Step: **NO**
Remarks:

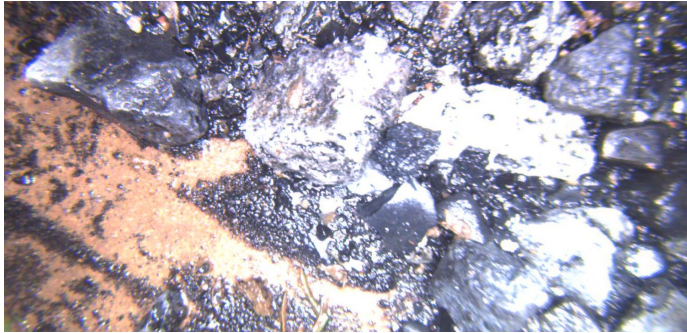
Code: **MGO**
Description: **General Observation**

Distance (ft): **12.6**
Structural Grade: **0**
O&M Grade: **0**
Clock Start/From:
Clock To:
1st Value:
2nd Value:
Value Percent:
Step: **NO**
Remarks: **END SURVEY**
