Manhole Inspection Report

Date:	04/16/2018	Weather:		Coding:	RZMACP
MH#:	M-910-006	Owner:	NA	Len. Surveyed:	12.3
P.O.#:		Surveyor:	Jen Costello	Rim to Invert:	12.8
Customer:		Cert. #:	U-907-5518	Wall Material:	Concrete (reinforced)

Street:	Norris Dr. 837' East of Randolph St.	Project:	Hobart, IN
City:	Hobart, IN	GPS Northing:	2910853.082
Location:		GPS Easting:	2910853.082
Drain Area:	Southeast	GPS Accuracy:	Sub-Meter
Cover Shape:	Circular	Evidence of Surcharge:	No
Cover Size:	29.0	Potential for Runoff:	None
Comments:

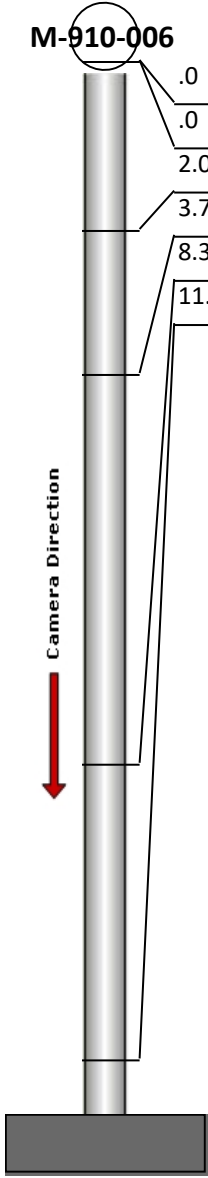
Position	Code	Observation	Video (sec)	Grade

.0	MGO	General Observation	10	NA
	.0	RMJ	Roots Medium Joint	21	M 3
	2.0	MGO	General Observation	38	NA
	3.7	OBP	Obstacle External Pipe or Cable	55	M 2
	8.3	IW	Infil Weeper	76	M 2
	11.8	MGO	General Observation	95	NA

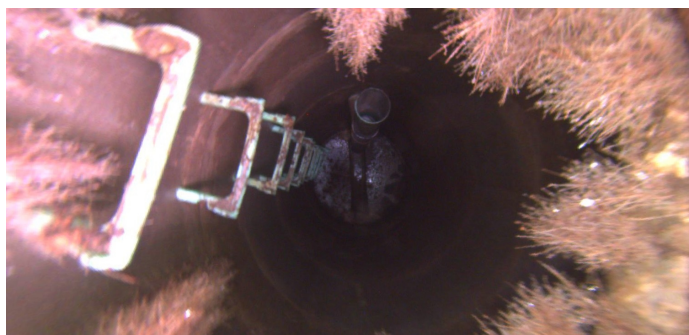
Code: **MGO**
Description: **General Observation**

Distance (ft): **.0**
Structural Grade: **0**
O&M Grade: **0**
Clock Start/From:
Clock To:
1st Value:
2nd Value:
Value Percent:
Step: **NO**
Remarks: **ACCESS MH**

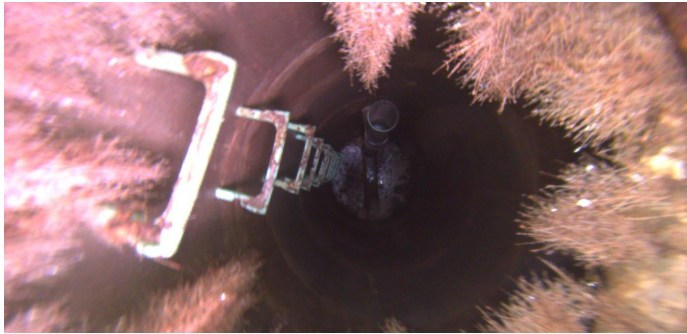
Code: **RMJ**
Description: **Roots Medium Joint**

Distance (ft): **.0**
Structural Grade: **0**
O&M Grade: **3**
Clock Start/From: **12**
Clock To: **12**
1st Value:
2nd Value:
Value Percent: **10.000**
Step: **NO**
Remarks:

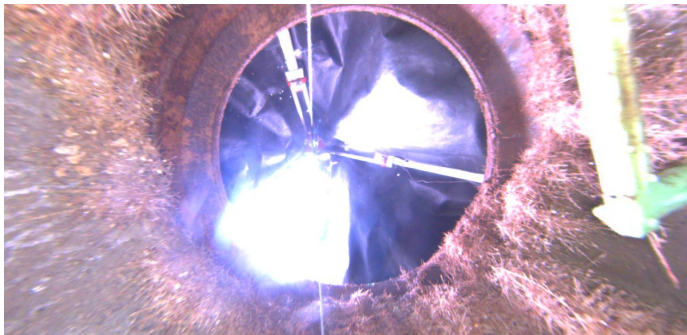
Code: **MGO**
Description: **General Observation**

Distance (ft): **2.0**
Structural Grade: **0**
O&M Grade: **0**
Clock Start/From:
Clock To:
1st Value:
2nd Value:
Value Percent:
Step: **NO**
Remarks: **UNDERSIDE OF FRAME**

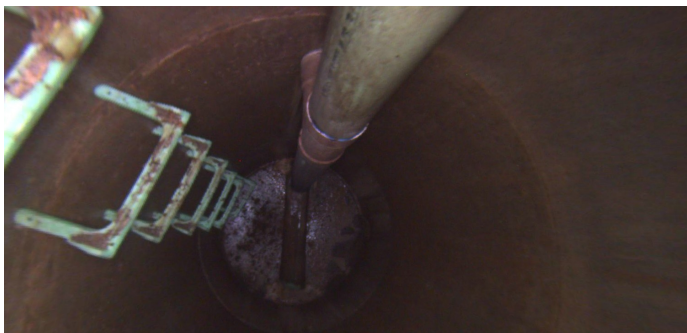
Code: **OBP**
Description: **Obstacle External Pipe or Cable**

Distance (ft): **3.7**
Structural Grade: **0**
O&M Grade: **2**
Clock Start/From: **12**
Clock To:
1st Value:
2nd Value:
Value Percent: **10.000**
Step: **NO**
Remarks:

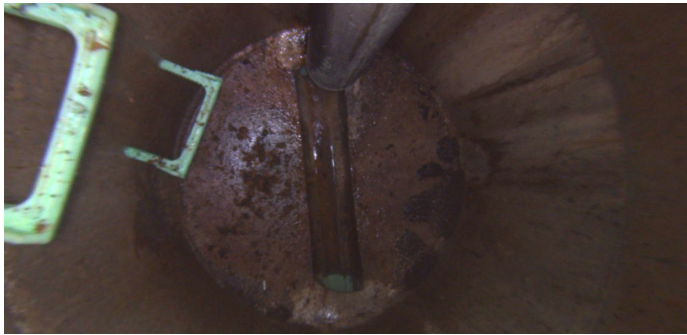
Code: **IW**
Description: **Infil Weeper**

Distance (ft): **8.3**
Structural Grade: **0**
O&M Grade: **2**
Clock Start/From: **12**
Clock To: **12**
1st Value:
2nd Value:
Value Percent:
Step: **NO**
Remarks:

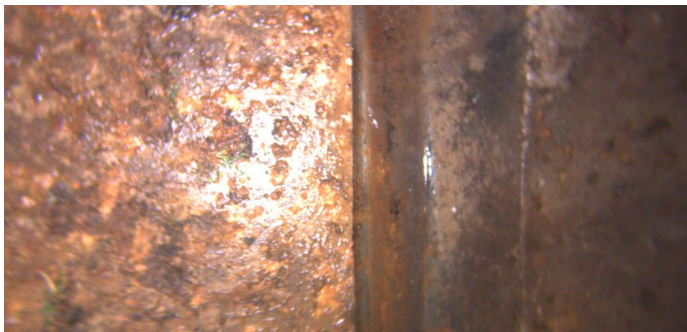
Code: **MGO**
Description: **General Observation**

Distance (ft): **11.8**
Structural Grade: **0**
O&M Grade: **0**
Clock Start/From:
Clock To:
1st Value:
2nd Value:
Value Percent:
Step: **NO**
Remarks: **END SURVEY**
