Manhole Inspection Report

Date:	09/24/2022	Weather:		Coding:	RZMACP
MH#:	M-910-008	Owner:	NA	Len. Surveyed:	12.8
P.O.#:		Surveyor:	Jen Costello	Rim to Invert:	14.0
Customer:		Cert. #:	U-907-5518	Wall Material:	Fiberglass Reinforced

Street:	Norris Dr. 1110' East of Randolph St.	Project:	Hobart, IN
City:	Hobart, IN	GPS Northing:	2276829.224
Location:	Local Rural Streets	GPS Easting:	2911124.377
Drain Area:	Southeast	GPS Accuracy:	Sub-Meter
Cover Shape:	Circular	Evidence of Surcharge:	No
Cover Size:	24.0	Potential for Runoff:	None
Comments:

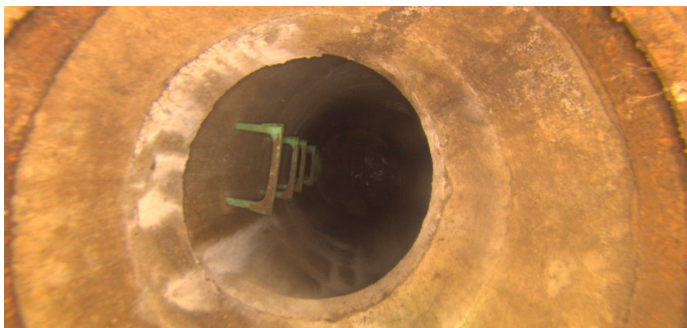
Code: **MGO**
Description: **General Observation**

Distance (ft): **.0**
Structural Grade: **0**
O&M Grade: **0**
Clock Start/From:
Clock To:
1st Value:
2nd Value:
Value Percent:
Step: **NO**
Remarks: **access mh**

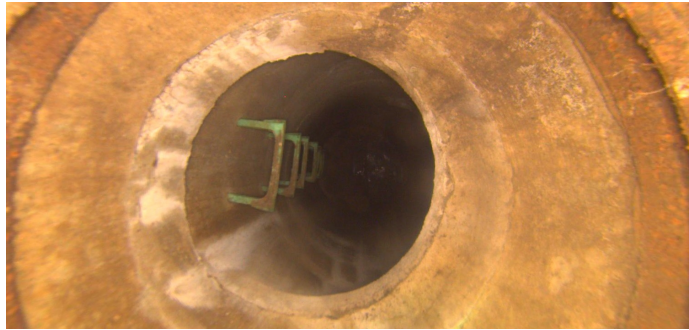
Code: **SRI**
Description: **Surface Roughness Increased**

Distance (ft): **.0**
Structural Grade: **1**
O&M Grade: **0**
Clock Start/From: **12**
Clock To: **12**
1st Value:
2nd Value:
Value Percent:
Step: **NO**
Remarks:

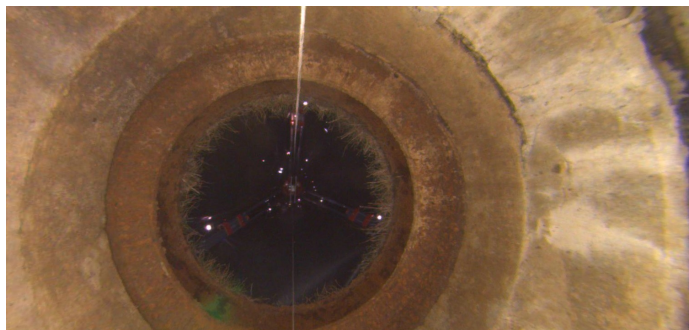
Code: **MGO**
Description: **General Observation**

Distance (ft): **2.7**
Structural Grade: **0**
O&M Grade: **0**
Clock Start/From:
Clock To:
1st Value:
2nd Value:
Value Percent:
Step: **NO**
Remarks: **underside of frame**

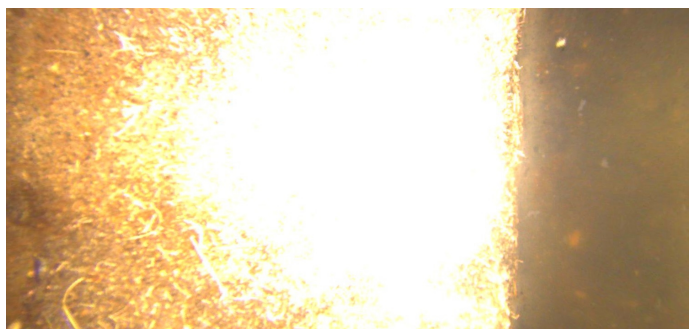
Code: **DSF**
Description: **Deposits Settled Fine**

Distance (ft): **12.8**
Structural Grade: **0**
O&M Grade: **2**
Clock Start/From: **12**
Clock To: **12**
1st Value:
2nd Value:
Value Percent: **5.000**
Step: **NO**
Remarks:

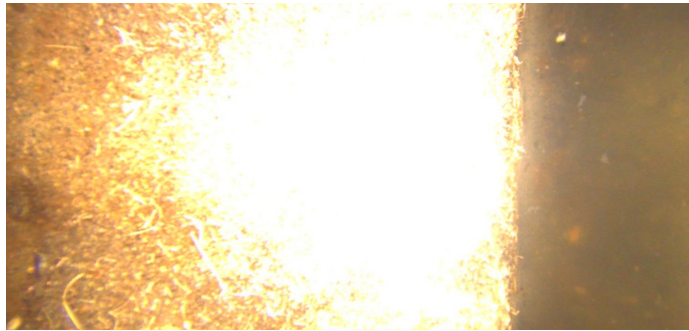
Code: **SRI**
Description: **Surface Roughness Increased**

Distance (ft): **12.8**
Structural Grade: **1**
O&M Grade: **0**
Clock Start/From: **12**
Clock To: **12**
1st Value:
2nd Value:
Value Percent:
Step: **NO**
Remarks:

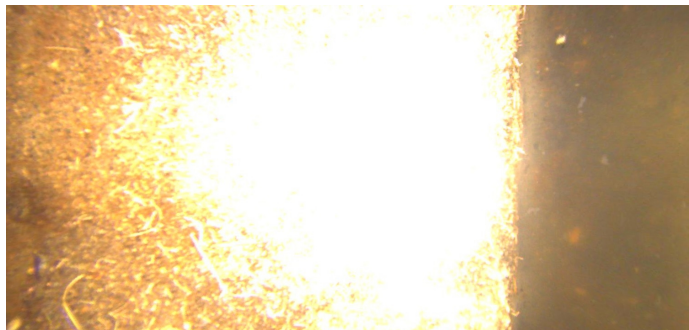
Code: **MGO**
Description: **General Observation**

Distance (ft): **12.8**
Structural Grade: **0**
O&M Grade: **0**
Clock Start/From:
Clock To:
1st Value:
2nd Value:
Value Percent:
Step: **NO**
Remarks: **end of survey**
