Manhole Inspection Report

Date:	04/16/2018	Weather:		Coding:	RZMACP
MH#:	M-910-011	Owner:	NA	Len. Surveyed:	10.6
P.O.#:		Surveyor:	Jen Costello	Rim to Invert:	10.7
Customer:		Cert. #:	U-907-5518	Wall Material:	Concrete (reinforced)

Street:	NORRIS DR	Project:	Hobart, IN
City:	Hobart, IN	GPS Northing:	2911503.958
Location:		GPS Easting:	2911503.958
Drain Area:	Southeast	GPS Accuracy:	Sub-Meter
Cover Shape:	Circular	Evidence of Surcharge:	No
Cover Size:	29.0	Potential for Runoff:	None
Comments:

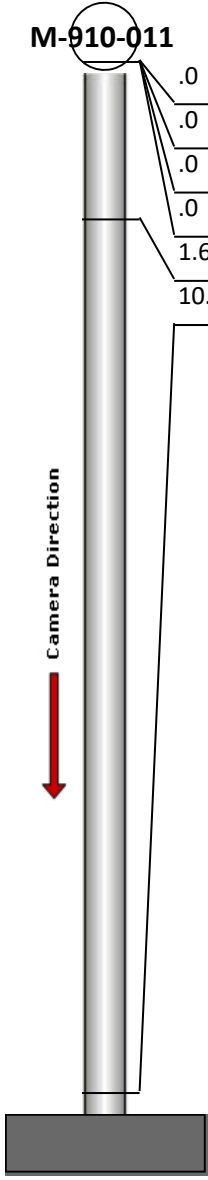
.0	MGO	General Observation	10	NA
	.0	MGO	General Observation	20	NA
	.0	RFB	Roots Fine Barrel	30	M 2
	.0	FM	Fracture Multiple	40	S 4
	1.6	MGO	General Observation	57	NA
	10.5	MGO	General Observation	88	NA

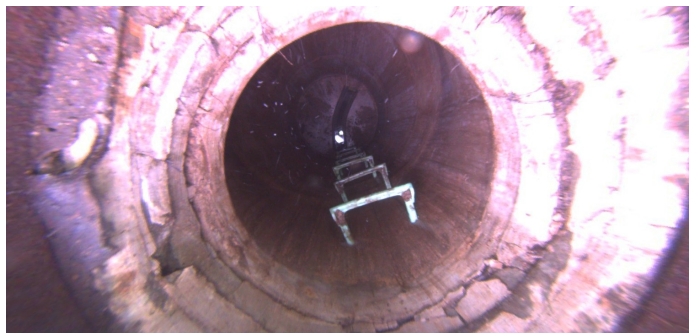
Code: **MGO**
Description: **General Observation**

Distance (ft): **.0**
Structural Grade: **0**
O&M Grade: **0**
Clock Start/From:
Clock To:
1st Value:
2nd Value:
Value Percent:
Step: **NO**
Remarks: **ACCESS MH**

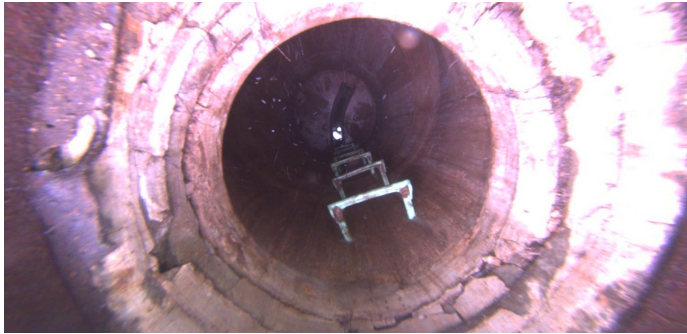
Code:	MGO
Description:	General Observation
Distance (ft):	.0
Structural Grade:	0
O&M Grade:	0
Clock Start/From:	
Clock To:	
1st Value:	
2nd Value:	
Value Percent:	
Step:	NO
Remarks:	ACCESS MH

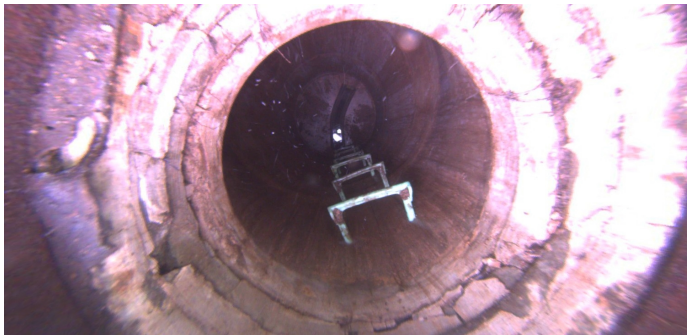
Code:	RFB
Description:	Roots Fine Barrel
Distance (ft):	.0
Structural Grade:	0
O&M Grade:	2
Clock Start/From:	12
Clock To:	12
1st Value:	
2nd Value:	
Value Percent:	
Step:	NO
Remarks:

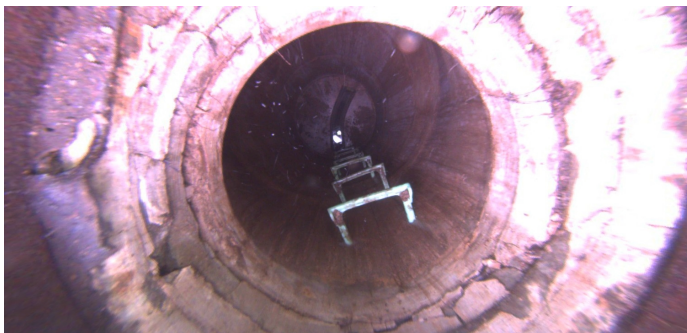
Code:	FM
Description:	Fracture Multiple
Distance (ft):	.0
Structural Grade:	4
O&M Grade:	0
Clock Start/From:	12
Clock To:	12
1st Value:	
2nd Value:	
Value Percent:	
Step:	NO
Remarks:

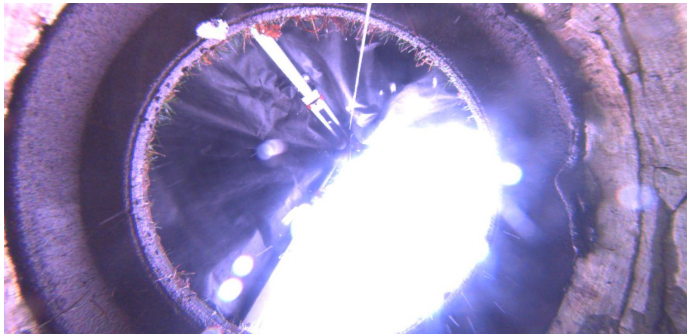
Code:	MGO
Description:	General Observation
Distance (ft):	1.6
Structural Grade:	0
O&M Grade:	0
Clock Start/From:	
Clock To:	
1st Value:	
2nd Value:	
Value Percent:	
Step:	NO
Remarks:	UNDERSIDE OF FRAME

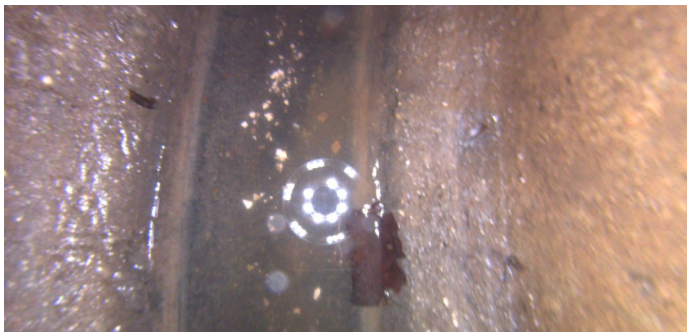
Code:	MGO
Description:	General Observation
Distance (ft):	10.5
Structural Grade:	0
O&M Grade:	0
Clock Start/From:	
Clock To:	
1st Value:	
2nd Value:	
Value Percent:	
Step:	NO
Remarks:	END SURVEY
