Manhole Inspection Report

Date:	04/16/2018	Weather:		Coding:	RZMACP
MH#:	M-910-016	Owner:	NA	Len. Surveyed:	7.7
P.O.#:		Surveyor:	Jen Costello	Rim to Invert:	8.2
Customer:		Cert. #:	U-907-5518	Wall Material:	Concrete (reinforced)

Street:	Norris Dr. 1710' East of Randolph St.	Project:	Hobart, IN
City:	Hobart, IN	GPS Northing:	2911718.303
Location:		GPS Easting:	2911718.303
Drain Area:	Southeast	GPS Accuracy:	Sub-Meter
Cover Shape:	Circular	Evidence of Surcharge:	No
Cover Size:	29.0	Potential for Runoff:	None
Comments:

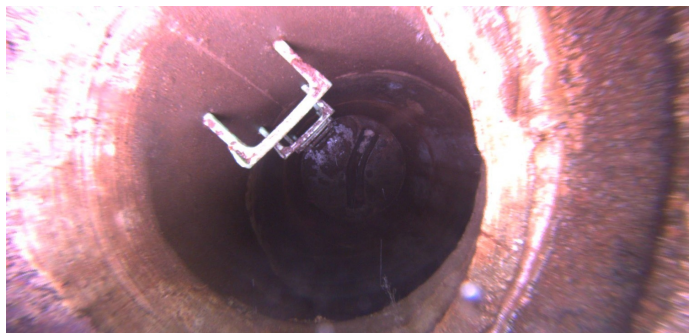
Code: **MGO**
Description: **General Observation**

Distance (ft): **.0**
Structural Grade: **0**
O&M Grade: **0**
Clock Start/From:
Clock To:
1st Value:
2nd Value:
Value Percent:
Step: **NO**
Remarks: **ACCESS MH**

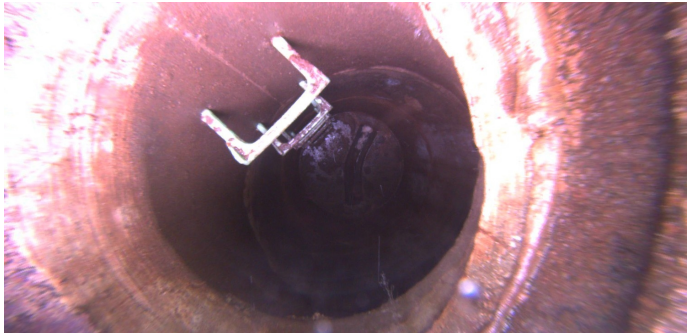
Code: **RFB**
Description: **Roots Fine Barrel**

Distance (ft): **.0**
Structural Grade: **0**
O&M Grade: **2**
Clock Start/From: **5**
Clock To:
1st Value:
2nd Value:
Value Percent:
Step: **NO**
Remarks:
