Manhole Inspection Report

Date:	04/16/2018	Weather:		Coding:	RZMACP
MH#:	M-910-019	Owner:	NA	Len. Surveyed:	7.3
P.O.#:		Surveyor:	Jen Costello	Rim to Invert:	8.2
Customer:		Cert. #:	U-907-5518	Wall Material:	Concrete (reinforced)

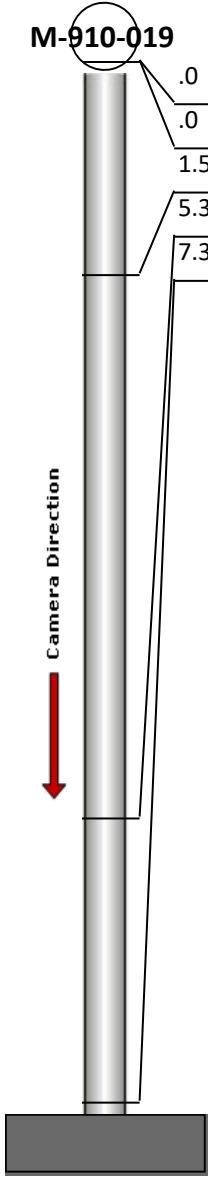
.0	MGO	General Observation	10	NA
	.0	RFJ	Roots Fine Joint	21	M 1
	1.5	MGO	General Observation	37	NA
	5.3	DSF	Deposits Settled Fine	58	M 2
	7.3	DSF	Deposits Settled Fine	74	M 2

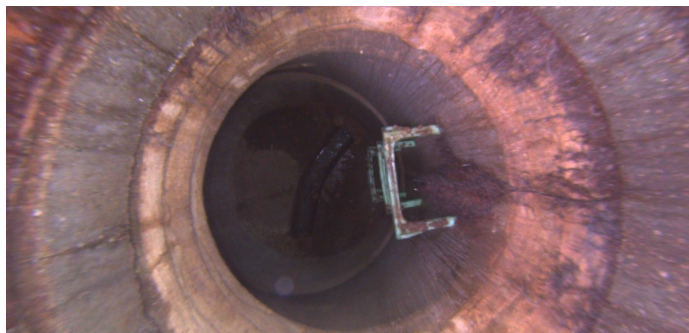
Code: **MGO**
Description: **General Observation**

Distance (ft): **.0**
Structural Grade: **0**
O&M Grade: **0**
Clock Start/From:
Clock To:
1st Value:
2nd Value:
Value Percent:
Step: **NO**
Remarks: **ACCESS MH**

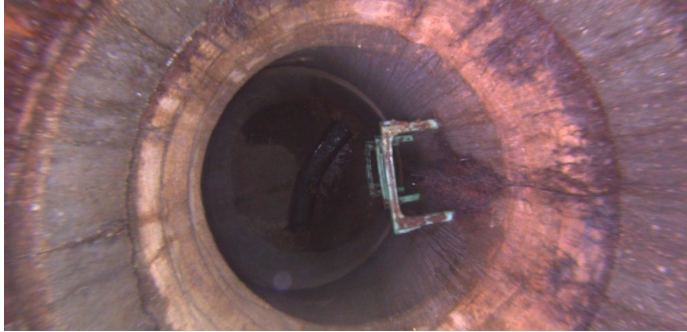
Code: **RFJ**
Description: **Roots Fine Joint**

Distance (ft): **.0**
Structural Grade: **0**
O&M Grade: **1**
Clock Start/From: **12**
Clock To: **12**
1st Value:
2nd Value:
Value Percent:
Step: **NO**
Remarks:

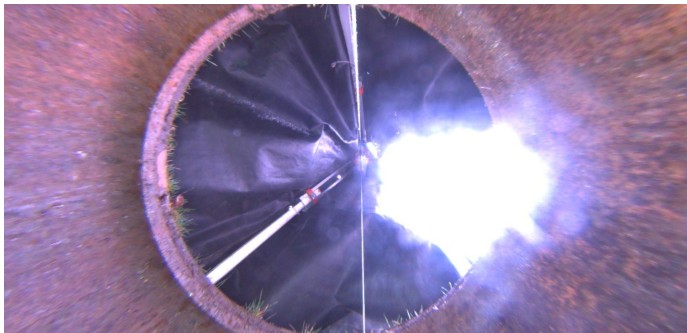
Code: **MGO**
Description: **General Observation**

Distance (ft): **1.5**
Structural Grade: **0**
O&M Grade: **0**
Clock Start/From:
Clock To:
1st Value:
2nd Value:
Value Percent:
Step: **NO**
Remarks: **UNDERSIDE OF FRAME**

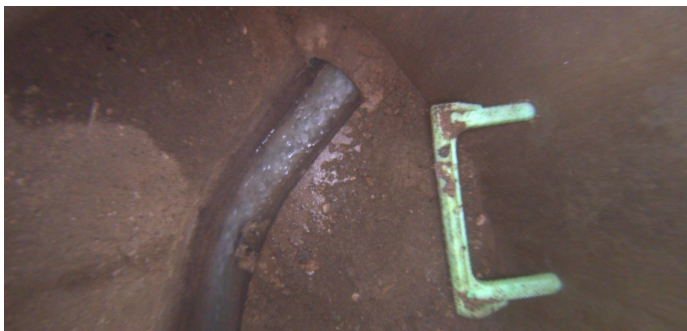
Code: **DSF**
Description: **Deposits Settled Fine**

Distance (ft): **5.3**
Structural Grade: **0**
O&M Grade: **2**
Clock Start/From: **12**
Clock To: **5**
1st Value:
2nd Value:
Value Percent: **5.000**
Step: **NO**
Remarks:

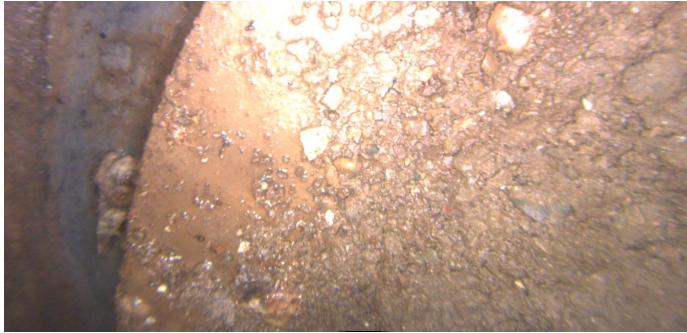
Code:	DSF
Description:	Deposits Settled Fine
Distance (ft):	7.3
Structural Grade:	0
O&M Grade:	2
Clock Start/From:	12
Clock To:	12
1st Value:	
2nd Value:	
Value Percent:	5.000
Step:	NO
Remarks:
