Manhole Inspection Report

Street:	Norris Dr. 1184' East of Randolph St.	Project:	Hobart, IN
City:	Hobart, IN	GPS Northing:	2911206.038
Location:		GPS Easting:	2911206.038
Drain Area:	Southeast	GPS Accuracy:	Sub-Meter
Cover Shape:	Circular	Evidence of Surcharge:	No
Cover Size:	29.0	Potential for Runoff:	None
Comments:

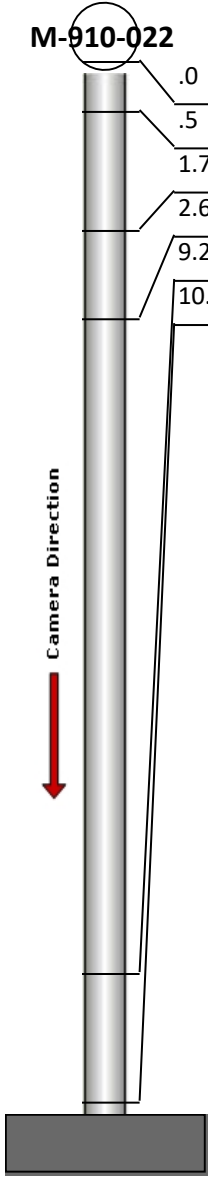
.0	MGO	General Observation	10	NA
	.5	DSF	Deposits Settled Fine	23	M 2
	1.7	IS	Infil Stain	37	NA
	2.6	MGP	General Photo	52	NA
	9.2	DSF	Deposits Settled Fine	79	M 2
	10.5	MGO	General Observation	93	NA

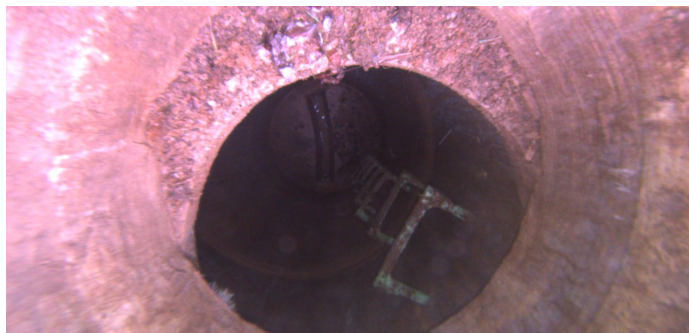
Code: **MGO**
Description: **General Observation**

Distance (ft): **.0**
Structural Grade: **0**
O&M Grade: **0**
Clock Start/From:
Clock To:
1st Value:
2nd Value:
Value Percent:
Step: **NO**
Remarks: **ACCESS MH**

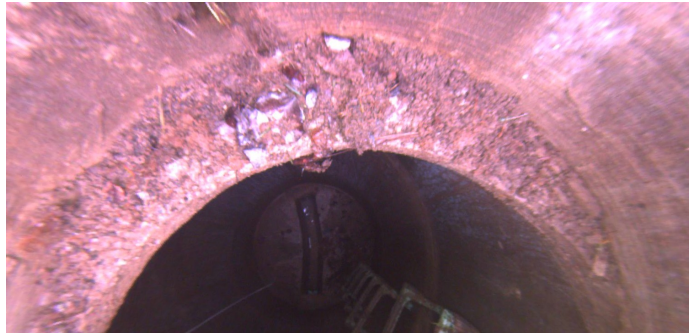
Code: **DSF**
Description: **Deposits Settled Fine**

Distance (ft): **.5**
Structural Grade: **0**
O&M Grade: **2**
Clock Start/From: **9**
Clock To: **3**
1st Value:
2nd Value:
Value Percent: **5.000**
Step: **NO**
Remarks:

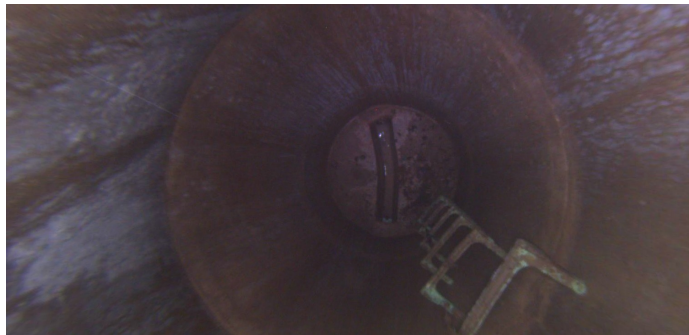
Code: **IS**
Description: **Infil Stain**

Distance (ft): **1.7**
Structural Grade: **0**
O&M Grade: **0**
Clock Start/From: **12**
Clock To: **12**
1st Value:
2nd Value:
Value Percent:
Step: **NO**
Remarks:

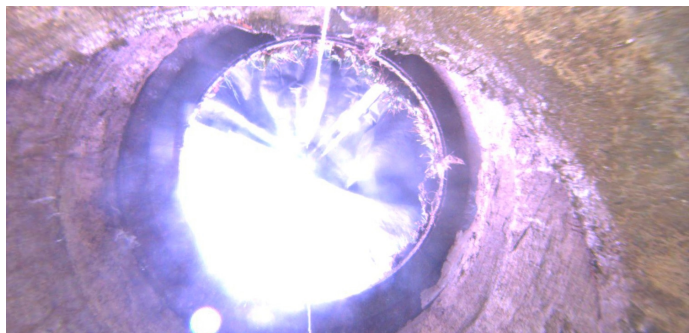
Code: **MGP**
Description: **General Photo**

Distance (ft): **2.6**
Structural Grade: **0**
O&M Grade: **0**
Clock Start/From:
Clock To:
1st Value:
2nd Value:
Value Percent:
Step: **NO**
Remarks: **UNDERSIDE OF FRAME**

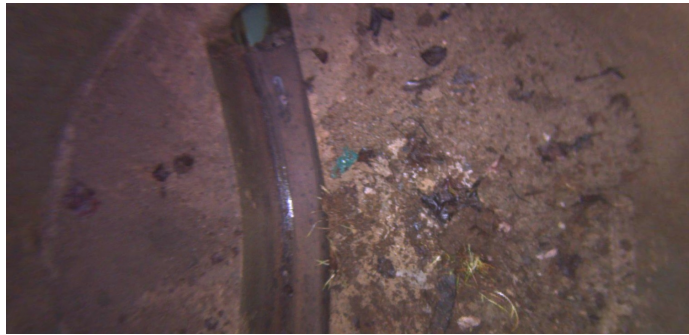
Code:	DSF
Description:	Deposits Settled Fine
Distance (ft):	9.2
Structural Grade:	0
O&M Grade:	2
Clock Start/From:	12
Clock To:	12
1st Value:	
2nd Value:	
Value Percent:	5.000
Step:	NO
Remarks:

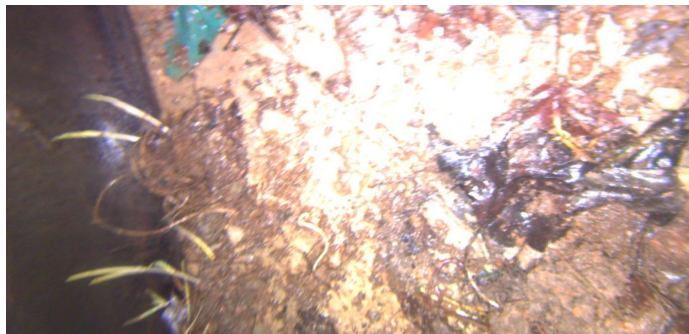
Code:	MGO
Description:	General Observation
Distance (ft):	10.5
Structural Grade:	0
O&M Grade:	0
Clock Start/From:	
Clock To:	
1st Value:	
2nd Value:	
Value Percent:	
Step:	NO
Remarks:	END SURVEY
