Manhole Inspection Report

Date:	04/16/2018	Weather:		Coding:	RZMACP
MH#:	M-910-023	Owner:	NA	Len. Surveyed:	8.0
P.O.#:		Surveyor:	Jen Costello	Rim to Invert:	8.9
Customer:		Cert. #:	U-907-5518	Wall Material:	Concrete (reinforced)

Street:	Norris Dr. 1641' East of Randolph St.	Project:	Hobart, IN
City:	Hobart, IN	GPS Northing:	2911656.846
Location:		GPS Easting:	2911656.846
Drain Area:	Southeast	GPS Accuracy:	Sub-Meter
Cover Shape:	Circular	Evidence of Surcharge:	No
Cover Size:	29.0	Potential for Runoff:	None
Comments:

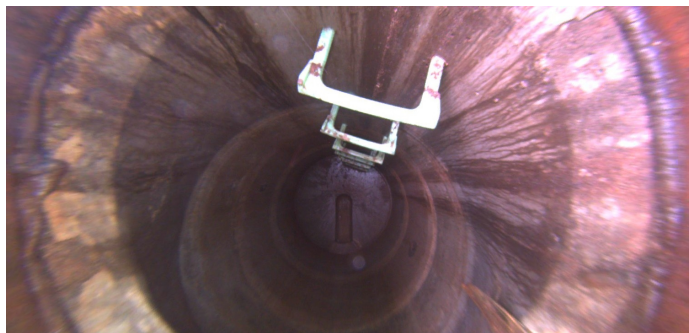
Code: **MGO**
Description: **General Observation**

Distance (ft): **.0**
Structural Grade: **0**
O&M Grade: **0**
Clock Start/From:
Clock To:
1st Value:
2nd Value:
Value Percent:
Step: **NO**
Remarks: **ACCESS MH**

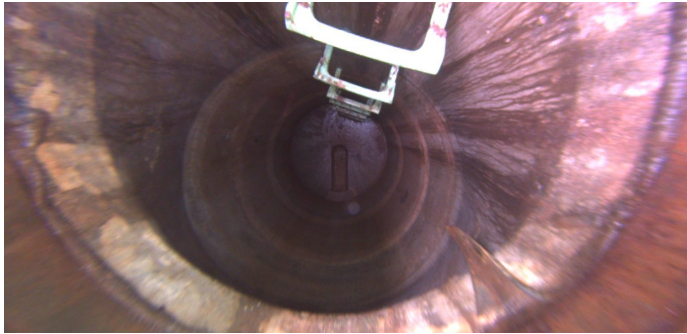
Code: **RFJ**
Description: **Roots Fine Joint**

Distance (ft): **.0**
Structural Grade: **0**
O&M Grade: **1**
Clock Start/From: **5**
Clock To:
1st Value:
2nd Value:
Value Percent:
Step: **NO**
Remarks:

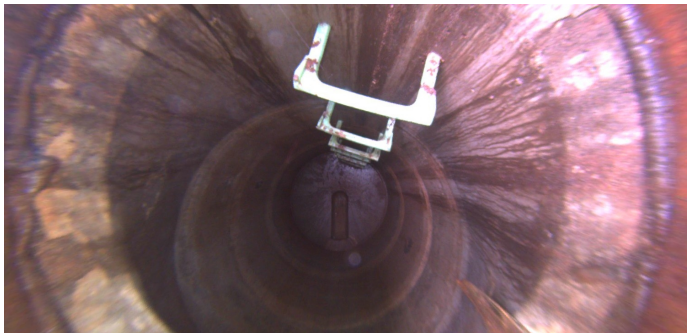
Code: **IW**
Description: **Infil Weeper**

Distance (ft): **.0**
Structural Grade: **0**
O&M Grade: **2**
Clock Start/From: **12**
Clock To: **12**
1st Value:
2nd Value:
Value Percent:
Step: **NO**
Remarks:

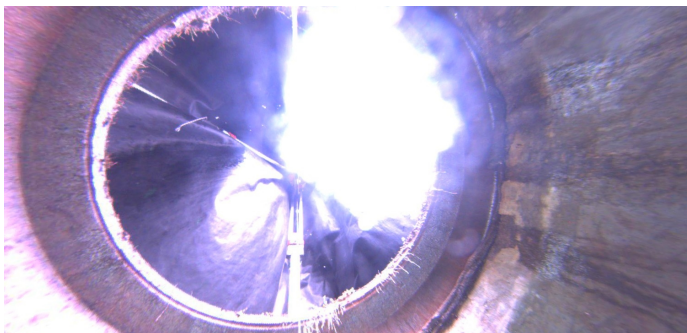
Code: **MGO**
Description: **General Observation**

Distance (ft): **1.5**
Structural Grade: **0**
O&M Grade: **0**
Clock Start/From:
Clock To:
1st Value:
2nd Value:
Value Percent:
Step: **NO**
Remarks: **UNDERSIDE OF FRAME**

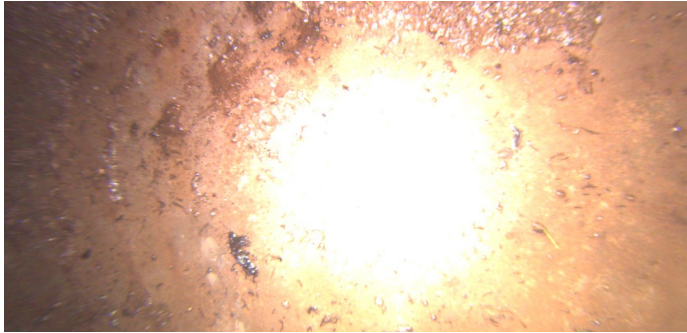
Code:	MGO
Description:	General Observation
Distance (ft):	8.0
Structural Grade:	0
O&M Grade:	0
Clock Start/From:	
Clock To:	
1st Value:	
2nd Value:	
Value Percent:	
Step:	NO
Remarks:	END SURVEY
