Manhole Inspection Report

Date:	11/01/2022	Weather:		Coding:	RZMACP
MH#:	M-910-024	Owner:	NA	Len. Surveyed:	10.6
P.O.#:		Surveyor:	Jen Costello	Rim to Invert:	11.5
Customer:		Cert. #:	U-907-5518	Wall Material:	Concrete (non-reinforced)

Street:	Norris Dr. 1361' East of Randolph St.	Project:	Missing GPS
City:	Hobart, IN	GPS Northing:	2276888.284
Location:		GPS Easting:	2911378.476
Drain Area:	Southeast	GPS Accuracy:	Sub-Meter
Cover Shape:	Circular	Evidence of Surcharge:	No
Cover Size:	24.0	Potential for Runoff:	None
Comments:

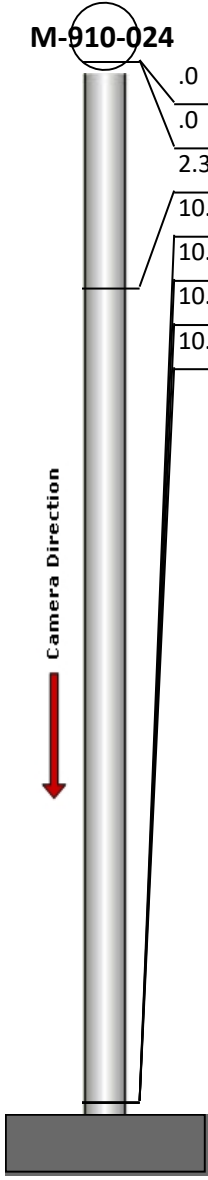
M-910-024				
	.0	SRI	Surface Roughness Increased	10	S 1
	.0	MGO	General Observation	21	NA
	2.3	MGO	General Observation	39	NA
	10.6	DSF	Deposits Settled Fine	70	M 2
	10.6	SRI	Surface Roughness Increased	81	S 1
	10.6	MGO	General Observation	92	NA
	10.6	SRI	Surface Roughness Increased	103	S 1

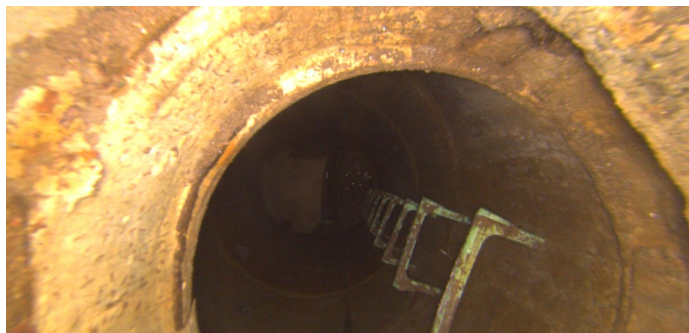
Code: **SRI**
 Description: **Surface Roughness Increased**

Distance (ft): **.0**
 Structural Grade: **1**
 O&M Grade: **0**
 Clock Start/From: **12**
 Clock To: **12**
 1st Value:
 2nd Value:
 Value Percent:
 Step: **NO**
 Remarks:

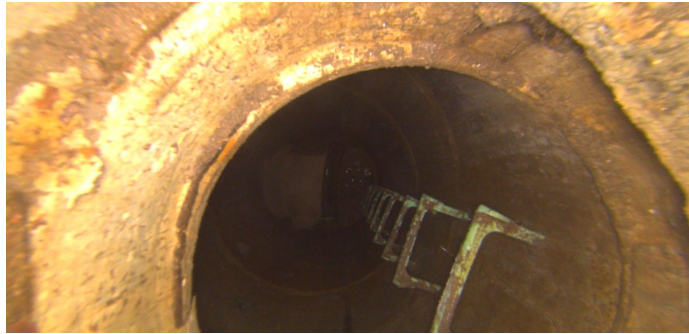
Code: **MGO**
Description: **General Observation**

Distance (ft): **.0**
Structural Grade: **0**
O&M Grade: **0**
Clock Start/From:
Clock To:
1st Value:
2nd Value:
Value Percent:
Step: **NO**
Remarks: **access mh**

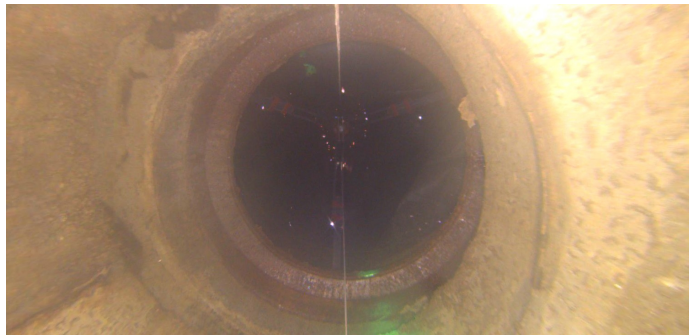
Code: **MGO**
Description: **General Observation**

Distance (ft): **2.3**
Structural Grade: **0**
O&M Grade: **0**
Clock Start/From:
Clock To:
1st Value:
2nd Value:
Value Percent:
Step: **NO**
Remarks: **underside of frame**

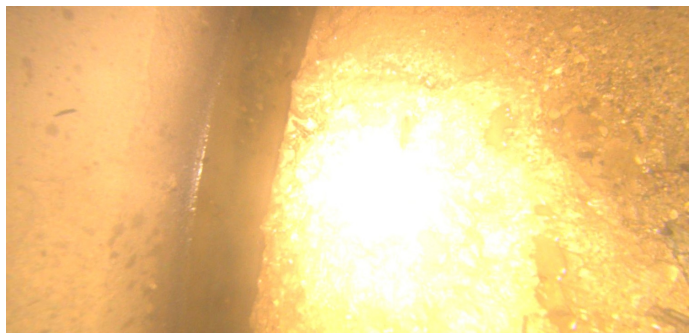
Code: **DSF**
Description: **Deposits Settled Fine**

Distance (ft): **10.6**
Structural Grade: **0**
O&M Grade: **2**
Clock Start/From: **12**
Clock To: **12**
1st Value:
2nd Value:
Value Percent: **5.000**
Step: **NO**
Remarks:

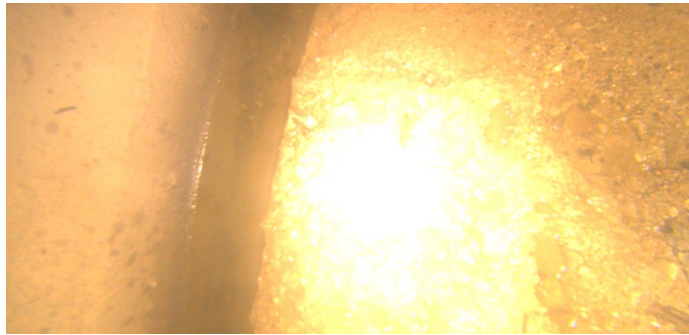
Code: **SRI**
Description: **Surface Roughness Increased**

Distance (ft): **10.6**
Structural Grade: **1**
O&M Grade: **0**
Clock Start/From: **12**
Clock To: **12**
1st Value:
2nd Value:
Value Percent:
Step: **NO**
Remarks:

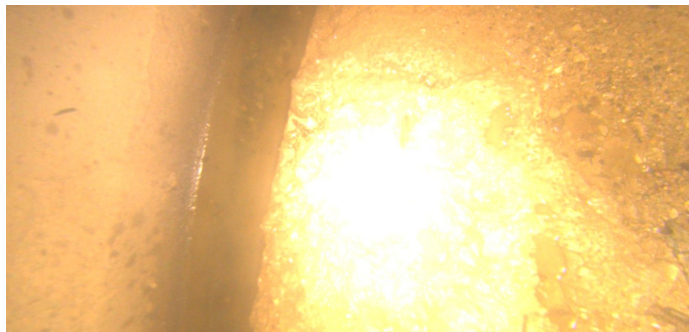
Code: **MGO**
Description: **General Observation**

Distance (ft): **10.6**
Structural Grade: **0**
O&M Grade: **0**
Clock Start/From:
Clock To:
1st Value:
2nd Value:
Value Percent:
Step: **NO**
Remarks: **end of survey**

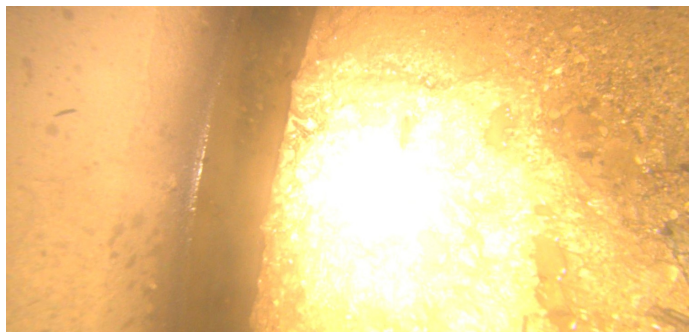
Code: **SRI**
Description: **Surface Roughness Increased**

Distance (ft): **10.6**
Structural Grade: **1**
O&M Grade: **0**
Clock Start/From: **3**
Clock To: **9**
1st Value:
2nd Value:
Value Percent:
Step: **NO**
Remarks:
