Profile/Photo Observation Report

Date:	03/26/2018	Weather:		Coding:	PACP 6.0
Pipe Length (ft):	78.0	Owner:	NA	Pre Clean:	Not Known
P.O.#:		Surveyor:	Byrd Fitzgerald	PSR:	P-1003-003-LS025
Customer:		Clean Date:	01/01/1900	Shape:	C

Street:	E 37TH AV & N COUNTY LINE RD	Flow Control:	Not Controlled
City:	Hobart, IN	Year Renewed:	
Location:	Other	Tape/Media #:	
Purpose:	Not Known	Dia/Height:	10"
Use:	Sanitary	Material:	PVC
Drain Area:	NA	Lining:	
Category:	NA		
Comment:			
Location Details:		Direction of Survey:	Downstream
US MH:	M-1003-003	DS MH:	M-1003-003
		Total Length Surveyed (ft):	68.9

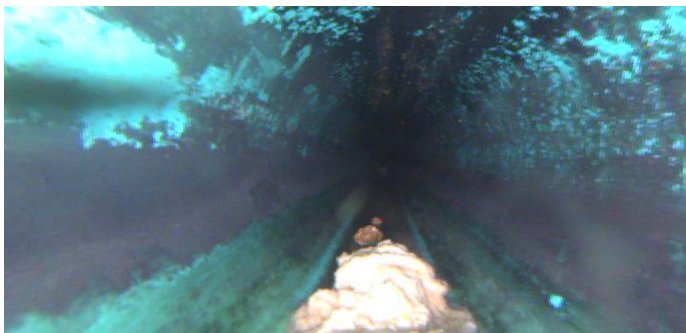
Code: **AMH**
Description: **Manhole**

Distance (ft): **.0**
Structural Grade: **0**
O&M Grade: **0**
Clock Start/From:
Clock To:
1st Value:
2nd Value:
Value Percent:
Continuous Index:
Within 8" of Joint: **NO**
Remarks: **M-1003-003**

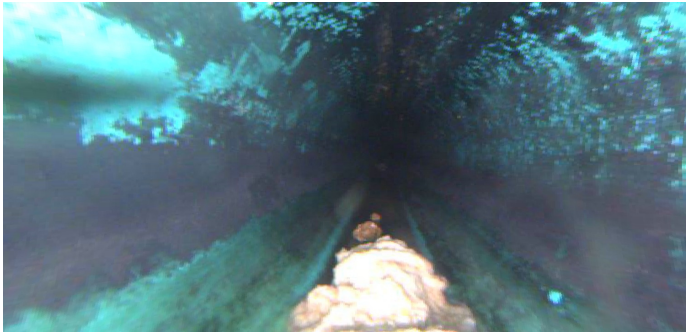
Code:	MWL
Description:	Water Level

Distance (ft):	.0
Structural Grade:	0
O&M Grade:	0
Clock Start/From:	
Clock To:	
1st Value:	
2nd Value:	
Value Percent:	5.000
Continuous Index:	
Within 8" of Joint:	NO
Remarks:

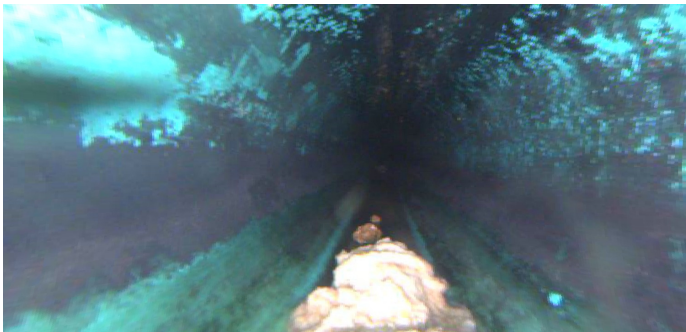
Code:	DSZ
Description:	Deposits Settled Other

Distance (ft):	.0
Structural Grade:	0
O&M Grade:	2
Clock Start/From:	6
Clock To:	
1st Value:	
2nd Value:	
Value Percent:	5.000
Continuous Index:	
Within 8" of Joint:	NO
Remarks:	tissue

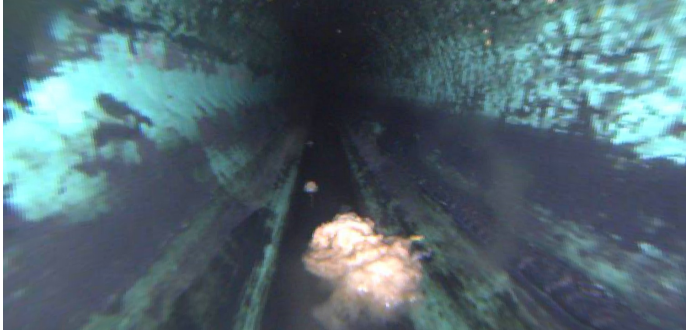
Code: **DSZ**
Description: **Deposits Settled Other**

Distance (ft): **13.2**
Structural Grade: **0**
O&M Grade: **2**
Clock Start/From: **6**
Clock To:
1st Value:
2nd Value:
Value Percent: **5.000**
Continuous Index:
Within 8" of Joint: **NO**
Remarks: **tissue**

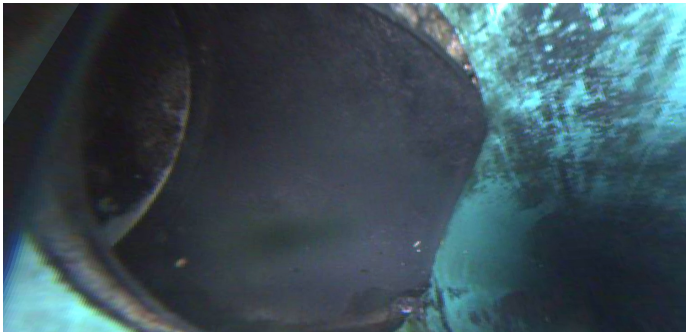
Code: **TF**
Description: **Tap Factory**

Distance (ft): **58.2**
Structural Grade: **0**
O&M Grade: **0**
Clock Start/From: **10**
Clock To:
1st Value: **6.000**
2nd Value:
Value Percent:
Continuous Index:
Within 8" of Joint:
Remarks:
