## Profile/Photo Observation Report

Street:	<b>E 37TH AV</b>	Flow Control:	<b>Not Controlled</b>
City:	<b>Hobart, IN</b>	Year Renewed:	
Location:	<b>Other</b>	Tape/Media #:	
Purpose:	<b>Not Known</b>	Dia/Height:	<b>10"</b>
Use:	<b>Sanitary</b>	Material:	<b>PVC</b>
Drain Area:	<b>NA</b>	Lining:	
Category:	<b>NA</b>		
Comment:

Location Details:		Direction of Survey:	<b>Downstream</b>
US MH:	<b>M-1003-003</b>	DS MH:	<b>M-1003-003</b>
		Total Length Surveyed (ft):	<b>68.9</b>

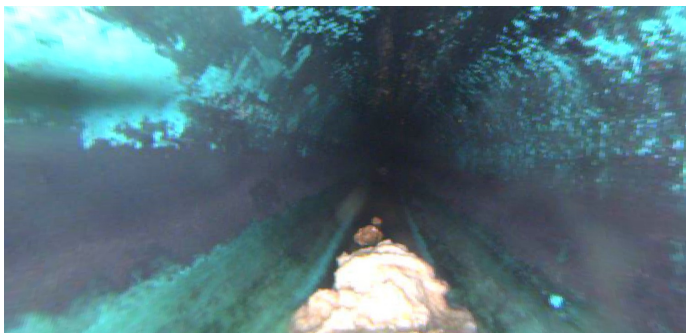
Code: **AMH**  
Description: **Manhole**

Distance (ft): **.0**  
Structural Grade: **0**  
O&M Grade: **0**  
Clock Start/From:  
Clock To:  
1st Value:  
2nd Value:  
Value Percent:  
Continuous Index:  
Within 8" of Joint: **NO**  
Remarks: **M-1003-003**

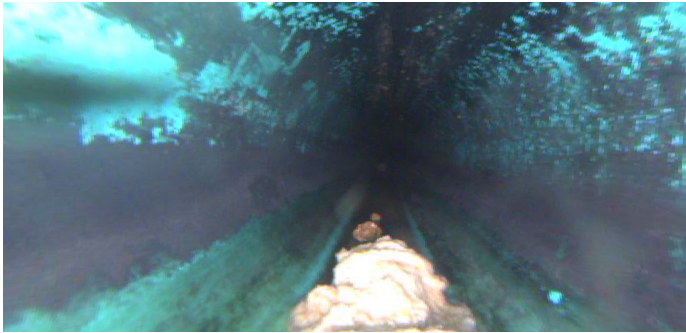
Code:	<b>MWL</b>
Description:	<b>Water Level</b>

Distance (ft):	<b>.0</b>
Structural Grade:	<b>0</b>
O&M Grade:	<b>0</b>
Clock Start/From:	
Clock To:	
1st Value:	
2nd Value:	
Value Percent:	<b>5.000</b>
Continuous Index:	
Within 8" of Joint:	<b>NO</b>
Remarks:

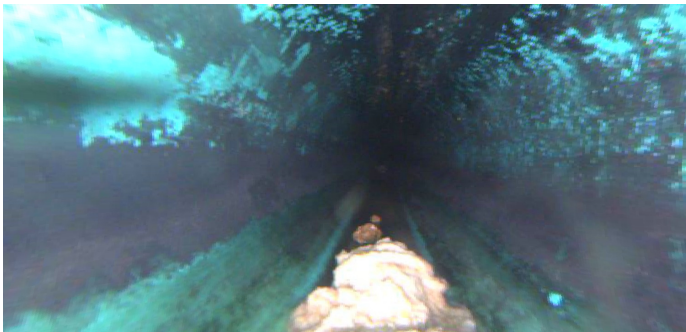
Code:	<b>DSZ</b>
Description:	<b>Deposits Settled Other</b>

Distance (ft):	<b>.0</b>
Structural Grade:	<b>0</b>
O&M Grade:	<b>2</b>
Clock Start/From:	<b>6</b>
Clock To:	
1st Value:	
2nd Value:	
Value Percent:	<b>5.000</b>
Continuous Index:	
Within 8" of Joint:	<b>NO</b>
Remarks:	<b>tissue</b>

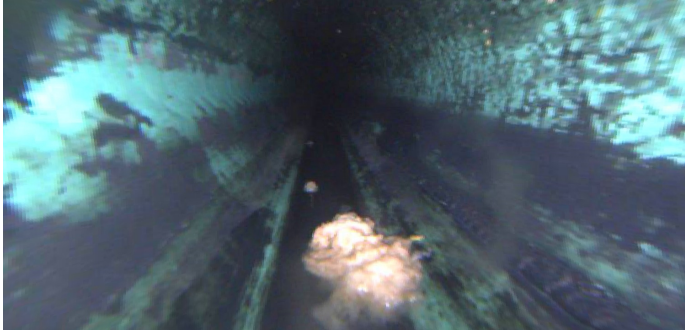
Code: **DSZ**  
Description: **Deposits Settled Other**

Distance (ft): **13.2**  
Structural Grade: **0**  
O&M Grade: **2**  
Clock Start/From: **6**  
Clock To:  
1st Value:  
2nd Value:  
Value Percent: **5.000**  
Continuous Index:  
Within 8" of Joint: **NO**  
Remarks: **tissue**

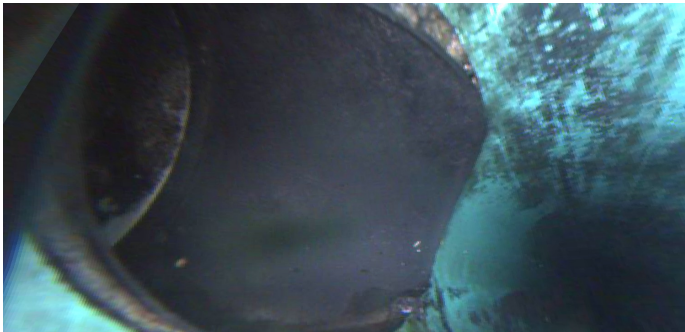
Code: **TF**  
Description: **Tap Factory**

Distance (ft): **58.2**  
Structural Grade: **0**  
O&M Grade: **0**  
Clock Start/From: **10**  
Clock To:  
1st Value: **6.000**  
2nd Value:  
Value Percent:  
Continuous Index:  
Within 8" of Joint:  
Remarks:
