Profile/Photo Observation Report

Date:	04/14/2018	Weather:		Coding:	PACP 6.0
Pipe Length (ft):	287.2	Owner:	NA	Pre Clean:	Not Known
P.O.#:		Surveyor:	Jen Costello	PSR:	P-1004-001-002
Customer:		Clean Date:	01/01/1900	Shape:	C

Street:	E CLEVELAND AV	Flow Control:	Not Controlled
City:	Hobart, IN	Year Renewed:	
Location:	Other	Tape/Media #:	
Purpose:	Not Known	Dia/Height:	8"
Use:	Sanitary	Material:	PVC
Drain Area:	NA	Lining:	
Category:	NA		
Comment:

Location Details:		Direction of Survey:	Upstream
US MH:	M-1004-002	DS MH:	M-1004-001
		Total Length Surveyed (ft):	282.2

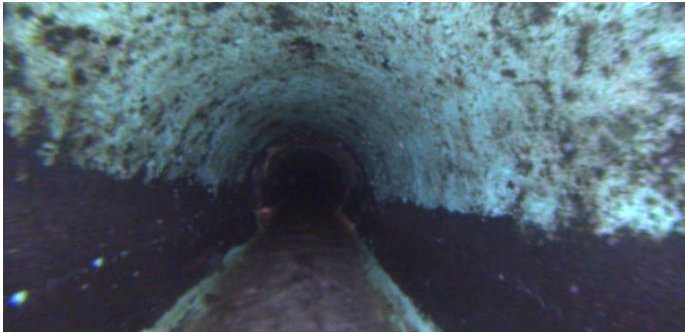
Code: **AMH**
Description: **Manhole**

Code:	MWL
Description:	Water Level

Distance (ft):	.0
Structural Grade:	0
O&M Grade:	0
Clock Start/From:	
Clock To:	
1st Value:	
2nd Value:	
Value Percent:	5.000
Continuous Index:	
Within 8" of Joint:	NO
Remarks:

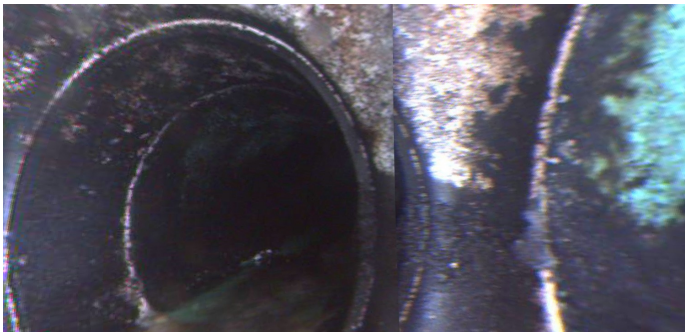
Code:	TFA
Description:	Tap Factory Active

Distance (ft):	3.3
Structural Grade:	0
O&M Grade:	0
Clock Start/From:	9
Clock To:	
1st Value:	4.000
2nd Value:	
Value Percent:	
Continuous Index:	
Within 8" of Joint:	
Remarks:

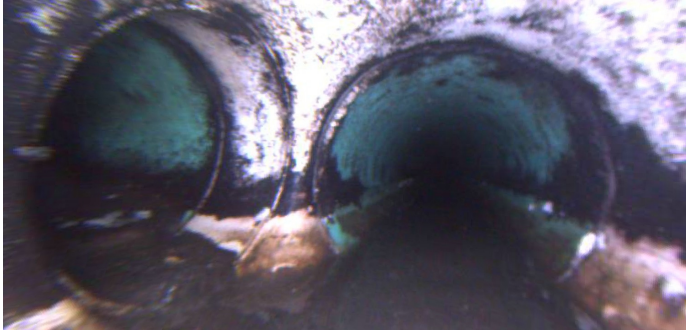
Code: **TFA**
Description: **Tap Factory Active**

Distance (ft): **70.6**
Structural Grade: **0**
O&M Grade: **0**
Clock Start/From: **9**
Clock To:
1st Value: **4.000**
2nd Value:
Value Percent:
Continuous Index:
Within 8" of Joint:
Remarks:

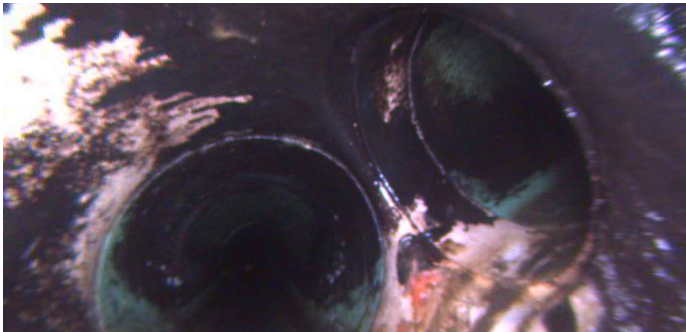
Code: **TFA**
Description: **Tap Factory Active**

Distance (ft): **94.5**
Structural Grade: **0**
O&M Grade: **0**
Clock Start/From: **2**
Clock To:
1st Value: **4.000**
2nd Value:
Value Percent:
Continuous Index:
Within 8" of Joint:
Remarks:

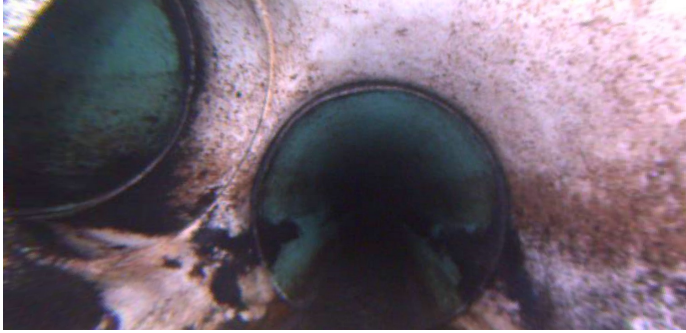
Code: **TF**
Description: **Tap Factory**

Distance (ft): **136.0**
Structural Grade: **0**
O&M Grade: **0**
Clock Start/From: **10**
Clock To:
1st Value: **4.000**
2nd Value:
Value Percent:
Continuous Index:
Within 8" of Joint:
Remarks:

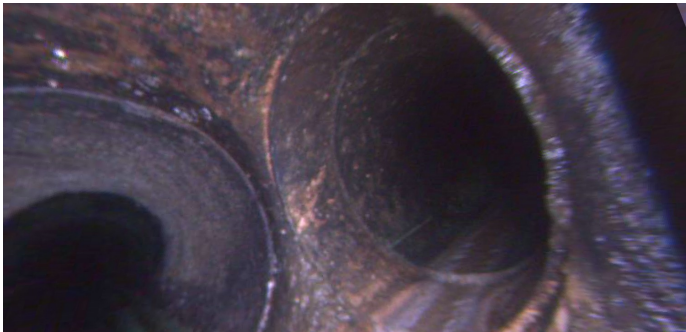
Code: **TF**
Description: **Tap Factory**

Distance (ft): **167.7**
Structural Grade: **0**
O&M Grade: **0**
Clock Start/From: **3**
Clock To:
1st Value: **4.000**
2nd Value:
Value Percent:
Continuous Index:
Within 8" of Joint:
Remarks:

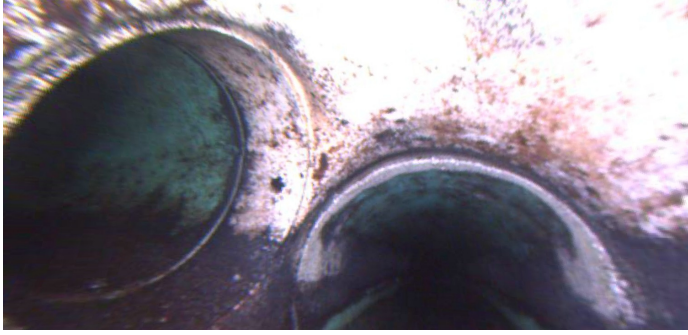
Code: **TF**
Description: **Tap Factory**

Distance (ft): **209.7**
Structural Grade: **0**
O&M Grade: **0**
Clock Start/From: **10**
Clock To:
1st Value: **4.000**
2nd Value:
Value Percent:
Continuous Index:
Within 8" of Joint:
Remarks:

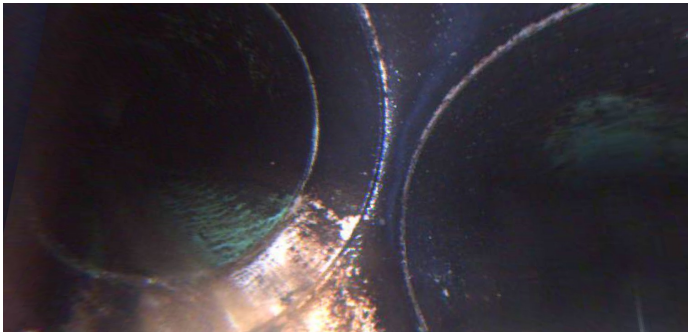
Code: **TFA**
Description: **Tap Factory Active**

Distance (ft): **244.6**
Structural Grade: **0**
O&M Grade: **0**
Clock Start/From: **3**
Clock To:
1st Value: **4.000**
2nd Value:
Value Percent:
Continuous Index:
Within 8" of Joint:
Remarks:

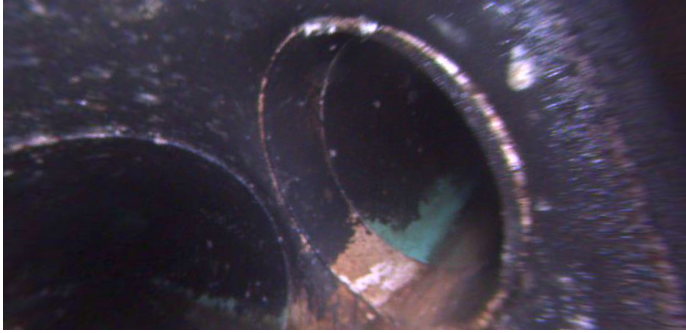
Code: **TF**
Description: **Tap Factory**

Distance (ft): **267.0**
Structural Grade: **0**
O&M Grade: **0**
Clock Start/From: **2**
Clock To:
1st Value: **4.000**
2nd Value:
Value Percent:
Continuous Index:
Within 8" of Joint:
Remarks:

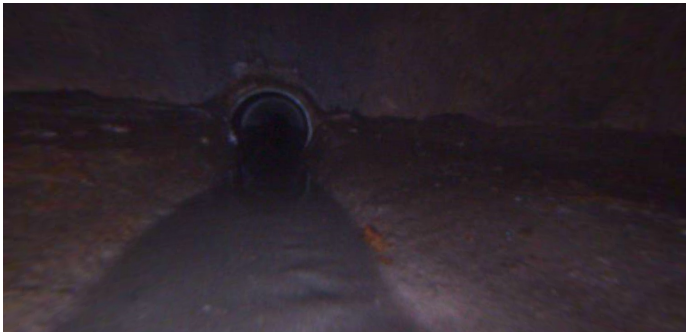
Code: **AMH**
Description: **Manhole**

Distance (ft): **282.2**
Structural Grade: **0**
O&M Grade: **0**
Clock Start/From:
Clock To:
1st Value:
2nd Value:
Value Percent:
Continuous Index:
Within 8" of Joint: **NO**
Remarks: **M-1004-002**
