Profile/Photo Observation Report

Date:	04/14/2018	Weather:		Coding:	PACP 6.0
Pipe Length (ft):	303.8	Owner:	NA	Pre Clean:	Not Known
P.O.#:		Surveyor:	Jen Costello	PSR:	P-1004-002-003
Customer:		Clean Date:	01/01/1900	Shape:	C

Street:	E CLEVELAND AV	Flow Control:	Not Controlled
City:	Hobart, IN	Year Renewed:	
Location:	Other	Tape/Media #:	
Purpose:	Not Known	Dia/Height:	8"
Use:	Sanitary	Material:	PVC
Drain Area:	NA	Lining:	
Category:	NA		
Comment:

Location Details:		Direction of Survey:	Downstream
US MH:	M-1004-003	DS MH:	M-1004-002
		Total Length Surveyed (ft):	299.3

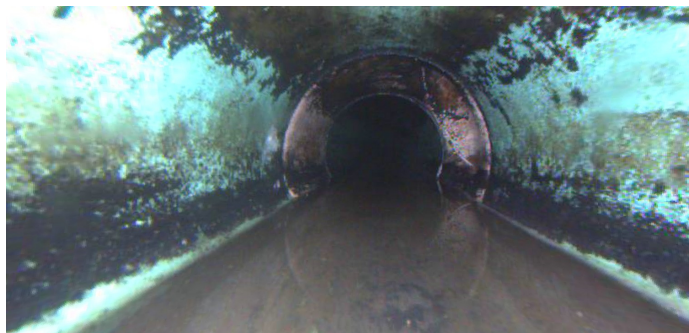
Code: **AMH**
 Description: **Manhole**
 Distance (ft): **.0**
 Structural Grade: **0**
 O&M Grade: **0**
 Clock Start/From:
 Clock To:
 1st Value:
 2nd Value:
 Value Percent:
 Continuous Index:
 Within 8" of Joint: **NO**
 Remarks: **M-1004-003**

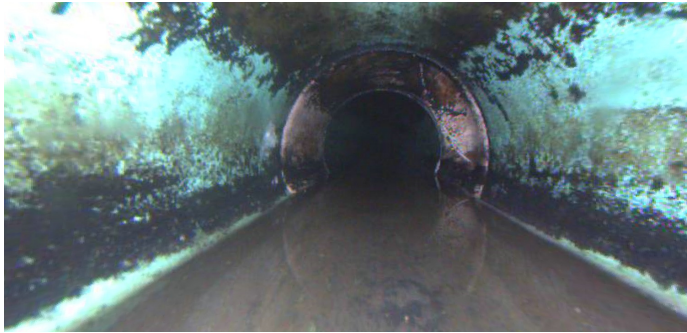
Code: **MWL**
Description: **Water Level**

Distance (ft): **.0**
Structural Grade: **0**
O&M Grade: **0**
Clock Start/From:
Clock To:
1st Value:
2nd Value:
Value Percent: **30.000**
Continuous Index:
Within 8" of Joint: **NO**
Remarks:

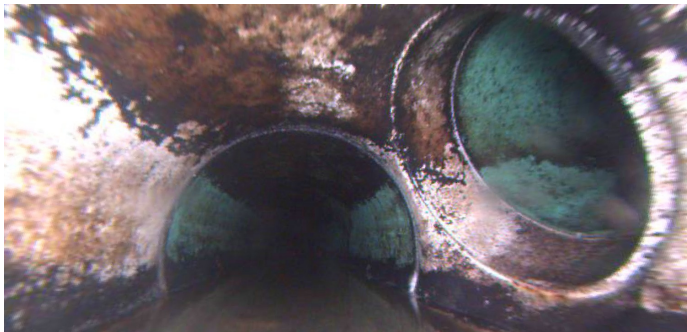
Code: **TF**
Description: **Tap Factory**

Distance (ft): **2.0**
Structural Grade: **0**
O&M Grade: **0**
Clock Start/From: **3**
Clock To:
1st Value: **4.000**
2nd Value:
Value Percent:
Continuous Index:
Within 8" of Joint:
Remarks:

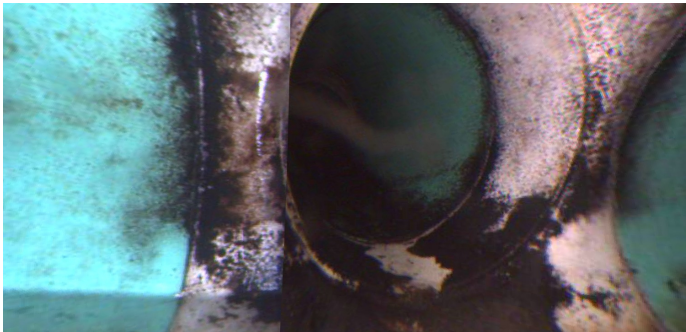
Code: **TF**
Description: **Tap Factory**

Distance (ft): **158.2**
Structural Grade: **0**
O&M Grade: **0**
Clock Start/From: **3**
Clock To:
1st Value: **4.000**
2nd Value:
Value Percent:
Continuous Index:
Within 8" of Joint:
Remarks:

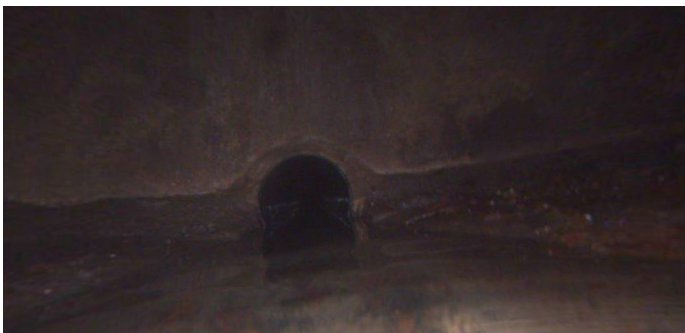
Code: **AMH**
Description: **Manhole**

Distance (ft): **299.3**
Structural Grade: **0**
O&M Grade: **0**
Clock Start/From:
Clock To:
1st Value:
2nd Value:
Value Percent:
Continuous Index:
Within 8" of Joint: **NO**
Remarks: **M-1004-002**
