## Profile/Photo Observation Report

Street:	<b>E Cleveland Ave.</b>	Flow Control:	<b>Not Controlled</b>
City:	<b>Hobart, IN</b>	Year Renewed:	
Location:	<b>Other</b>	Tape/Media #:	
Purpose:	<b>Not Known</b>	Dia/Height:	<b>8"</b>
Use:	<b>Sanitary</b>	Material:	<b>PVC</b>
Drain Area:	<b>NA</b>	Lining:	
Category:	<b>NA</b>		
Comment:

Location Details:		Direction of Survey:	<b>Downstream</b>
US MH:	<b>M-1004-003</b>	DS MH:	<b>M-1004-002</b>
		Total Length Surveyed (ft):	<b>299.3</b>

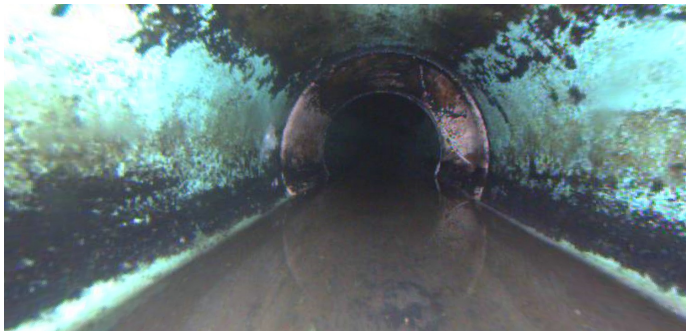
Code: **AMH**  
Description: **Manhole**

Distance (ft): **.0**  
Structural Grade: **0**  
O&M Grade: **0**  
Clock Start/From:  
Clock To:  
1st Value:  
2nd Value:  
Value Percent:  
Continuous Index:  
Within 8" of Joint: **NO**  
Remarks: **M-1004-003**

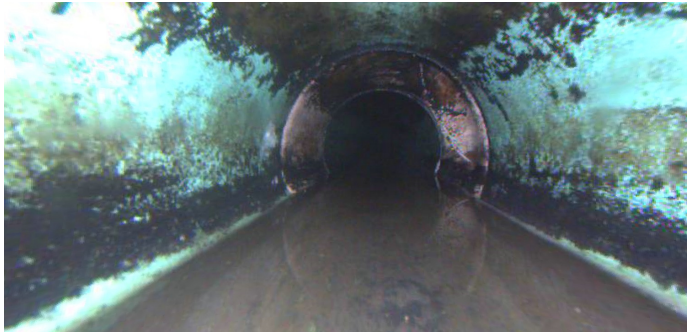
Code: **MWL**  
Description: **Water Level**

Distance (ft): **.0**  
Structural Grade: **0**  
O&M Grade: **0**  
Clock Start/From:  
Clock To:  
1st Value:  
2nd Value:  
Value Percent: **30.000**  
Continuous Index:  
Within 8" of Joint: **NO**  
Remarks:

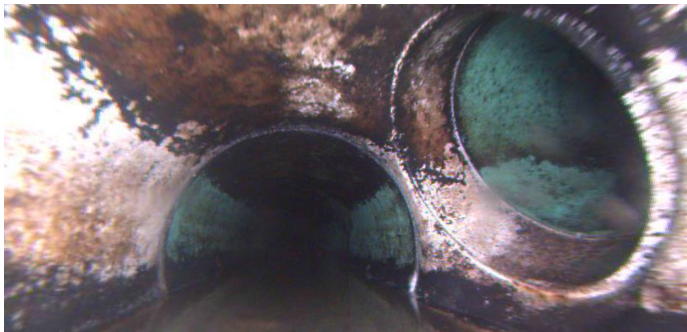
Code: **TF**  
Description: **Tap Factory**

Distance (ft): **2.0**  
Structural Grade: **0**  
O&M Grade: **0**  
Clock Start/From: **3**  
Clock To:  
1st Value: **4.000**  
2nd Value:  
Value Percent:  
Continuous Index:  
Within 8" of Joint:  
Remarks:

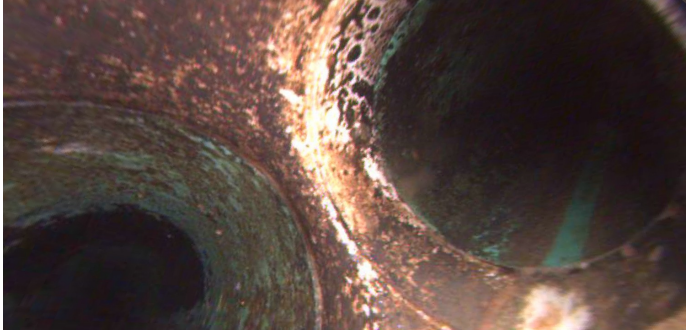
Code: **TF**  
Description: **Tap Factory**

Distance (ft): **132.0**  
Structural Grade: **0**  
O&M Grade: **0**  
Clock Start/From: **10**  
Clock To:  
1st Value: **4.000**  
2nd Value:  
Value Percent:  
Continuous Index:  
Within 8" of Joint:  
Remarks:

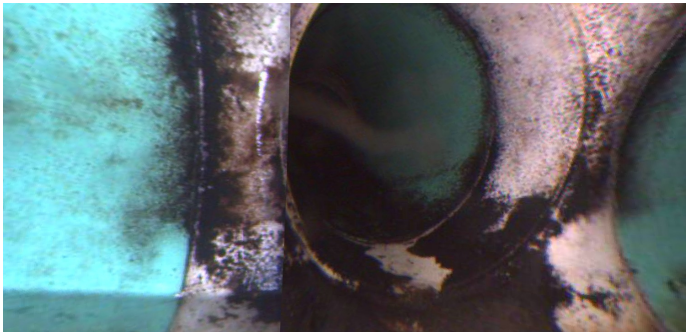
Code: **TF**  
Description: **Tap Factory**

Distance (ft): **158.2**  
Structural Grade: **0**  
O&M Grade: **0**  
Clock Start/From: **3**  
Clock To:  
1st Value: **4.000**  
2nd Value:  
Value Percent:  
Continuous Index:  
Within 8" of Joint:  
Remarks:

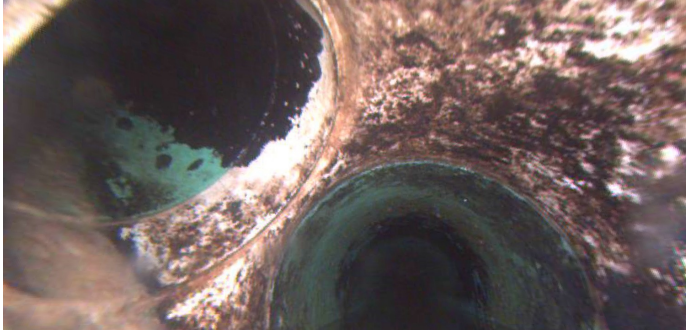
Code: **TFA**  
Description: **Tap Factory Active**

Distance (ft): **203.8**  
Structural Grade: **0**  
O&M Grade: **0**  
Clock Start/From: **10**  
Clock To:  
1st Value: **4.000**  
2nd Value:  
Value Percent:  
Continuous Index:  
Within 8" of Joint:  
Remarks:

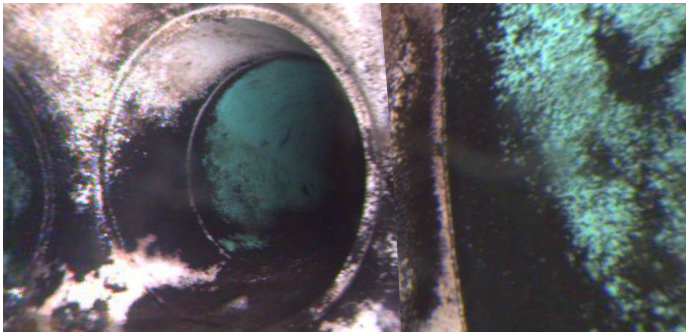
Code: **TF**  
Description: **Tap Factory**

Distance (ft): **226.3**  
Structural Grade: **0**  
O&M Grade: **0**  
Clock Start/From: **3**  
Clock To:  
1st Value: **4.000**  
2nd Value:  
Value Percent:  
Continuous Index:  
Within 8" of Joint:  
Remarks:

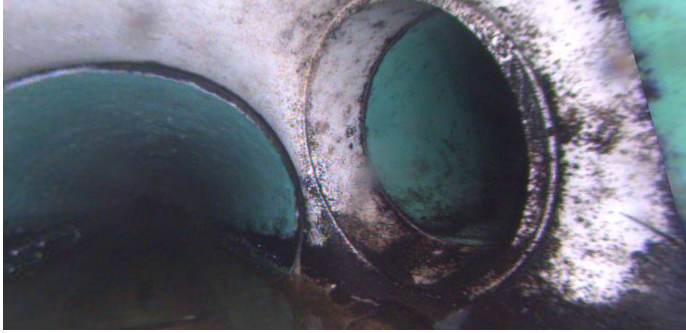
Code: **TF**  
Description: **Tap Factory**

Distance (ft): **291.0**  
Structural Grade: **0**  
O&M Grade: **0**  
Clock Start/From: **2**  
Clock To:  
1st Value: **4.000**  
2nd Value:  
Value Percent:  
Continuous Index:  
Within 8" of Joint:  
Remarks:

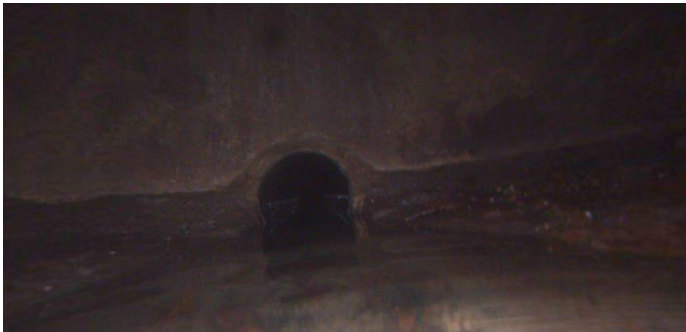
Code: **AMH**  
Description: **Manhole**

Distance (ft): **299.3**  
Structural Grade: **0**  
O&M Grade: **0**  
Clock Start/From:  
Clock To:  
1st Value:  
2nd Value:  
Value Percent:  
Continuous Index:  
Within 8" of Joint: **NO**  
Remarks: **M-1004-002**
