## Profile/Photo Observation Report

Date:	<b>04/14/2018</b>	Weather:		Coding:	<b>PACP 6.0</b>
Pipe Length (ft):	<b>368.3</b>	Owner:	<b>NA</b>	Pre Clean:	<b>Not Known</b>
P.O.#:		Surveyor:	<b>Jen Costello</b>	PSR:	<b>P-1004-007-008</b>
Customer:		Clean Date:	<b>01/01/1900</b>	Shape:	<b>C</b>

Street:	<b>Coral Dr.</b>	Flow Control:	<b>Not Controlled</b>
City:	<b>Hobart, IN</b>	Year Renewed:	
Location:	<b>Other</b>	Tape/Media #:	
Purpose:	<b>Not Known</b>	Dia/Height:	<b>10"</b>
Use:	<b>Sanitary</b>	Material:	<b>PVC</b>
Drain Area:	<b>NA</b>	Lining:	
Category:	<b>NA</b>		
Comment:	<b>NULL - CNA DC at MH-M-804-023</b>

Location Details:		Direction of Survey:	<b>Downstream</b>
US MH:	<b>M-1004-008</b>	DS MH:	<b>M-1004-007</b>
		Total Length Surveyed (ft):	<b>362.0</b>

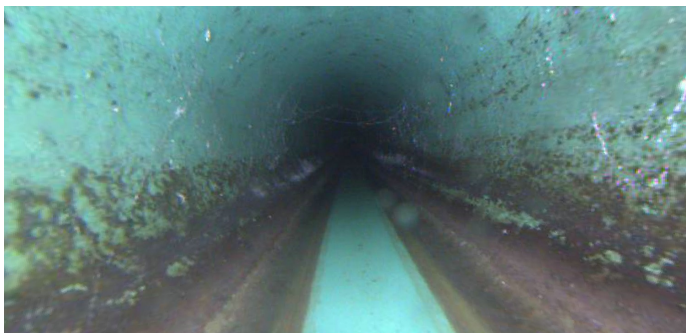
Code:	AMH
Description:	Manhole
Distance (ft):	.0
Structural Grade:	0
O&M Grade:	0
Clock Start/From:	
Clock To:	
1st Value:	
2nd Value:	
Value Percent:	
Continuous Index:	
Within 8" of Joint:	NO
Remarks:	M-1004-008

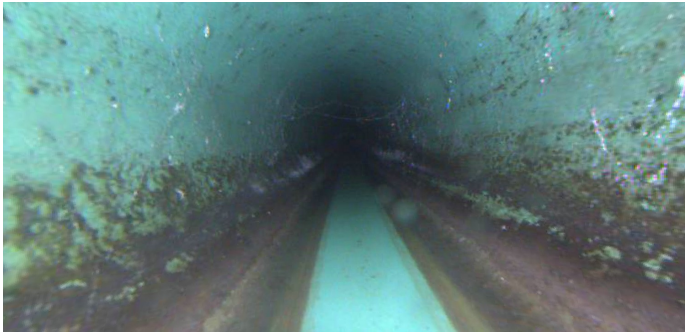
Code:	<b>MWL</b>
Description:	<b>Water Level</b>

Distance (ft):	<b>.0</b>
Structural Grade:	<b>0</b>
O&M Grade:	<b>0</b>
Clock Start/From:	
Clock To:	
1st Value:	
2nd Value:	
Value Percent:	<b>5.000</b>
Continuous Index:	
Within 8" of Joint:	<b>NO</b>
Remarks:

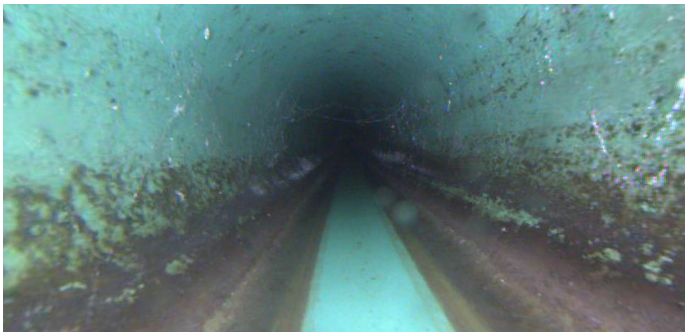
Code:	<b>DAGS</b>
Description:	<b>Deposits Attached Grease</b>

Distance (ft):	<b>.0</b>
Structural Grade:	<b>0</b>
O&M Grade:	<b>2</b>
Clock Start/From:	<b>8</b>
Clock To:	<b>7</b>
1st Value:	
2nd Value:	
Value Percent:	<b>5.000</b>
Continuous Index:	<b>S01</b>
Within 8" of Joint:	<b>NO</b>
Remarks:

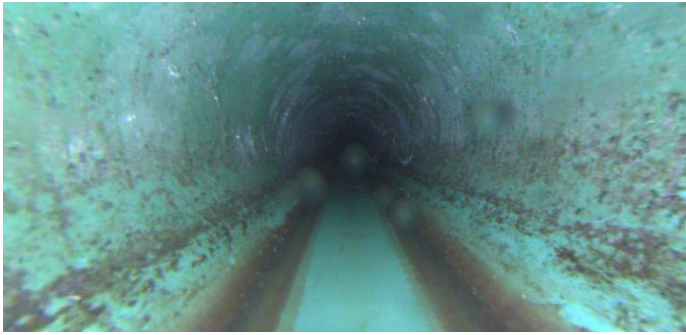
Code: **DAGS**  
Description: **Deposits Attached Grease**

Distance (ft): **20.4**  
Structural Grade: **0**  
O&M Grade: **2**  
Clock Start/From: **8**  
Clock To: **7**  
1st Value:  
2nd Value:  
Value Percent: **5.000**  
Continuous Index: **F01**  
Within 8" of Joint: **NO**  
Remarks:

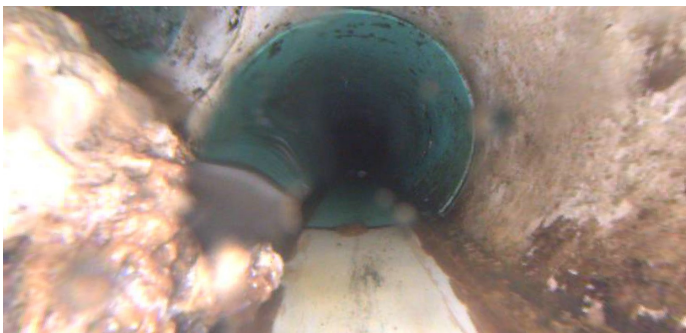
Code: **DAGS**  
Description: **Deposits Attached Grease**

Distance (ft): **33.2**  
Structural Grade: **0**  
O&M Grade: **2**  
Clock Start/From: **7**  
Clock To: **11**  
1st Value:  
2nd Value:  
Value Percent: **10.000**  
Continuous Index:  
Within 8" of Joint: **NO**  
Remarks:

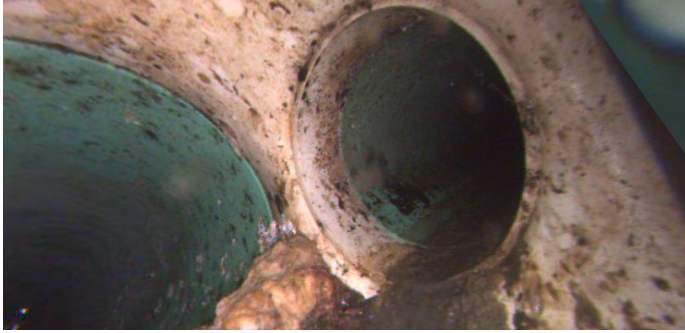
Code: **TF**  
Description: **Tap Factory**

Distance (ft): **34.1**  
Structural Grade: **0**  
O&M Grade: **0**  
Clock Start/From: **10**  
Clock To:  
1st Value: **4.000**  
2nd Value:  
Value Percent:  
Continuous Index:  
Within 8" of Joint:  
Remarks:

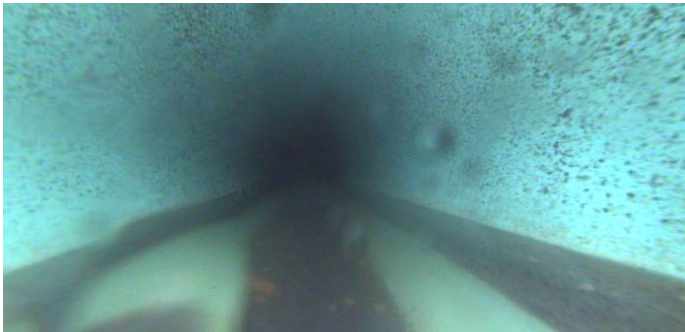
Code: **MWL**  
Description: **Water Level**

Distance (ft): **52.3**  
Structural Grade: **0**  
O&M Grade: **0**  
Clock Start/From:  
Clock To:  
1st Value:  
2nd Value:  
Value Percent: **30.000**  
Continuous Index:  
Within 8" of Joint: **NO**  
Remarks:

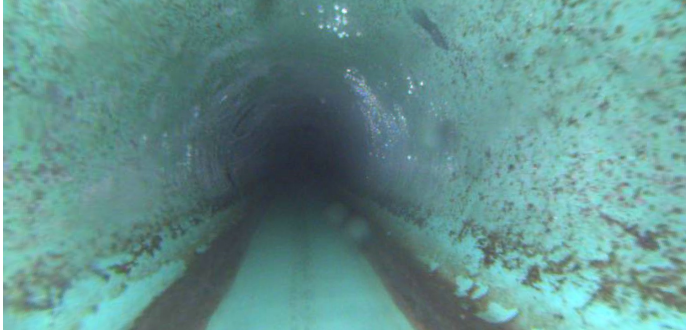
Code: **MWL**  
Description: **Water Level**

Distance (ft): **79.1**  
Structural Grade: **0**  
O&M Grade: **0**  
Clock Start/From:  
Clock To:  
1st Value:  
2nd Value:  
Value Percent: **5.000**  
Continuous Index:  
Within 8" of Joint: **NO**  
Remarks:

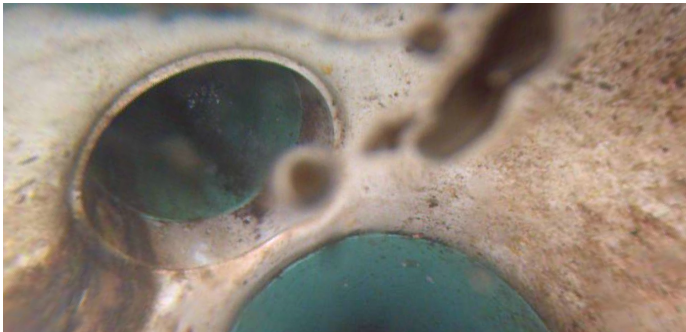
Code: **TF**  
Description: **Tap Factory**

Distance (ft): **106.0**  
Structural Grade: **0**  
O&M Grade: **0**  
Clock Start/From: **11**  
Clock To:  
1st Value: **4.000**  
2nd Value:  
Value Percent:  
Continuous Index:  
Within 8" of Joint:  
Remarks:

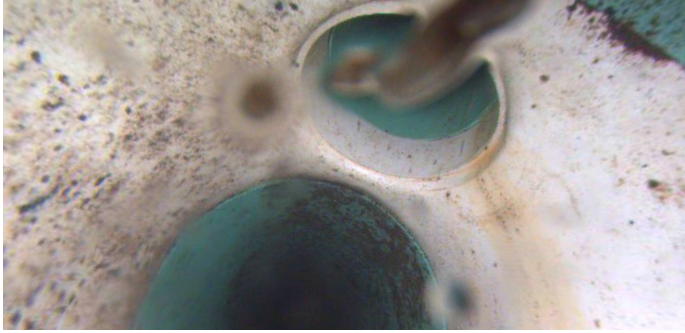
Code: **TF**  
Description: **Tap Factory**

Distance (ft): **169.2**  
Structural Grade: **0**  
O&M Grade: **0**  
Clock Start/From: **1**  
Clock To:  
1st Value: **4.000**  
2nd Value:  
Value Percent:  
Continuous Index:  
Within 8" of Joint:  
Remarks:

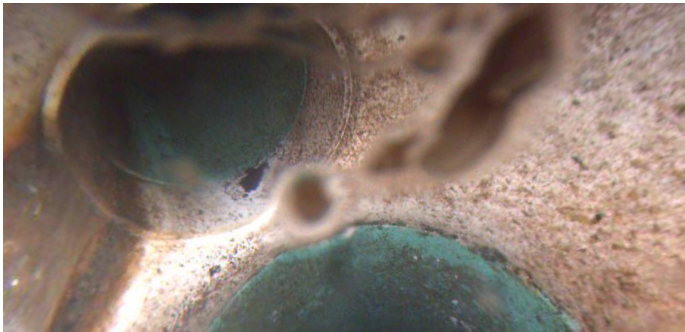
Code: **TF**  
Description: **Tap Factory**

Distance (ft): **176.0**  
Structural Grade: **0**  
O&M Grade: **0**  
Clock Start/From: **11**  
Clock To:  
1st Value: **4.000**  
2nd Value:  
Value Percent:  
Continuous Index:  
Within 8" of Joint:  
Remarks:

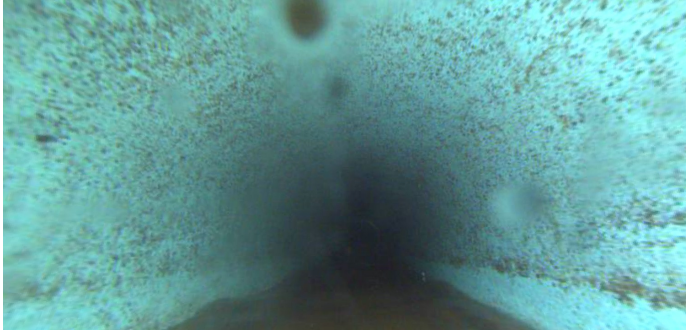
Code: **MWL**  
Description: **Water Level**

Distance (ft): **239.1**  
Structural Grade: **0**  
O&M Grade: **0**  
Clock Start/From:  
Clock To:  
1st Value:  
2nd Value:  
Value Percent: **20.000**  
Continuous Index:  
Within 8" of Joint: **NO**  
Remarks:

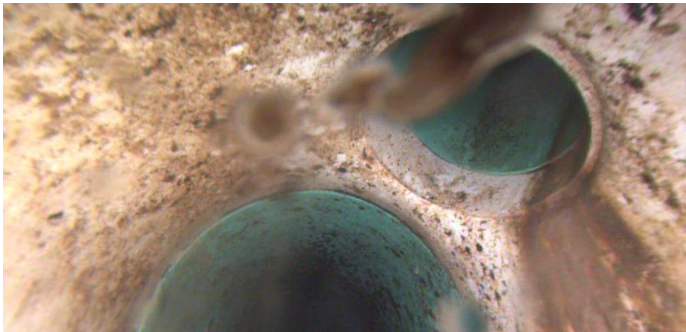
Code: **TF**  
Description: **Tap Factory**

Distance (ft): **245.0**  
Structural Grade: **0**  
O&M Grade: **0**  
Clock Start/From: **1**  
Clock To:  
1st Value: **4.000**  
2nd Value:  
Value Percent:  
Continuous Index:  
Within 8" of Joint:  
Remarks:

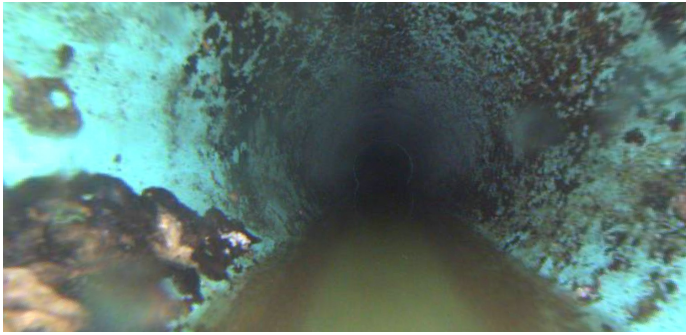
Code: **DAGS**  
Description: **Deposits Attached Grease**

Distance (ft): **246.1**  
Structural Grade: **0**  
O&M Grade: **2**  
Clock Start/From: **8**  
Clock To: **9**  
1st Value:  
2nd Value:  
Value Percent: **5.000**  
Continuous Index:  
Within 8" of Joint: **NO**  
Remarks:

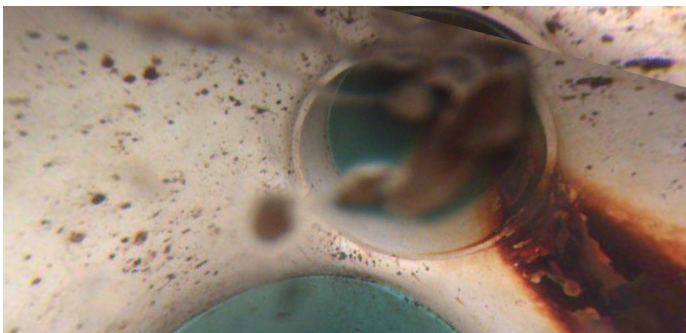
Code: **TFA**  
Description: **Tap Factory Active**

Distance (ft): **258.0**  
Structural Grade: **0**  
O&M Grade: **0**  
Clock Start/From: **1**  
Clock To:  
1st Value: **4.000**  
2nd Value:  
Value Percent:  
Continuous Index:  
Within 8" of Joint:  
Remarks:

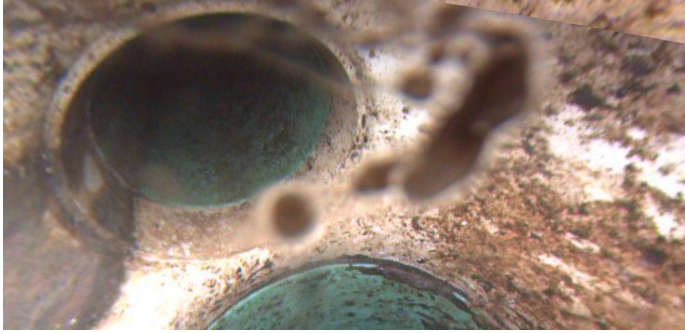
Code: **TF**  
Description: **Tap Factory**

Distance (ft): **318.7**  
Structural Grade: **0**  
O&M Grade: **0**  
Clock Start/From: **11**  
Clock To:  
1st Value: **4.000**  
2nd Value:  
Value Percent:  
Continuous Index:  
Within 8" of Joint:  
Remarks:

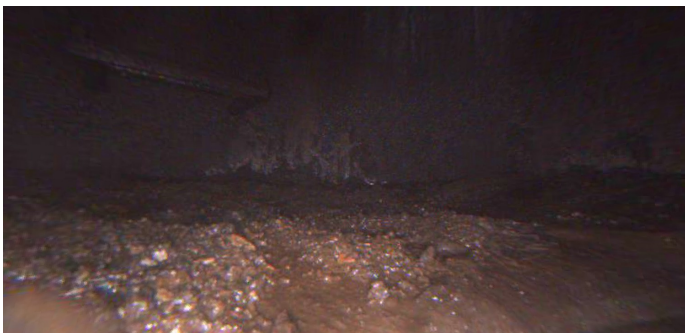
Code: **AMH**  
Description: **Manhole**

Distance (ft): **362.0**  
Structural Grade: **0**  
O&M Grade: **0**  
Clock Start/From:  
Clock To:  
1st Value:  
2nd Value:  
Value Percent:  
Continuous Index:  
Within 8" of Joint: **NO**  
Remarks: **M-1004-007**
