Profile/Photo Observation Report

Date:	10/16/2021	Weather:		Coding:	PACP 6.0
Pipe Length (ft):		Owner:	Hobart, IN	Pre Clean:	Not Known
P.O.#:	842_1	Surveyor:	M. Pielacha	PSR:	M-504-043_M-504-041
Customer:	Hobart, IN	Clean Date:		Shape:	C

Street:	West 43rd Street	Flow Control:	
City:	Hobart, IN	Year Renewed:	
Location:	Light Highway	Tape/Media #:	842
Purpose:	Routine Assessment	Dia/Height:	10"
Use:	Sanitary	Material:	PVC
Drain Area:		Lining:	
Category:	NA

Location Details:		Direction of Survey:	Upstream
US MH:	M-504-043	DS MH:	M-504-041
		Total Length Surveyed (ft):	410.0

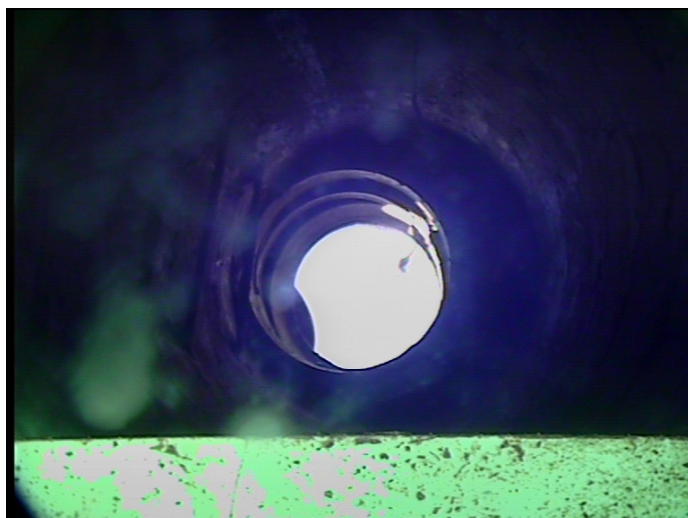
Code: **AMH**
Description: **Manhole**

Distance (ft): **.0**
Structural Grade: **0**
O&M Grade: **0**
Clock Start/From:
Clock To:
1st Value:
2nd Value:
Value Percent:
Continuous Index:
Within 8" of Joint: **NO**
Remarks: **M-504-041**

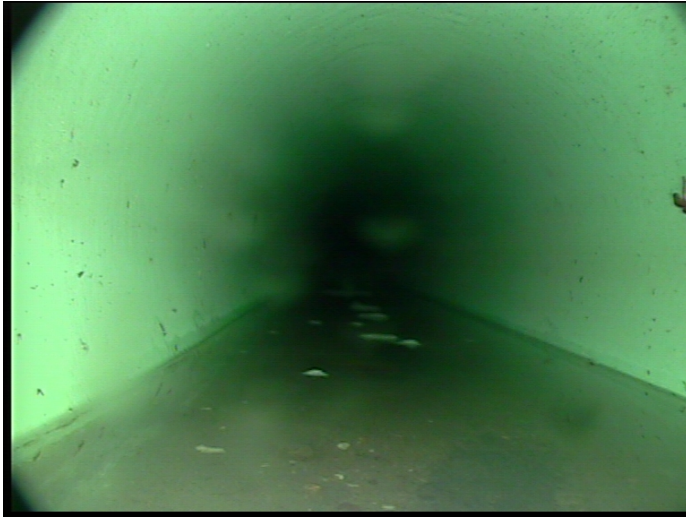
Code:	MWL
Description:	Water Level
Distance (ft):	.0
Structural Grade:	0
O&M Grade:	0
Clock Start/From:	
Clock To:	
1st Value:	
2nd Value:	
Value Percent:	10.000
Continuous Index:	
Within 8" of Joint:	NO
Remarks:

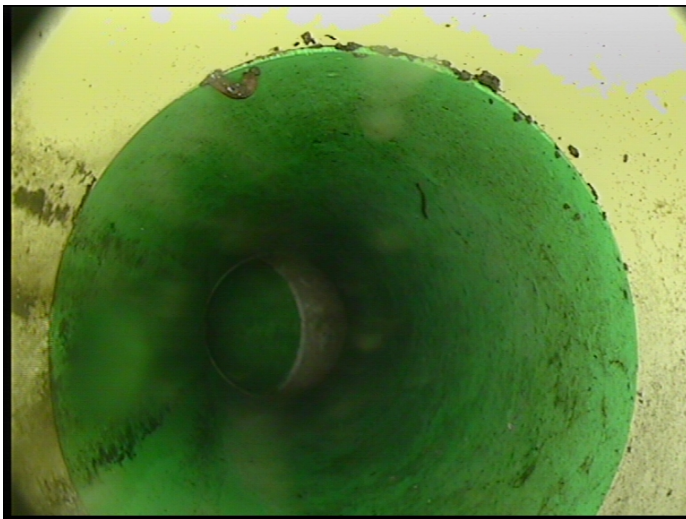
Code:	TF
Description:	Tap Factory
Distance (ft):	47.4
Structural Grade:	0
O&M Grade:	0
Clock Start/From:	10
Clock To:	
1st Value:	4.000
2nd Value:	
Value Percent:	
Continuous Index:	
Within 8" of Joint:	NO
Remarks:

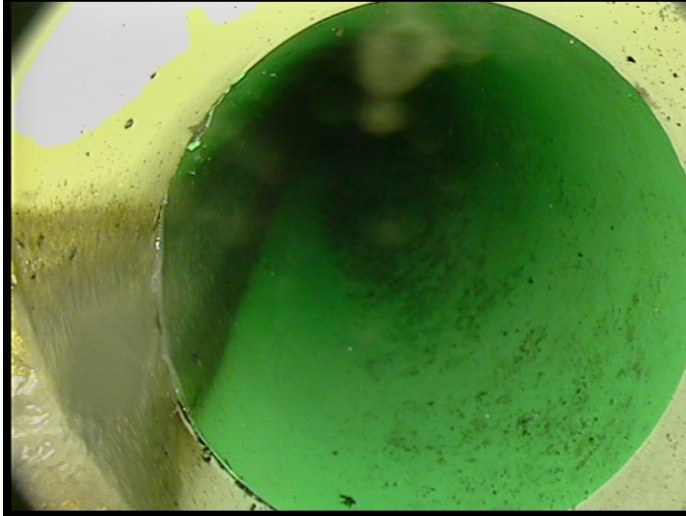
Code: **TFA**
Description: **Tap Factory Active**

Distance (ft): **85.7**
Structural Grade: **0**
O&M Grade: **0**
Clock Start/From: **10**
Clock To:
1st Value: **4.000**
2nd Value:
Value Percent:
Continuous Index:
Within 8" of Joint: **NO**
Remarks:

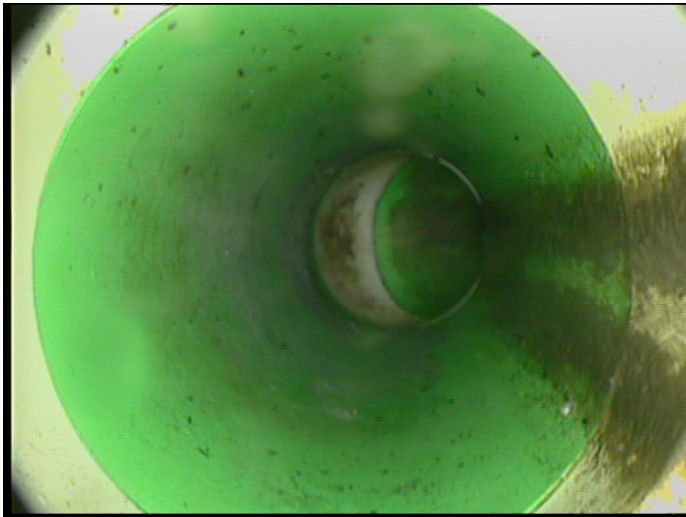
Code: **TFA**
Description: **Tap Factory Active**

Distance (ft): **88.1**
Structural Grade: **0**
O&M Grade: **0**
Clock Start/From: **2**
Clock To:
1st Value: **4.000**
2nd Value:
Value Percent:
Continuous Index:
Within 8" of Joint: **NO**
Remarks:

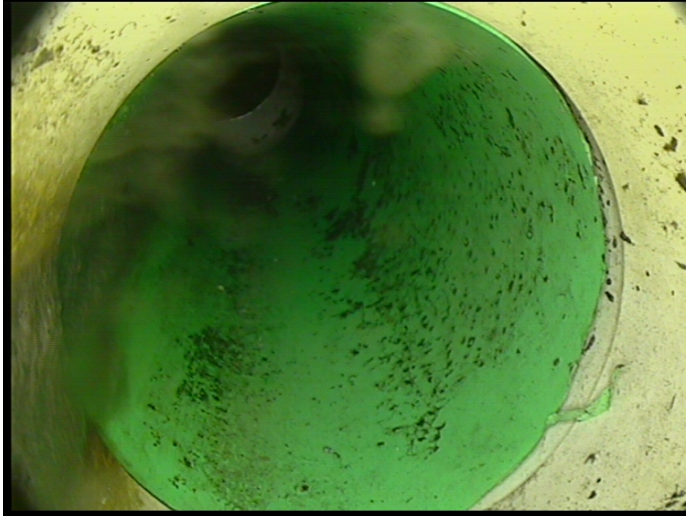
Code: **TFA**
Description: **Tap Factory Active**

Distance (ft): **126.5**
Structural Grade: **0**
O&M Grade: **0**
Clock Start/From: **10**
Clock To:
1st Value: **4.000**
2nd Value:
Value Percent:
Continuous Index:
Within 8" of Joint: **NO**
Remarks:

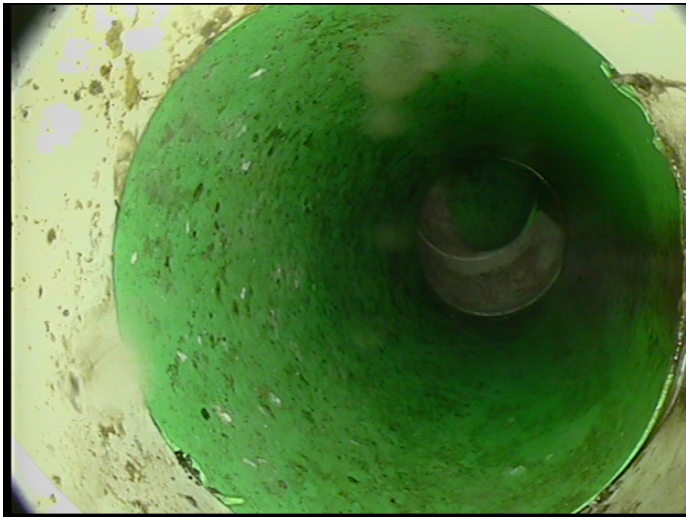
Code: **TF**
Description: **Tap Factory**

Distance (ft): **128.6**
Structural Grade: **0**
O&M Grade: **0**
Clock Start/From: **2**
Clock To:
1st Value: **4.000**
2nd Value:
Value Percent:
Continuous Index:
Within 8" of Joint: **NO**
Remarks:

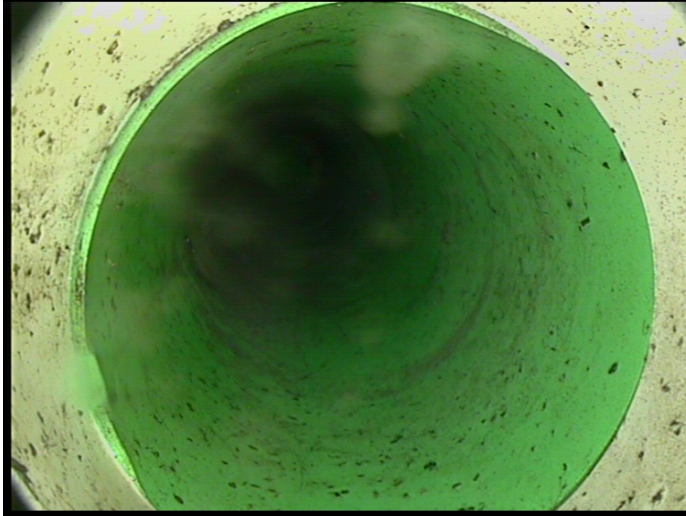
Code: **TF**
Description: **Tap Factory**

Distance (ft): **158.9**
Structural Grade: **0**
O&M Grade: **0**
Clock Start/From: **10**
Clock To:
1st Value: **4.000**
2nd Value:
Value Percent:
Continuous Index:
Within 8" of Joint: **NO**
Remarks:

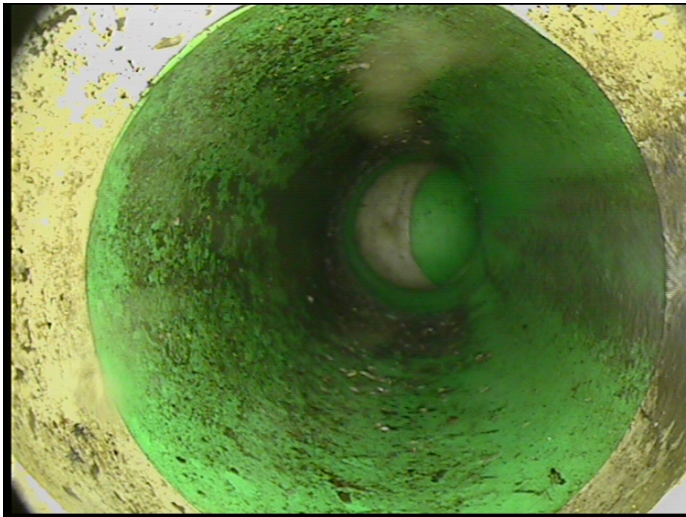
Code: **TFA**
Description: **Tap Factory Active**

Distance (ft): **160.5**
Structural Grade: **0**
O&M Grade: **0**
Clock Start/From: **2**
Clock To:
1st Value: **4.000**
2nd Value:
Value Percent:
Continuous Index:
Within 8" of Joint: **NO**
Remarks:

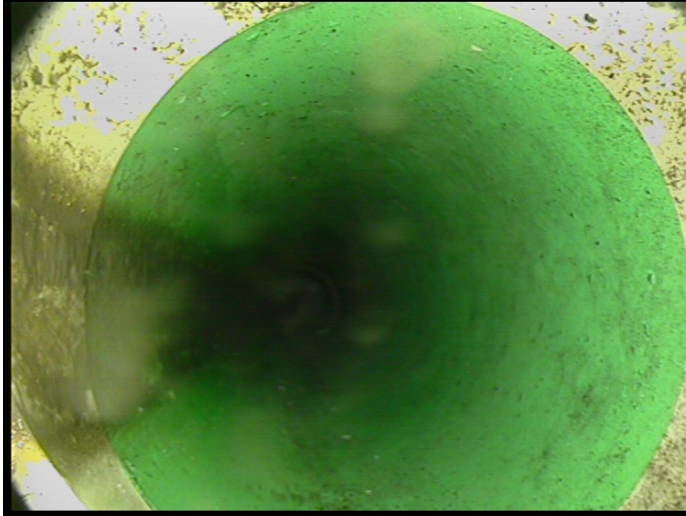
Code: **TF**
Description: **Tap Factory**

Distance (ft): **193.3**
Structural Grade: **0**
O&M Grade: **0**
Clock Start/From: **10**
Clock To:
1st Value: **4.000**
2nd Value:
Value Percent:
Continuous Index:
Within 8" of Joint: **NO**
Remarks:

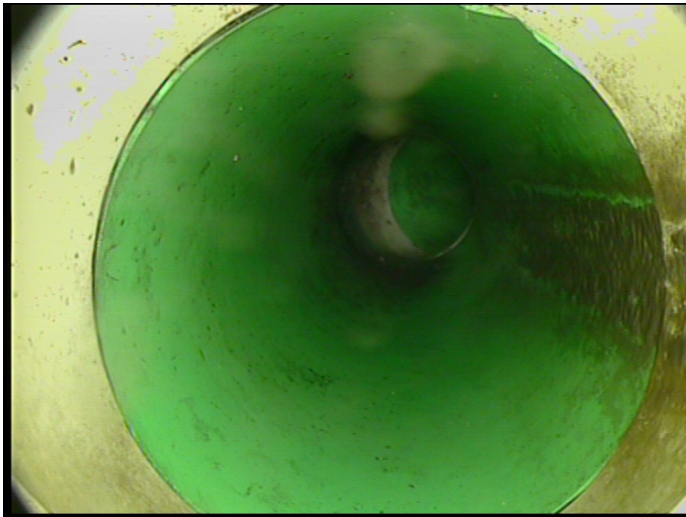
Code: **TF**
Description: **Tap Factory**

Distance (ft): **203.9**
Structural Grade: **0**
O&M Grade: **0**
Clock Start/From: **2**
Clock To:
1st Value: **4.000**
2nd Value:
Value Percent:
Continuous Index:
Within 8" of Joint: **NO**
Remarks:

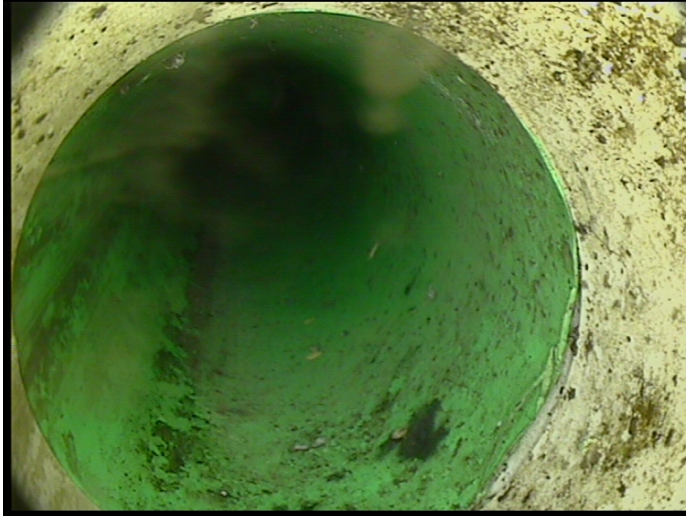
Code: **TFA**
Description: **Tap Factory Active**

Distance (ft): **238.7**
Structural Grade: **0**
O&M Grade: **0**
Clock Start/From: **10**
Clock To:
1st Value: **4.000**
2nd Value:
Value Percent:
Continuous Index:
Within 8" of Joint: **NO**
Remarks:

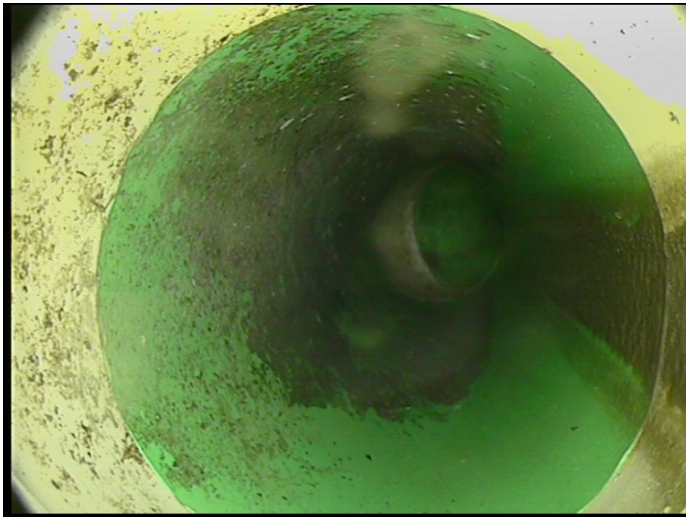
Code: **TF**
Description: **Tap Factory**

Distance (ft): **247.7**
Structural Grade: **0**
O&M Grade: **0**
Clock Start/From: **2**
Clock To:
1st Value: **4.000**
2nd Value:
Value Percent:
Continuous Index:
Within 8" of Joint: **NO**
Remarks:

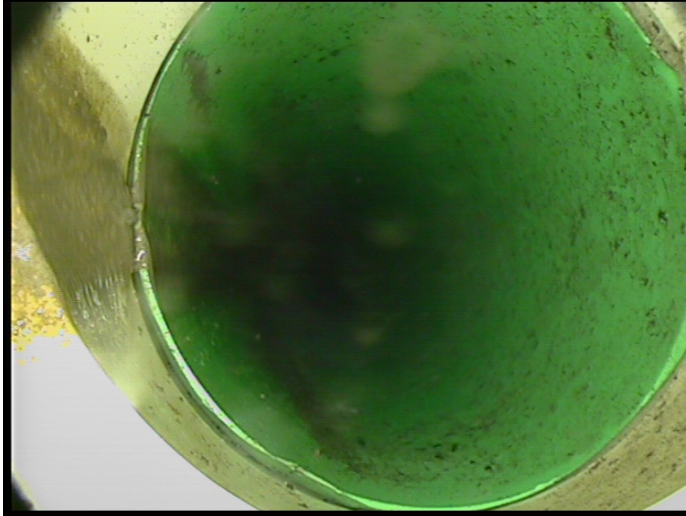
Code: **TFA**
Description: **Tap Factory Active**

Distance (ft): **276.7**
Structural Grade: **0**
O&M Grade: **0**
Clock Start/From: **10**
Clock To:
1st Value: **4.000**
2nd Value:
Value Percent:
Continuous Index:
Within 8" of Joint: **NO**
Remarks:

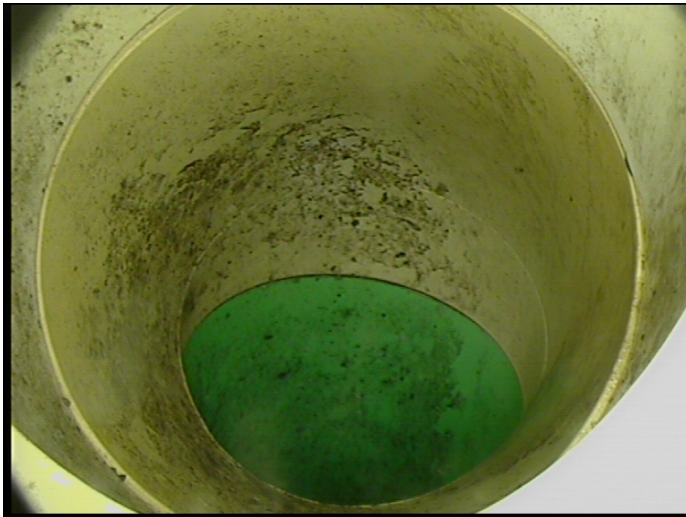
Code: **TF**
Description: **Tap Factory**

Distance (ft): **285.3**
Structural Grade: **0**
O&M Grade: **0**
Clock Start/From: **2**
Clock To:
1st Value: **4.000**
2nd Value:
Value Percent:
Continuous Index:
Within 8" of Joint: **NO**
Remarks:

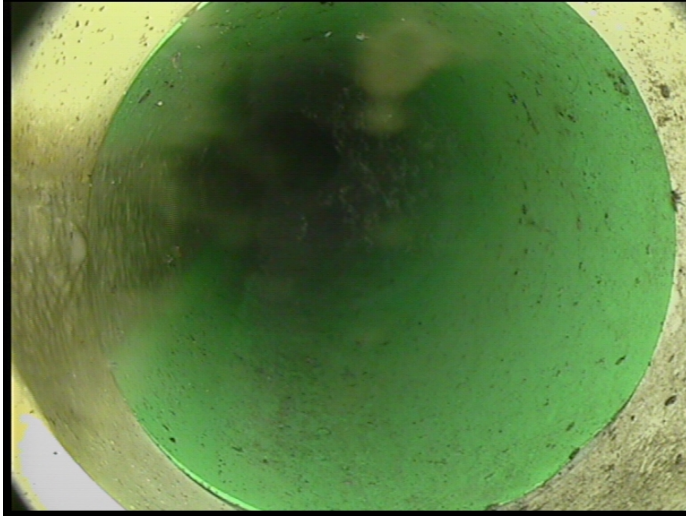
Code: **TFA**
Description: **Tap Factory Active**

Distance (ft): **321.2**
Structural Grade: **0**
O&M Grade: **0**
Clock Start/From: **10**
Clock To:
1st Value: **4.000**
2nd Value:
Value Percent:
Continuous Index:
Within 8" of Joint: **NO**
Remarks:

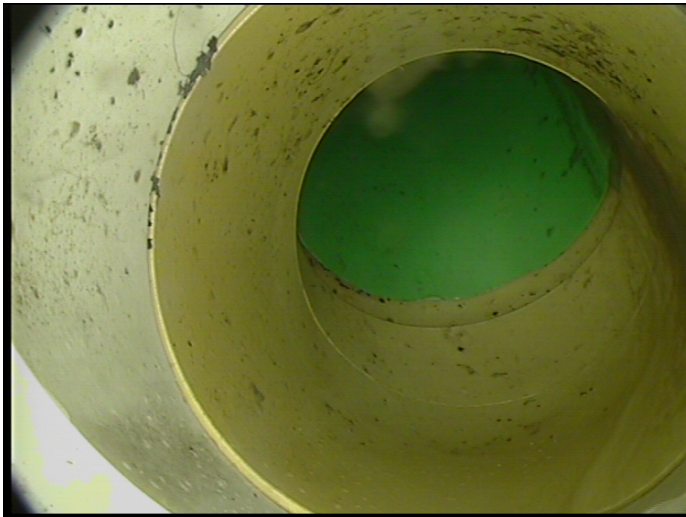
Code: **TFA**
Description: **Tap Factory Active**

Distance (ft): **322.9**
Structural Grade: **0**
O&M Grade: **0**
Clock Start/From: **3**
Clock To:
1st Value: **4.000**
2nd Value:
Value Percent:
Continuous Index:
Within 8" of Joint: **NO**
Remarks:

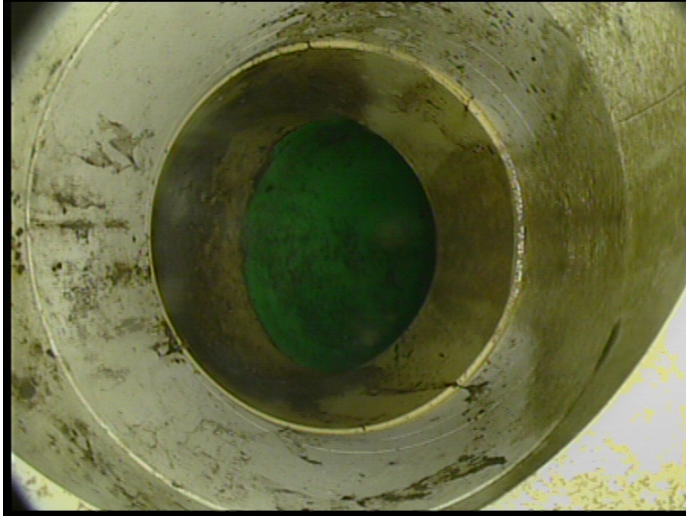
Code: **TF**
Description: **Tap Factory**

Distance (ft): **364.3**
Structural Grade: **0**
O&M Grade: **0**
Clock Start/From: **2**
Clock To:
1st Value: **4.000**
2nd Value:
Value Percent:
Continuous Index:
Within 8" of Joint: **NO**
Remarks:

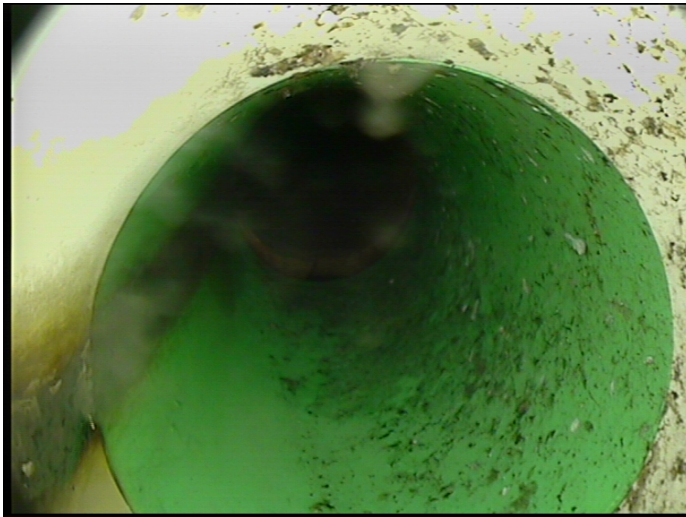
Code: **TF**
Description: **Tap Factory**

Distance (ft): **367.3**
Structural Grade: **0**
O&M Grade: **0**
Clock Start/From: **10**
Clock To:
1st Value: **4.000**
2nd Value:
Value Percent:
Continuous Index:
Within 8" of Joint: **NO**
Remarks:

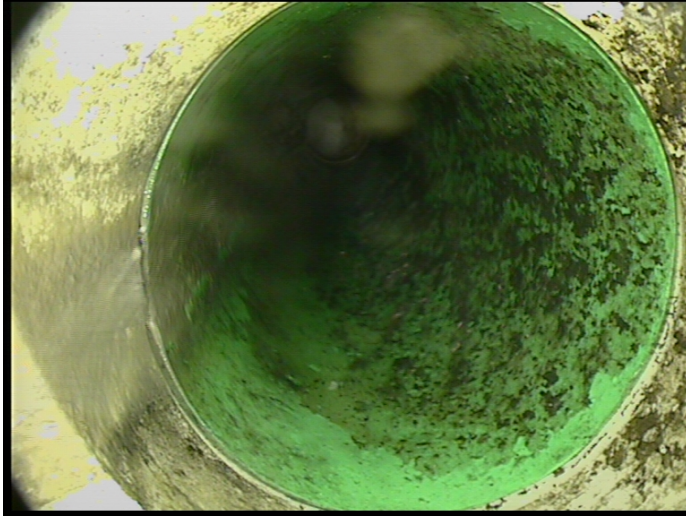
Code: **TFA**
Description: **Tap Factory Active**

Distance (ft): **392.9**
Structural Grade: **0**
O&M Grade: **0**
Clock Start/From: **10**
Clock To:
1st Value: **4.000**
2nd Value:
Value Percent:
Continuous Index:
Within 8" of Joint: **NO**
Remarks:

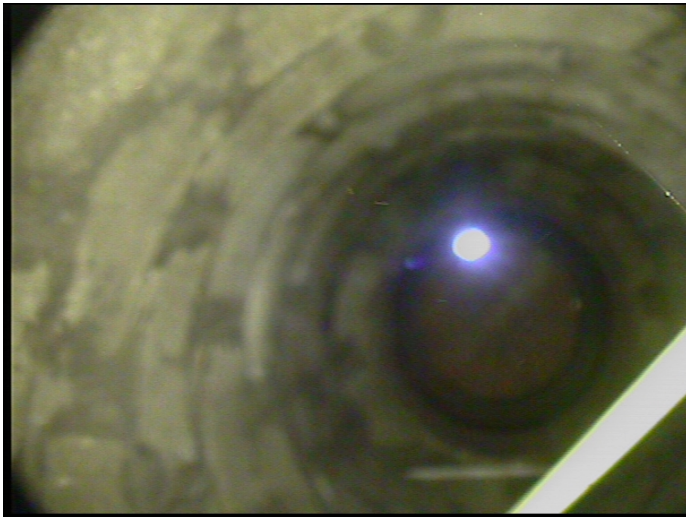
Code: **AMH**
Description: **Manhole**

Distance (ft): **410.0**
Structural Grade: **0**
O&M Grade: **0**
Clock Start/From:
Clock To:
1st Value:
2nd Value:
Value Percent:
Continuous Index:
Within 8" of Joint: **NO**
Remarks: **M-504-043**
