Profile/Photo Observation Report

Street:	MCAFEE DR	Flow Control:	Not Controlled
City:	Hobart, IN	Year Renewed:	
Location:	Other	Tape/Media #:	
Purpose:	Not Known	Dia/Height:	10"
Use:	Sanitary	Material:	PVC
Drain Area:	NA	Lining:	
Category:	NA		
Comment:

Location Details:		Direction of Survey:	Downstream
US MH:	M-1004-008	DS MH:	M-1004-009
		Total Length Surveyed (ft):	283.4

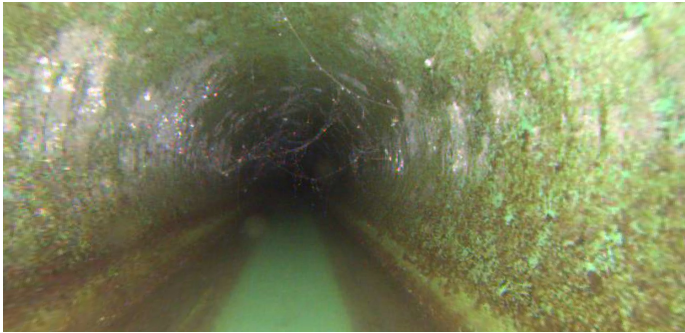
Code:	MWL
Description:	Water Level

Distance (ft):	.0
Structural Grade:	0
O&M Grade:	0
Clock Start/From:	
Clock To:	
1st Value:	
2nd Value:	
Value Percent:	5.000
Continuous Index:	
Within 8" of Joint:	NO
Remarks:

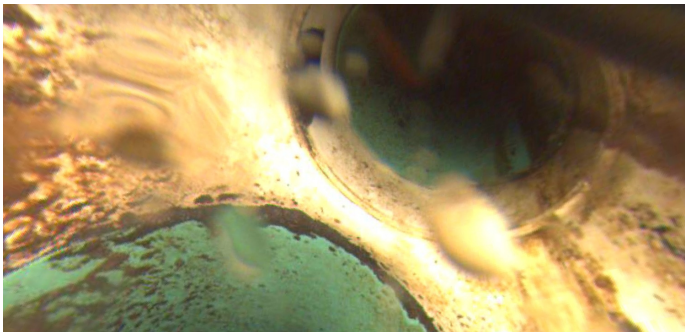
Code:	TF
Description:	Tap Factory

Distance (ft):	78.9
Structural Grade:	0
O&M Grade:	0
Clock Start/From:	1
Clock To:	
1st Value:	4.000
2nd Value:	
Value Percent:	
Continuous Index:	
Within 8" of Joint:	
Remarks:

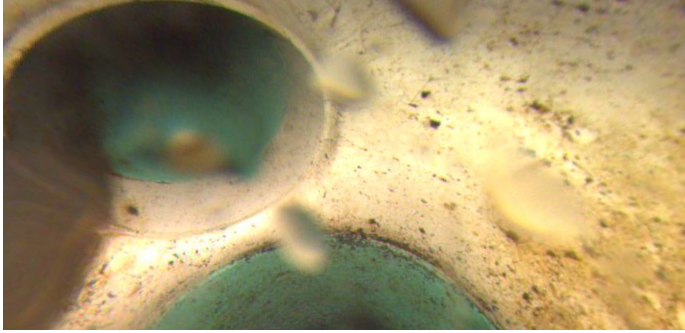
Code: **TF**
Description: **Tap Factory**

Distance (ft): **92.3**
Structural Grade: **0**
O&M Grade: **0**
Clock Start/From: **11**
Clock To:
1st Value: **4.000**
2nd Value:
Value Percent:
Continuous Index:
Within 8" of Joint:
Remarks:

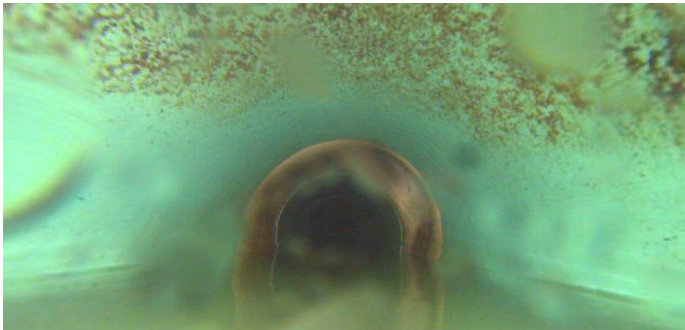
Code: **MWL**
Description: **Water Level**

Distance (ft): **187.1**
Structural Grade: **0**
O&M Grade: **0**
Clock Start/From:
Clock To:
1st Value:
2nd Value:
Value Percent: **40.000**
Continuous Index:
Within 8" of Joint: **NO**
Remarks:

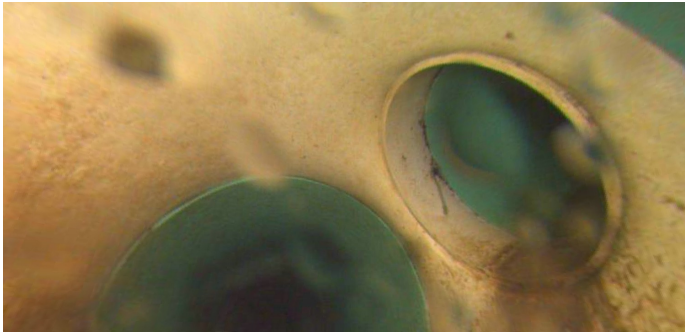
Code: **TF**
Description: **Tap Factory**

Distance (ft): **188.3**
Structural Grade: **0**
O&M Grade: **0**
Clock Start/From: **2**
Clock To:
1st Value: **4.000**
2nd Value:
Value Percent:
Continuous Index:
Within 8" of Joint:
Remarks:

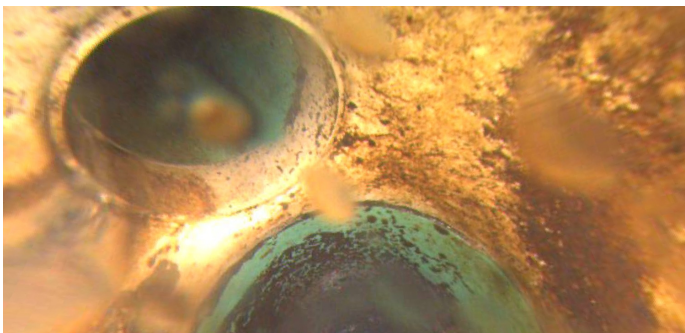
Code: **TF**
Description: **Tap Factory**

Distance (ft): **202.6**
Structural Grade: **0**
O&M Grade: **0**
Clock Start/From: **11**
Clock To:
1st Value: **4.000**
2nd Value:
Value Percent:
Continuous Index:
Within 8" of Joint:
Remarks:

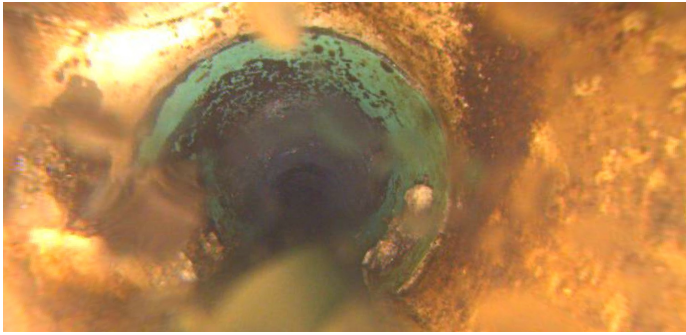
Code: **DAGS**
Description: **Deposits Attached Grease**

Distance (ft): **202.6**
Structural Grade: **0**
O&M Grade: **2**
Clock Start/From: **8**
Clock To: **4**
1st Value:
2nd Value:
Value Percent: **5.000**
Continuous Index:
Within 8" of Joint: **YES**
Remarks:

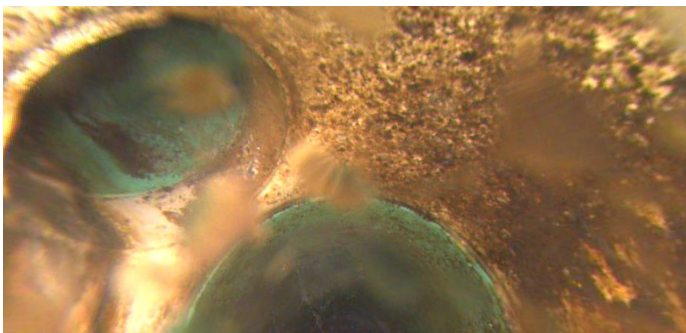
Code: **TF**
Description: **Tap Factory**

Distance (ft): **252.8**
Structural Grade: **0**
O&M Grade: **0**
Clock Start/From: **10**
Clock To:
1st Value: **4.000**
2nd Value:
Value Percent:
Continuous Index:
Within 8" of Joint:
Remarks:

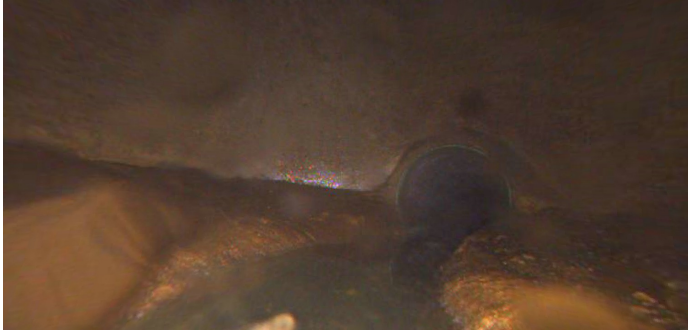
Code:	AMH
Description:	Manhole
Distance (ft):	283.4
Structural Grade:	0
O&M Grade:	0
Clock Start/From:	
Clock To:	
1st Value:	
2nd Value:	
Value Percent:	
Continuous Index:	
Within 8" of Joint:	NO
Remarks:	M-1004-009
