Profile/Photo Observation Report

Street:	McAfee Dr.	Flow Control:	Not Controlled
City:	Hobart, IN	Year Renewed:	
Location:	Other	Tape/Media #:	
Purpose:	Not Known	Dia/Height:	10"
Use:	Sanitary	Material:	PVC
Drain Area:	NA	Lining:	
Category:	NA		
Comment:

Location Details:		Direction of Survey:	Upstream
US MH:	M-1004-009	DS MH:	M-1004-010
		Total Length Surveyed (ft):	160.0

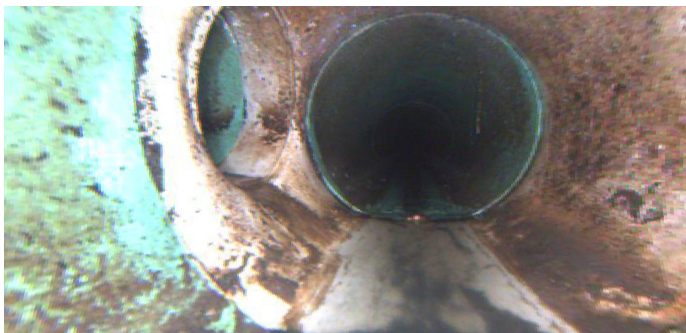
Code: **AMH**
Description: **Manhole**

Distance (ft): **.0**
Structural Grade: **0**
O&M Grade: **0**
Clock Start/From:
Clock To:
1st Value:
2nd Value:
Value Percent:
Continuous Index:
Within 8" of Joint: **NO**
Remarks: **M-1004-010**

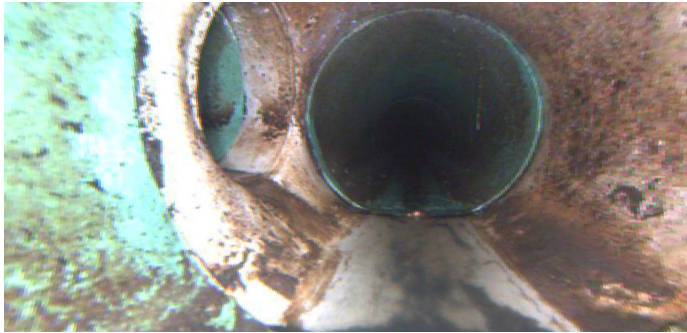
Code: **MWL**
Description: **Water Level**

Distance (ft): **.0**
Structural Grade: **0**
O&M Grade: **0**
Clock Start/From:
Clock To:
1st Value:
2nd Value:
Value Percent: **5.000**
Continuous Index:
Within 8" of Joint: **NO**
Remarks:

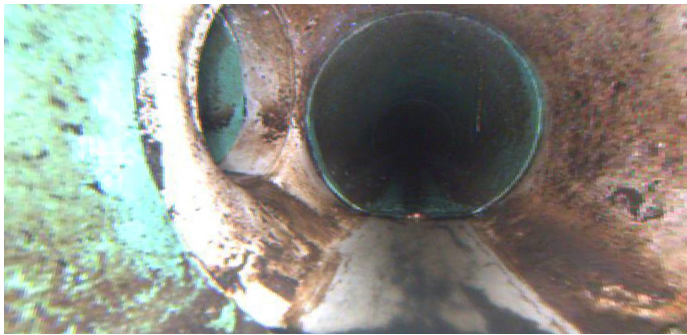
Code: **TF**
Description: **Tap Factory**

Distance (ft): **.0**
Structural Grade: **0**
O&M Grade: **0**
Clock Start/From: **9**
Clock To:
1st Value: **4.000**
2nd Value:
Value Percent:
Continuous Index:
Within 8" of Joint:
Remarks:

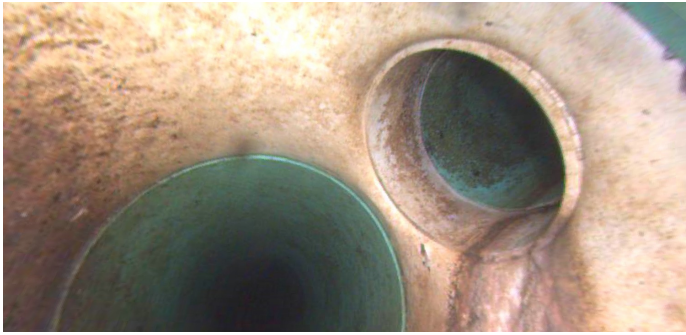
Code: **TF**
Description: **Tap Factory**

Distance (ft): **61.3**
Structural Grade: **0**
O&M Grade: **0**
Clock Start/From: **2**
Clock To:
1st Value: **4.000**
2nd Value:
Value Percent:
Continuous Index:
Within 8" of Joint:
Remarks:

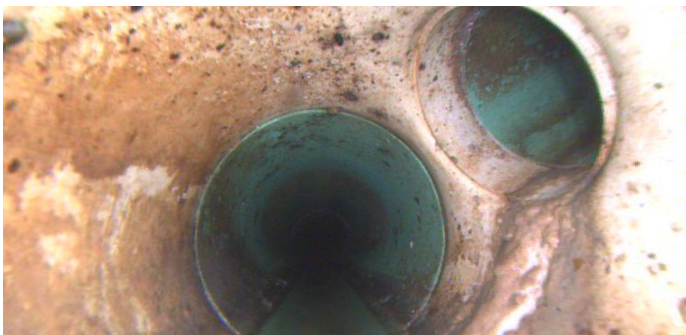
Code: **TF**
Description: **Tap Factory**

Distance (ft): **87.6**
Structural Grade: **0**
O&M Grade: **0**
Clock Start/From: **2**
Clock To:
1st Value: **4.000**
2nd Value:
Value Percent:
Continuous Index:
Within 8" of Joint:
Remarks:

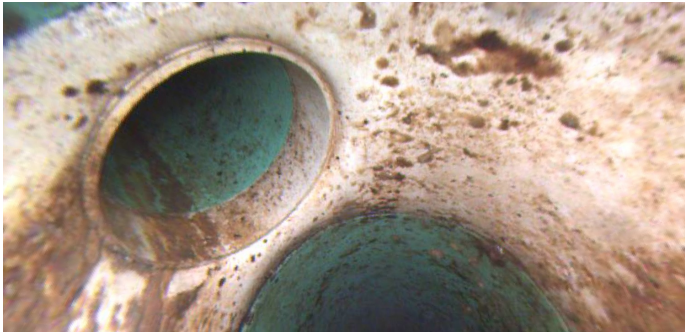
Code: **TF**
Description: **Tap Factory**

Distance (ft): **129.0**
Structural Grade: **0**
O&M Grade: **0**
Clock Start/From: **10**
Clock To:
1st Value: **4.000**
2nd Value:
Value Percent:
Continuous Index:
Within 8" of Joint:
Remarks:

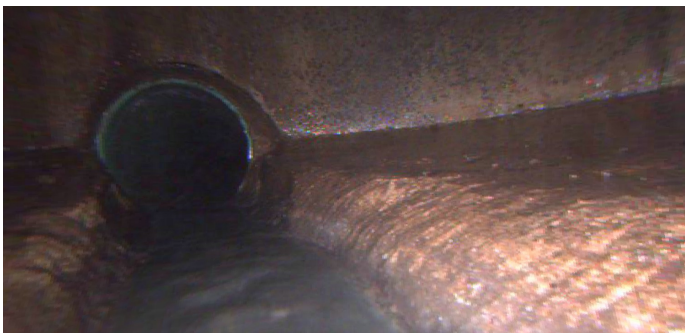
Code: **AMH**
Description: **Manhole**

Distance (ft): **160.0**
Structural Grade: **0**
O&M Grade: **0**
Clock Start/From:
Clock To:
1st Value:
2nd Value:
Value Percent:
Continuous Index:
Within 8" of Joint: **NO**
Remarks: **M-1004-009**
