## Profile/Photo Observation Report

Street:	<b>McAfee Dr.</b>	Flow Control:	<b>Not Controlled</b>
City:	<b>Hobart, IN</b>	Year Renewed:	
Location:	<b>Other</b>	Tape/Media #:	
Purpose:	<b>Not Known</b>	Dia/Height:	<b>10"</b>
Use:	<b>Sanitary</b>	Material:	<b>PVC</b>
Drain Area:	<b>NA</b>	Lining:	
Category:	<b>NA</b>		
Comment:

Location Details:		Direction of Survey:	<b>Upstream</b>
US MH:	<b>M-1004-010</b>	DS MH:	<b>M-1004-011</b>
		Total Length Surveyed (ft):	<b>170.4</b>

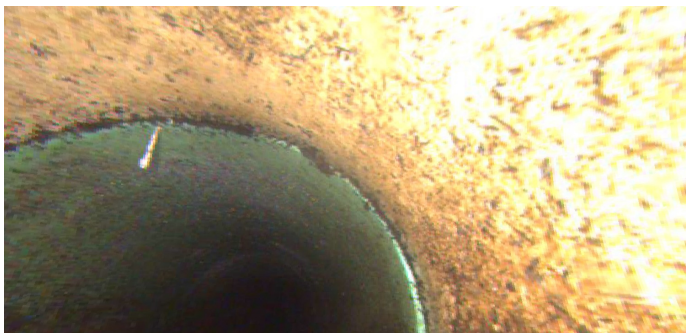
Code: **AMH**  
Description: **Manhole**

Distance (ft): **.0**  
Structural Grade: **0**  
O&M Grade: **0**  
Clock Start/From:  
Clock To:  
1st Value:  
2nd Value:  
Value Percent:  
Continuous Index:  
Within 8" of Joint: **NO**  
Remarks: **M-1004-011**

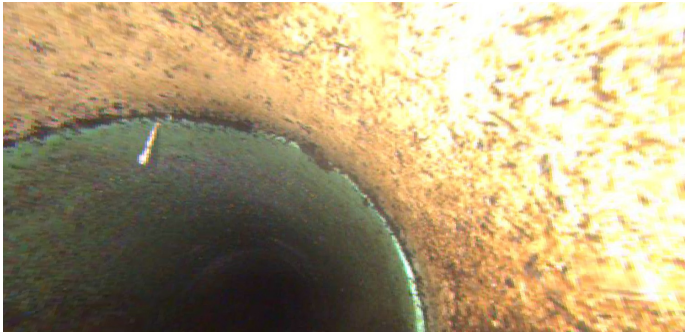
Code:	<b>MWL</b>
Description:	<b>Water Level</b>

Distance (ft):	<b>.0</b>
Structural Grade:	<b>0</b>
O&M Grade:	<b>0</b>
Clock Start/From:	
Clock To:	
1st Value:	
2nd Value:	
Value Percent:	<b>5.000</b>
Continuous Index:	
Within 8" of Joint:	<b>NO</b>
Remarks:

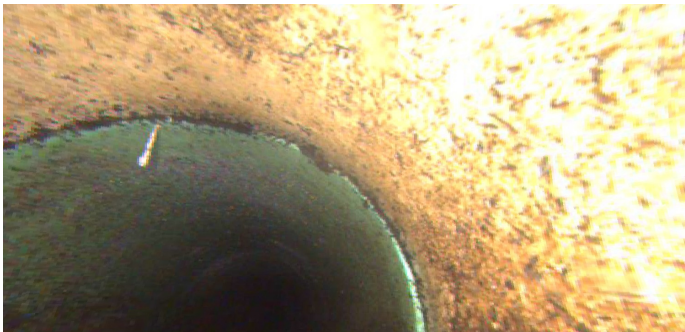
Code:	<b>RFJ</b>
Description:	<b>Roots Fine Joint</b>

Distance (ft):	<b>.0</b>
Structural Grade:	<b>0</b>
O&M Grade:	<b>1</b>
Clock Start/From:	<b>12</b>
Clock To:	
1st Value:	
2nd Value:	
Value Percent:	
Continuous Index:	
Within 8" of Joint:	<b>YES</b>
Remarks:

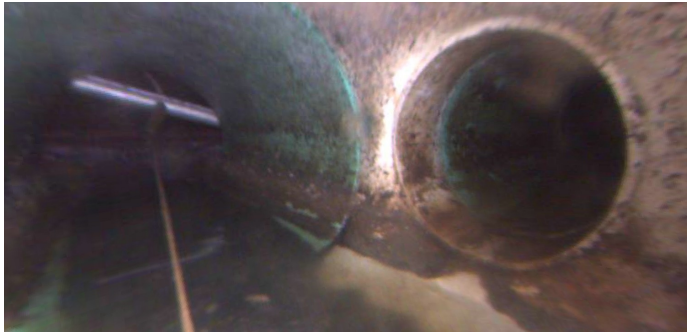
Code: **TFA**  
 Description: **Tap Factory Active**

Distance (ft): **1.8**  
 Structural Grade: **0**  
 O&M Grade: **0**  
 Clock Start/From: **9**  
 Clock To:  
 1st Value: **4.000**  
 2nd Value:  
 Value Percent:  
 Continuous Index:  
 Within 8" of Joint:  
 Remarks:

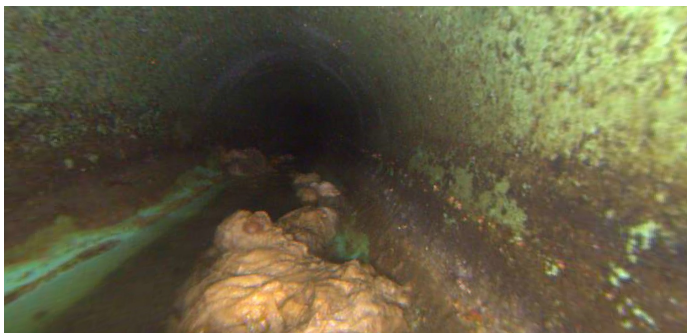
Code: **OBZ**  
 Description: **Obstacle Other**

Distance (ft): **1.8**  
 Structural Grade: **0**  
 O&M Grade: **2**  
 Clock Start/From: **5**  
 Clock To: **7**  
 1st Value:  
 2nd Value:  
 Value Percent: **10.000**  
 Continuous Index:  
 Within 8" of Joint: **NO**  
 Remarks: **paper products**

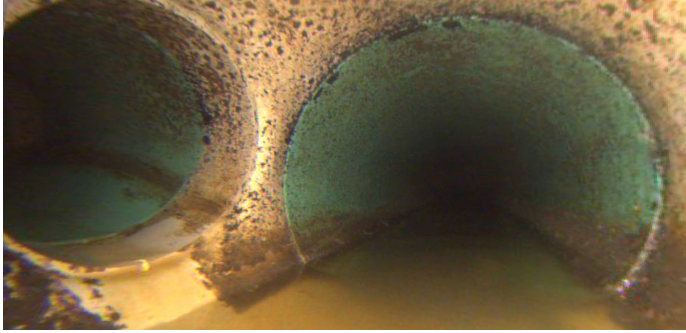
Code: **TF**  
Description: **Tap Factory**

Distance (ft): **27.6**  
Structural Grade: **0**  
O&M Grade: **0**  
Clock Start/From: **9**  
Clock To:  
1st Value: **4.000**  
2nd Value:  
Value Percent:  
Continuous Index:  
Within 8" of Joint:  
Remarks:

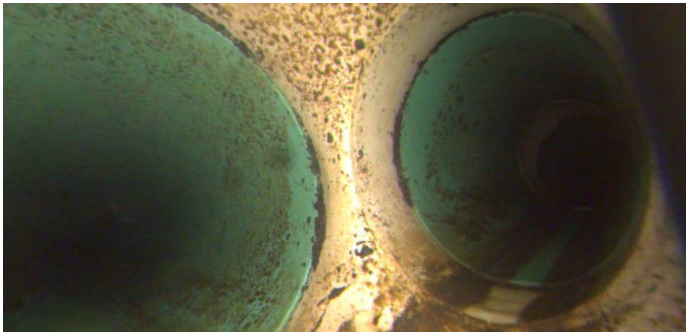
Code: **TF**  
Description: **Tap Factory**

Distance (ft): **78.3**  
Structural Grade: **0**  
O&M Grade: **0**  
Clock Start/From: **3**  
Clock To:  
1st Value: **4.000**  
2nd Value:  
Value Percent:  
Continuous Index:  
Within 8" of Joint:  
Remarks:

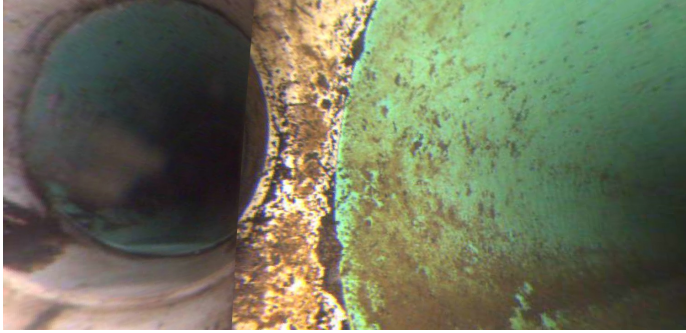
Code: **TF**  
Description: **Tap Factory**

Distance (ft): **86.8**  
Structural Grade: **0**  
O&M Grade: **0**  
Clock Start/From: **9**  
Clock To:  
1st Value: **4.000**  
2nd Value:  
Value Percent:  
Continuous Index:  
Within 8" of Joint:  
Remarks:

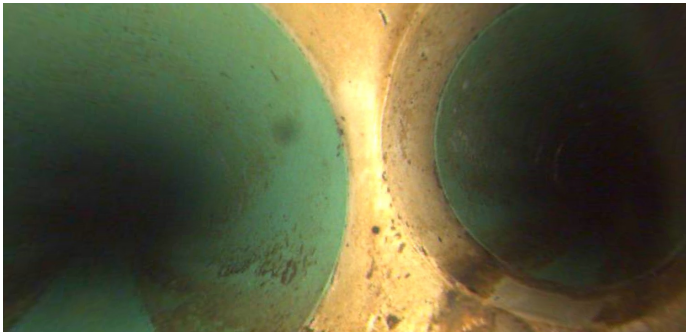
Code: **TF**  
Description: **Tap Factory**

Distance (ft): **152.1**  
Structural Grade: **0**  
O&M Grade: **0**  
Clock Start/From: **3**  
Clock To:  
1st Value: **4.000**  
2nd Value:  
Value Percent:  
Continuous Index:  
Within 8" of Joint:  
Remarks:

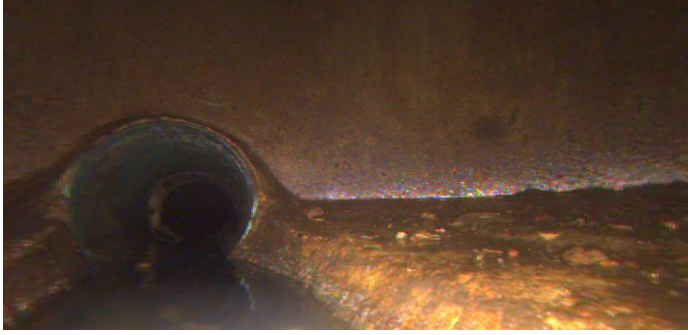
Code:	<b>AMH</b>
Description:	<b>Manhole</b>
Distance (ft):	<b>170.4</b>
Structural Grade:	<b>0</b>
O&M Grade:	<b>0</b>
Clock Start/From:	
Clock To:	
1st Value:	
2nd Value:	
Value Percent:	
Continuous Index:	
Within 8" of Joint:	<b>NO</b>
Remarks:	<b>M-1004-010</b>
