## Profile/Photo Observation Report

Street:	<b>Csokasy Lane</b>	Flow Control:	<b>Not Controlled</b>
City:	<b>Hobart, IN</b>	Year Renewed:	
Location:	<b>Yard</b>	Tape/Media #:	<b>DEP205</b>
Purpose:	<b>Routine Assessment</b>	Dia/Height:	<b>15"</b>
Use:	<b>Sanitary</b>	Material:	<b>VCP</b>
Drain Area:		Lining:	
Category:	<b>NA</b>		
Comment:	<b>YES501824 Submittal 2</b>		
Location Details:		Direction of Survey:	<b>Upstream</b>
US MH:	<b>M-507-019A</b>	DS MH:	<b>M-507-004</b>
		Total Length Surveyed (ft):	<b>8.8</b>

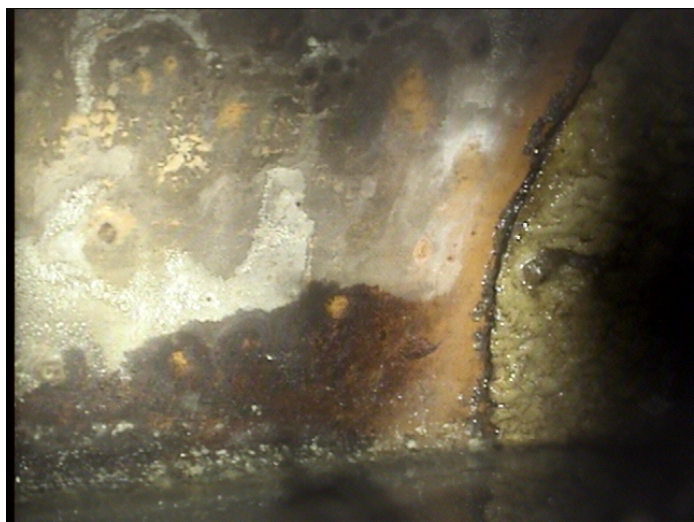
Code: **AMH**  
 Description: **Manhole**

Distance (ft): **.0**  
 Structural Grade: **0**  
 O&M Grade: **0**  
 Clock Start/From:  
 Clock To:  
 1st Value:  
 2nd Value:  
 Value Percent:  
 Continuous Index:  
 Within 8" of Joint: **NO**  
 Remarks: **M-507-004**

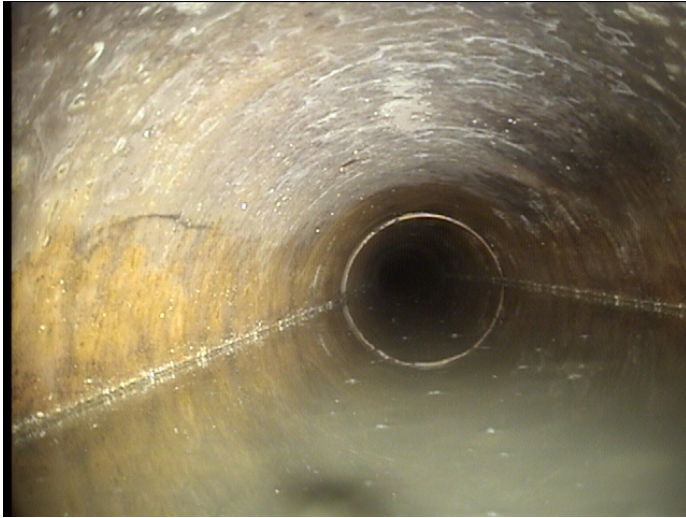
Code: **MWL**  
Description: **Water Level**

Distance (ft): **.0**  
Structural Grade: **0**  
O&M Grade: **0**  
Clock Start/From:  
Clock To:  
1st Value:  
2nd Value:  
Value Percent: **15.000**  
Continuous Index:  
Within 8" of Joint: **NO**  
Remarks:

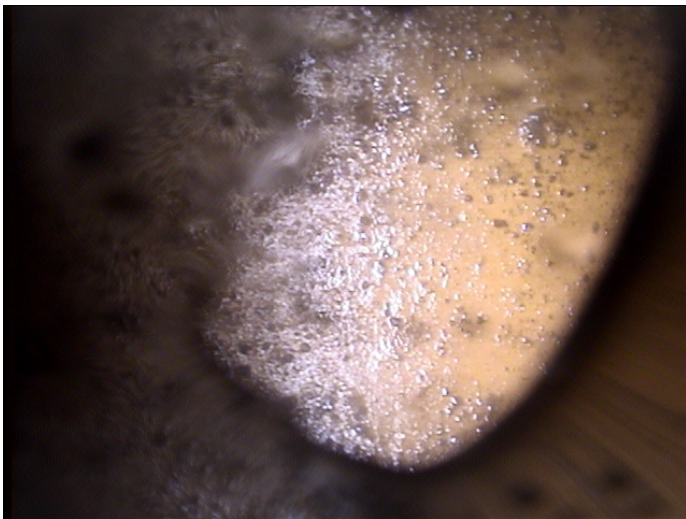
Code: **MSA**  
Description: **Abandoned Survey**

Distance (ft): **8.8**  
Structural Grade: **0**  
O&M Grade: **0**  
Clock Start/From:  
Clock To:  
1st Value:  
2nd Value:  
Value Percent:  
Continuous Index:  
Within 8" of Joint: **NO**  
Remarks: **Flow level over camera**
