Profile/Photo Observation Report

Street:	South Virginia Street	Flow Control:	Not Controlled
City:	Hobart, IN	Year Renewed:	
Location:	Light Highway	Tape/Media #:	DEP289
Purpose:	Routine Assessment	Dia/Height:	12"
Use:	Sanitary	Material:	PVC
Drain Area:		Lining:	
Category:	NA		
Comment:	5-21-2018

Location Details:		Direction of Survey:	Downstream
US MH:	M-507-041	DS MH:	M-507-089
		Total Length Surveyed (ft):	327.9

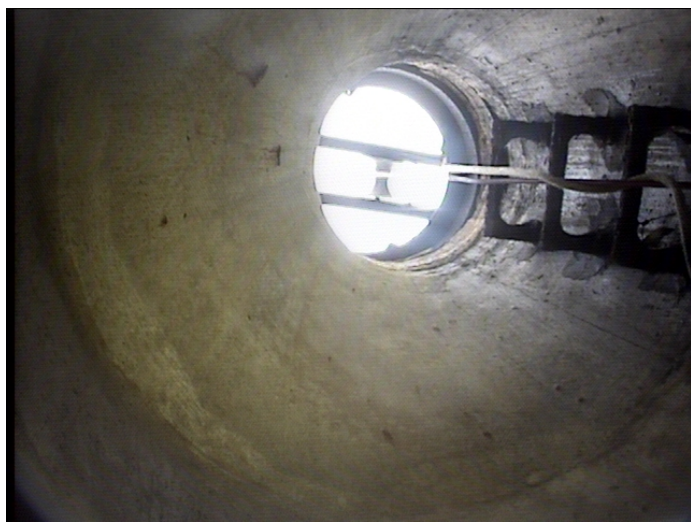
Code: **AMH**
Description: **Manhole**

Distance (ft): **.0**
Structural Grade: **0**
O&M Grade: **0**
Clock Start/From:
Clock To:
1st Value:
2nd Value:
Value Percent:
Continuous Index:
Within 8" of Joint: **NO**
Remarks: **M-507-041**

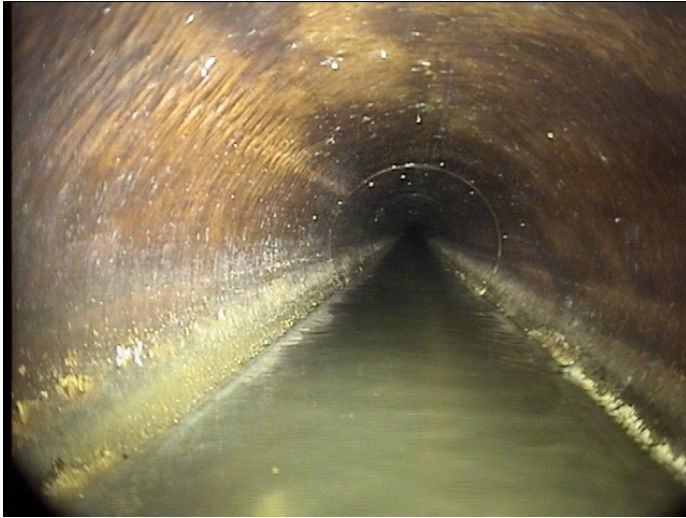
Code: **MWL**
Description: **Water Level**

Distance (ft): **.0**
Structural Grade: **0**
O&M Grade: **0**
Clock Start/From:
Clock To:
1st Value:
2nd Value:
Value Percent: **15.000**
Continuous Index:
Within 8" of Joint: **NO**
Remarks:

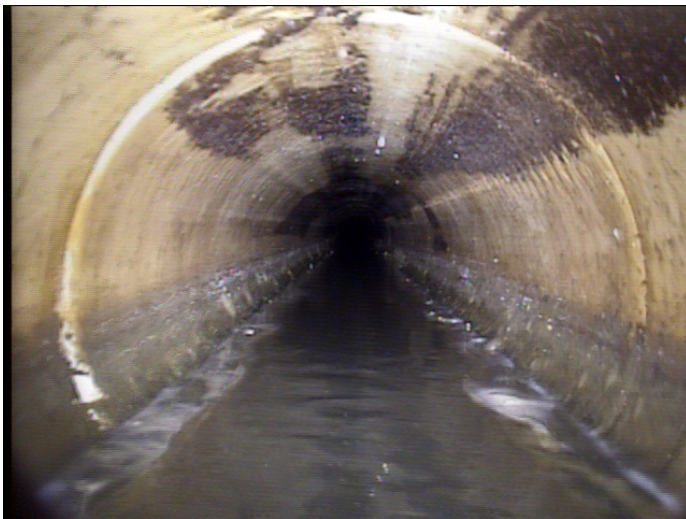
Code: **DSF**
Description: **Deposits Settled Fine**

Distance (ft): **134.5**
Structural Grade: **0**
O&M Grade: **2**
Clock Start/From: **5**
Clock To: **7**
1st Value:
2nd Value:
Value Percent: **5.000**
Continuous Index: **S01**
Within 8" of Joint: **NO**
Remarks:

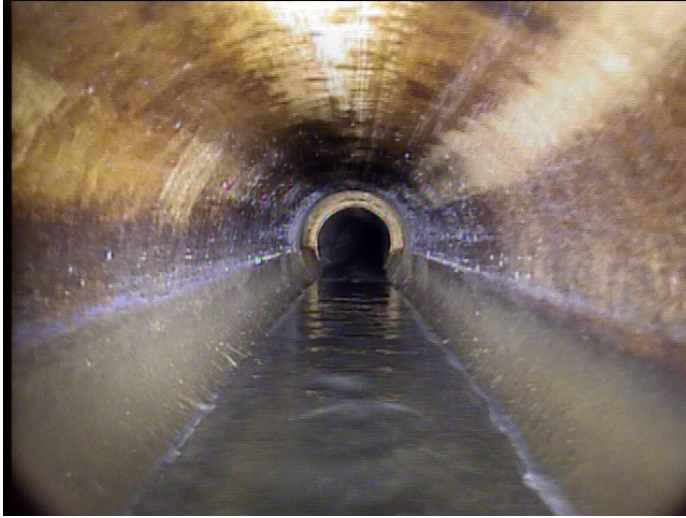
Code: **DSF**
Description: **Deposits Settled Fine**

Distance (ft): **317.2**
Structural Grade: **0**
O&M Grade: **2**
Clock Start/From: **5**
Clock To: **7**
1st Value:
2nd Value:
Value Percent: **5.000**
Continuous Index: **F01**
Within 8" of Joint: **NO**
Remarks:

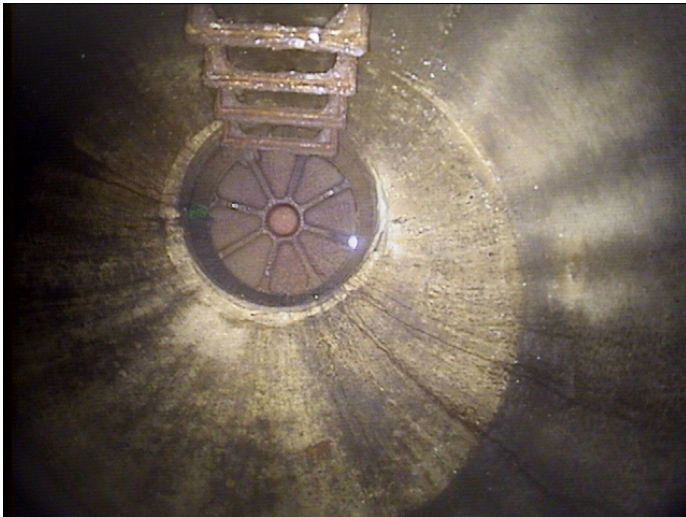
Code: **AMH**
Description: **Manhole**

Distance (ft): **327.9**
Structural Grade: **0**
O&M Grade: **0**
Clock Start/From:
Clock To:
1st Value:
2nd Value:
Value Percent:
Continuous Index:
Within 8" of Joint: **NO**
Remarks: **M-507-089**
