## Profile/Photo Observation Report

Street:	<b>MCAFEE CT</b>	Flow Control:	<b>Not Controlled</b>
City:	<b>Hobart, IN</b>	Year Renewed:	
Location:	<b>Other</b>	Tape/Media #:	
Purpose:	<b>Not Known</b>	Dia/Height:	<b>8"</b>
Use:	<b>Sanitary</b>	Material:	<b>PVC</b>
Drain Area:	<b>NA</b>	Lining:	
Category:	<b>NA</b>		
Comment:

Location Details:		Direction of Survey:	<b>Downstream</b>
US MH:	<b>M-1004-011</b>	DS MH:	<b>M-1004-012</b>
		Total Length Surveyed (ft):	<b>215.9</b>

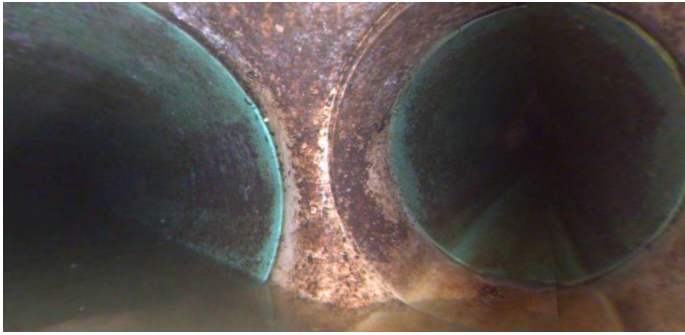
Code: **TF**  
Description: **Tap Factory**

Distance (ft): **94.0**  
Structural Grade: **0**  
O&M Grade: **0**  
Clock Start/From: **3**  
Clock To:  
1st Value: **4.000**  
2nd Value:  
Value Percent:  
Continuous Index:  
Within 8" of Joint:  
Remarks:

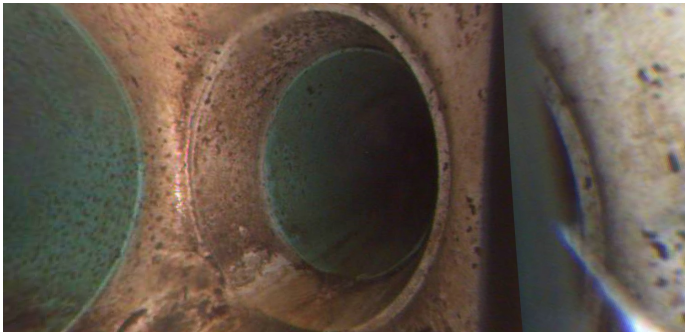
Code: **TF**  
Description: **Tap Factory**

Distance (ft): **144.4**  
Structural Grade: **0**  
O&M Grade: **0**  
Clock Start/From: **9**  
Clock To:  
1st Value: **4.000**  
2nd Value:  
Value Percent:  
Continuous Index:  
Within 8" of Joint:  
Remarks:

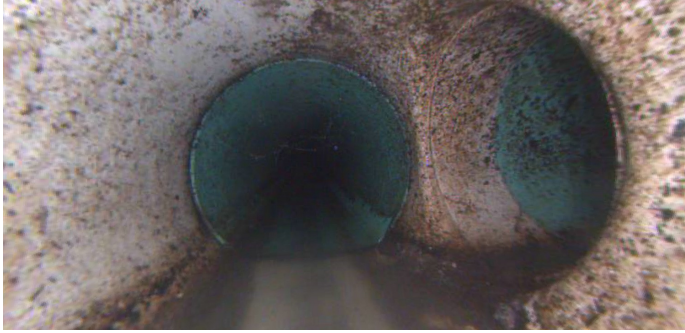
Code: **TF**  
Description: **Tap Factory**

Distance (ft): **179.1**  
Structural Grade: **0**  
O&M Grade: **0**  
Clock Start/From: **3**  
Clock To:  
1st Value: **4.000**  
2nd Value:  
Value Percent:  
Continuous Index:  
Within 8" of Joint:  
Remarks:

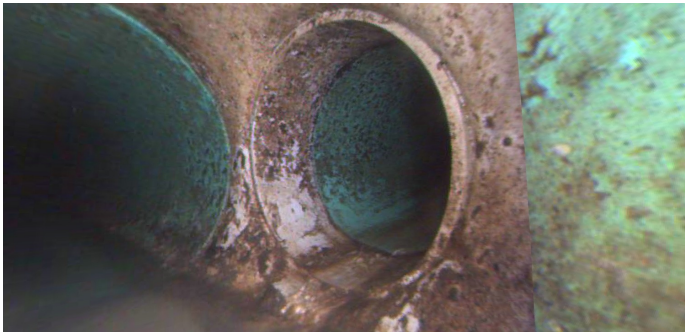
Code: **TF**  
Description: **Tap Factory**

Distance (ft): **199.1**  
Structural Grade: **0**  
O&M Grade: **0**  
Clock Start/From: **3**  
Clock To:  
1st Value: **4.000**  
2nd Value:  
Value Percent:  
Continuous Index:  
Within 8" of Joint:  
Remarks:

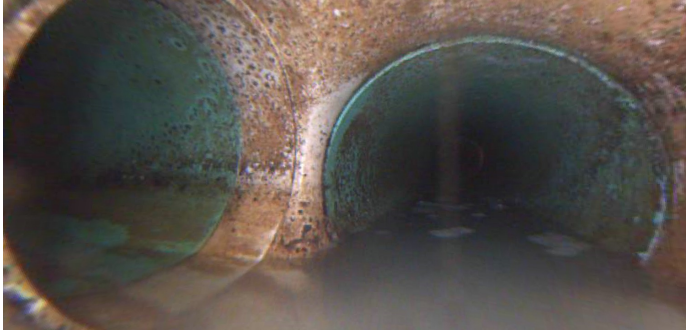
Code: **TFA**  
Description: **Tap Factory Active**

Distance (ft): **206.1**  
Structural Grade: **0**  
O&M Grade: **0**  
Clock Start/From: **9**  
Clock To:  
1st Value: **4.000**  
2nd Value:  
Value Percent:  
Continuous Index:  
Within 8" of Joint:  
Remarks:

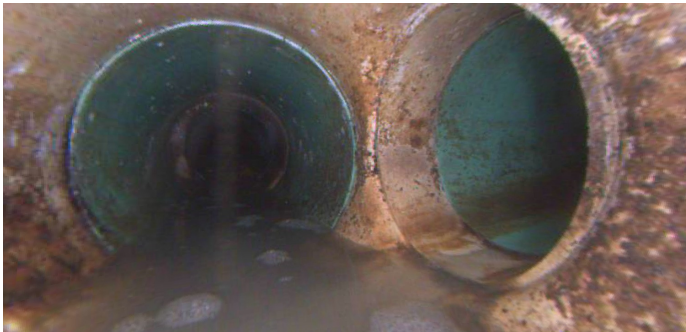
Code: **TFA**  
Description: **Tap Factory Active**

Distance (ft): **210.8**  
Structural Grade: **0**  
O&M Grade: **0**  
Clock Start/From: **3**  
Clock To:  
1st Value: **4.000**  
2nd Value:  
Value Percent:  
Continuous Index:  
Within 8" of Joint:  
Remarks:

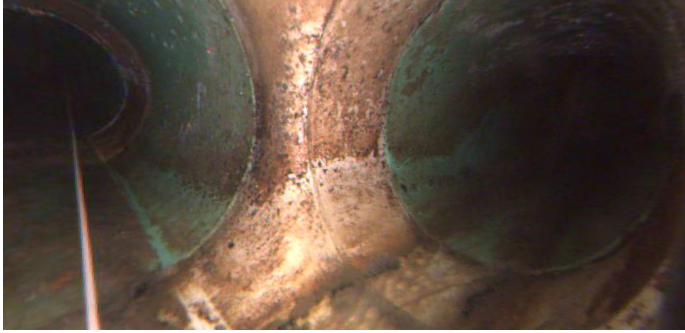
Code: **TFA**  
Description: **Tap Factory Active**

Distance (ft): **213.1**  
Structural Grade: **0**  
O&M Grade: **0**  
Clock Start/From: **9**  
Clock To:  
1st Value: **4.000**  
2nd Value:  
Value Percent:  
Continuous Index:  
Within 8" of Joint:  
Remarks:

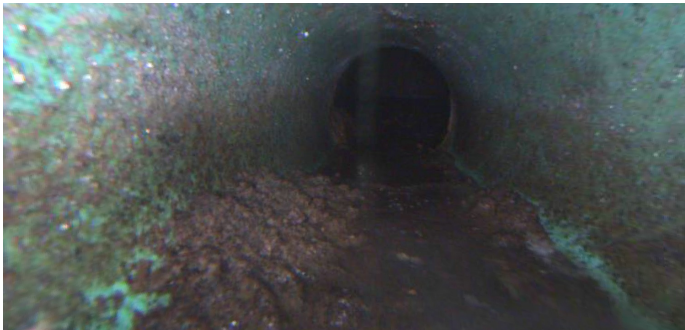
Code: **DSF**  
Description: **Deposits Settled Fine**

Distance (ft): **213.8**  
Structural Grade: **0**  
O&M Grade: **2**  
Clock Start/From: **7**  
Clock To: **9**  
1st Value:  
2nd Value:  
Value Percent: **5.000**  
Continuous Index:  
Within 8" of Joint: **NO**  
Remarks:

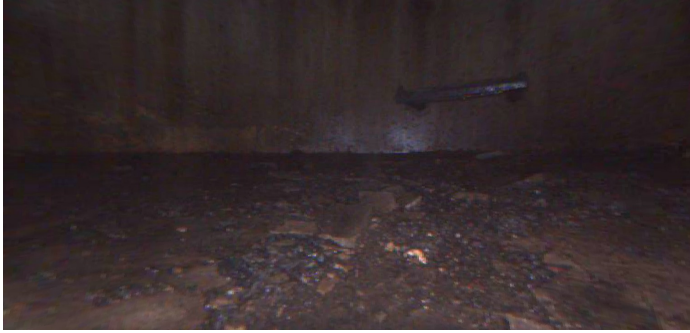
Code:	AMH
Description:	Manhole
Distance (ft):	215.9
Structural Grade:	0
O&M Grade:	0
Clock Start/From:	
Clock To:	
1st Value:	
2nd Value:	
Value Percent:	
Continuous Index:	
Within 8" of Joint:	NO
Remarks:	M-1004-012
