## Profile/Photo Observation Report

Street:	<b>McAfee Dr.</b>	Flow Control:	<b>Not Controlled</b>
City:	<b>Hobart, IN</b>	Year Renewed:	
Location:	<b>Other</b>	Tape/Media #:	
Purpose:	<b>Not Known</b>	Dia/Height:	<b>8"</b>
Use:	<b>Sanitary</b>	Material:	<b>PVC</b>
Drain Area:	<b>NA</b>	Lining:	
Category:	<b>NA</b>		
Comment:

Location Details:		Direction of Survey:	<b>Downstream</b>
US MH:	<b>M-1004-011</b>	DS MH:	<b>M-1004-012</b>
		Total Length Surveyed (ft):	<b>215.9</b>

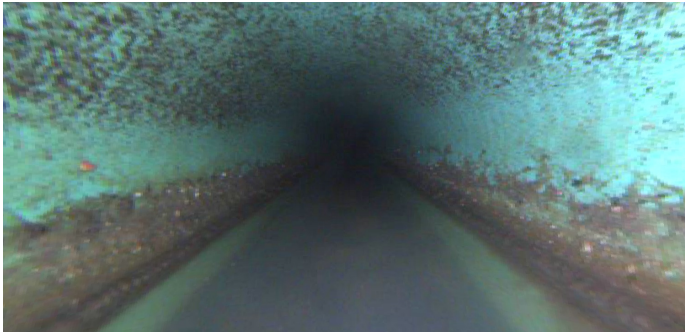
Code:	<b>MWL</b>
Description:	<b>Water Level</b>

Distance (ft):	<b>.0</b>
Structural Grade:	<b>0</b>
O&M Grade:	<b>0</b>
Clock Start/From:	
Clock To:	
1st Value:	
2nd Value:	
Value Percent:	<b>5.000</b>
Continuous Index:	
Within 8" of Joint:	<b>NO</b>
Remarks:

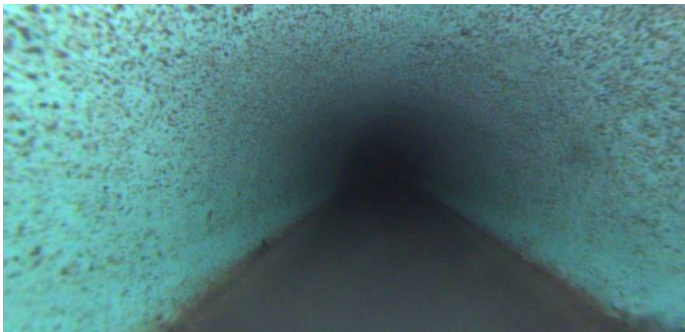
Code:	<b>MWL</b>
Description:	<b>Water Level</b>

Distance (ft):	<b>31.0</b>
Structural Grade:	<b>0</b>
O&M Grade:	<b>0</b>
Clock Start/From:	
Clock To:	
1st Value:	
2nd Value:	
Value Percent:	<b>20.000</b>
Continuous Index:	
Within 8" of Joint:	<b>NO</b>
Remarks:

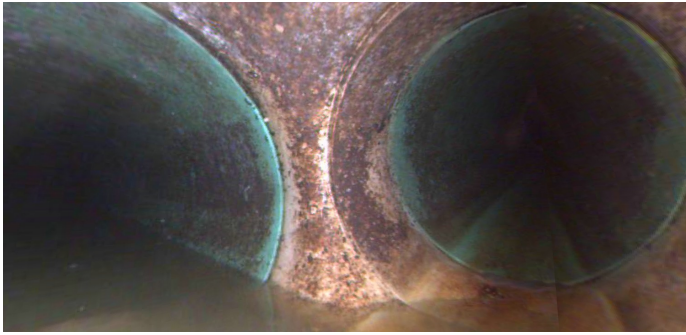
Code: **TF**  
Description: **Tap Factory**

Distance (ft): **94.0**  
Structural Grade: **0**  
O&M Grade: **0**  
Clock Start/From: **3**  
Clock To:  
1st Value: **4.000**  
2nd Value:  
Value Percent:  
Continuous Index:  
Within 8" of Joint:  
Remarks:

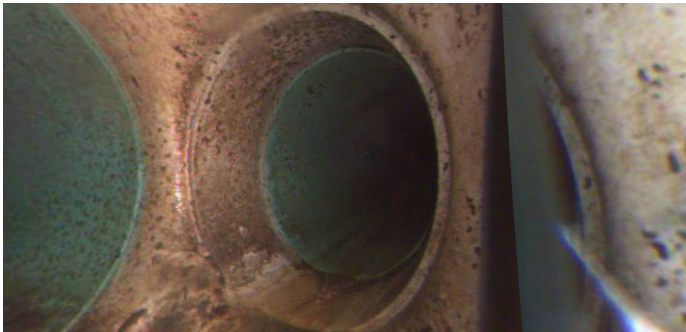
Code: **TF**  
Description: **Tap Factory**

Distance (ft): **144.4**  
Structural Grade: **0**  
O&M Grade: **0**  
Clock Start/From: **9**  
Clock To:  
1st Value: **4.000**  
2nd Value:  
Value Percent:  
Continuous Index:  
Within 8" of Joint:  
Remarks:

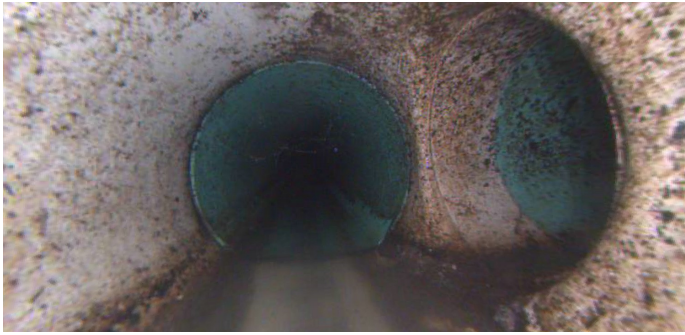
Code: **TF**  
Description: **Tap Factory**

Distance (ft): **179.1**  
Structural Grade: **0**  
O&M Grade: **0**  
Clock Start/From: **3**  
Clock To:  
1st Value: **4.000**  
2nd Value:  
Value Percent:  
Continuous Index:  
Within 8" of Joint:  
Remarks:

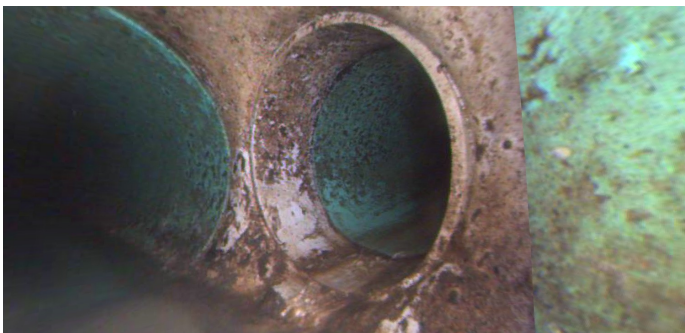
Code: **TF**  
Description: **Tap Factory**

Distance (ft): **199.1**  
Structural Grade: **0**  
O&M Grade: **0**  
Clock Start/From: **3**  
Clock To:  
1st Value: **4.000**  
2nd Value:  
Value Percent:  
Continuous Index:  
Within 8" of Joint:  
Remarks:

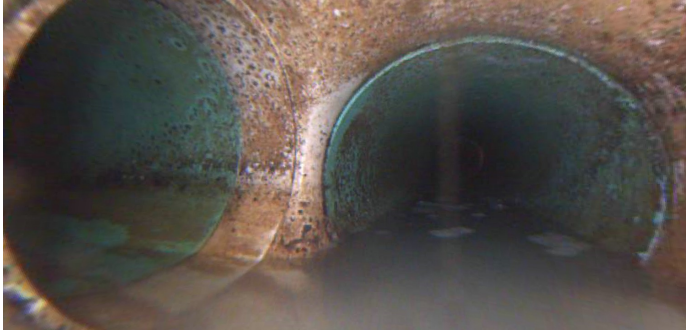
Code: **TFA**  
Description: **Tap Factory Active**

Distance (ft): **206.1**  
Structural Grade: **0**  
O&M Grade: **0**  
Clock Start/From: **9**  
Clock To:  
1st Value: **4.000**  
2nd Value:  
Value Percent:  
Continuous Index:  
Within 8" of Joint:  
Remarks:

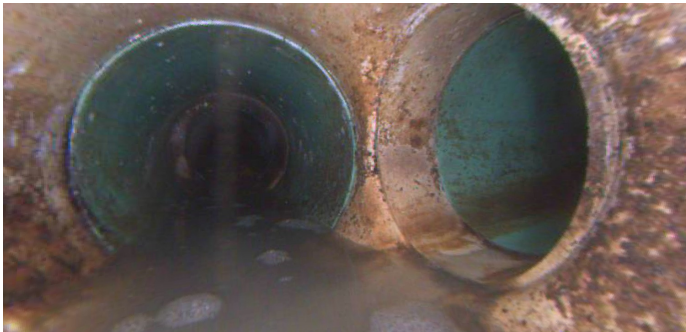
Code: **TFA**  
Description: **Tap Factory Active**

Distance (ft): **210.8**  
Structural Grade: **0**  
O&M Grade: **0**  
Clock Start/From: **3**  
Clock To:  
1st Value: **4.000**  
2nd Value:  
Value Percent:  
Continuous Index:  
Within 8" of Joint:  
Remarks:

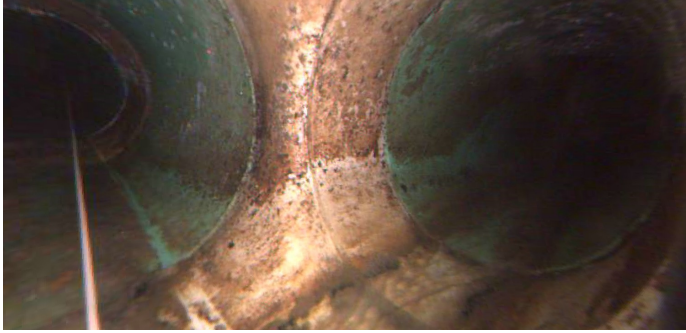
Code: **TFA**  
Description: **Tap Factory Active**

Distance (ft): **213.1**  
Structural Grade: **0**  
O&M Grade: **0**  
Clock Start/From: **9**  
Clock To:  
1st Value: **4.000**  
2nd Value:  
Value Percent:  
Continuous Index:  
Within 8" of Joint:  
Remarks:

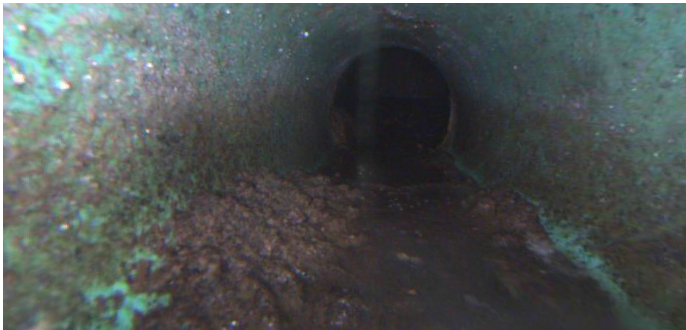
Code: **DSF**  
Description: **Deposits Settled Fine**

Distance (ft): **213.8**  
Structural Grade: **0**  
O&M Grade: **2**  
Clock Start/From: **7**  
Clock To: **9**  
1st Value:  
2nd Value:  
Value Percent: **5.000**  
Continuous Index:  
Within 8" of Joint: **NO**  
Remarks:

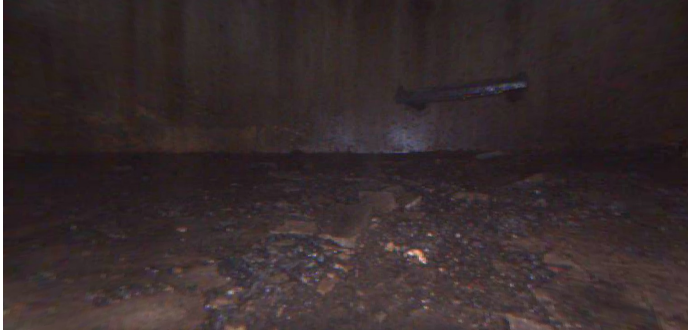
Code:	AMH
Description:	Manhole
Distance (ft):	215.9
Structural Grade:	0
O&M Grade:	0
Clock Start/From:	
Clock To:	
1st Value:	
2nd Value:	
Value Percent:	
Continuous Index:	
Within 8" of Joint:	NO
Remarks:	M-1004-012
