Profile/Photo Observation Report

Date:	10/20/2021	Weather:		Coding:	PACP 6.0
Pipe Length (ft):		Owner:	Hobart, IN	Pre Clean:	Not Known
P.O.#:	911_1	Surveyor:	M. Pielacha	PSR:	M-705-032A_M-705-032
Customer:	Hobart, IN	Clean Date:		Shape:	C

Street:	Center Street	Flow Control:	
City:	Hobart, IN	Year Renewed:	
Location:	Light Highway	Tape/Media #:	911
Purpose:	Routine Assessment	Dia/Height:	8"
Use:	Sanitary	Material:	PVC
Drain Area:		Lining:

US MH: **M-705-032A** DS MH: **M-705-032** Total Length Surveyed (ft): **257.9**

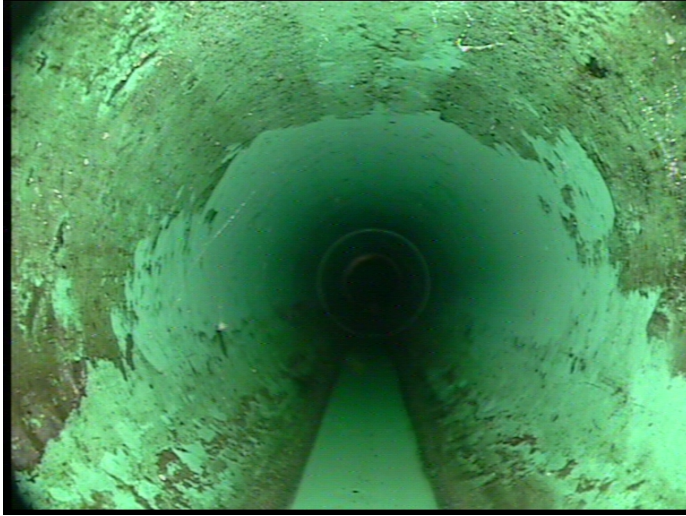
Code:	AMH
Description:	Manhole
Distance (ft):	.0
Structural Grade:	0
O&M Grade:	0
Clock Start/From:	
Clock To:	
1st Value:	
2nd Value:	
Value Percent:	
Continuous Index:	
Within 8" of Joint:	NO
Remarks:	M-705-032

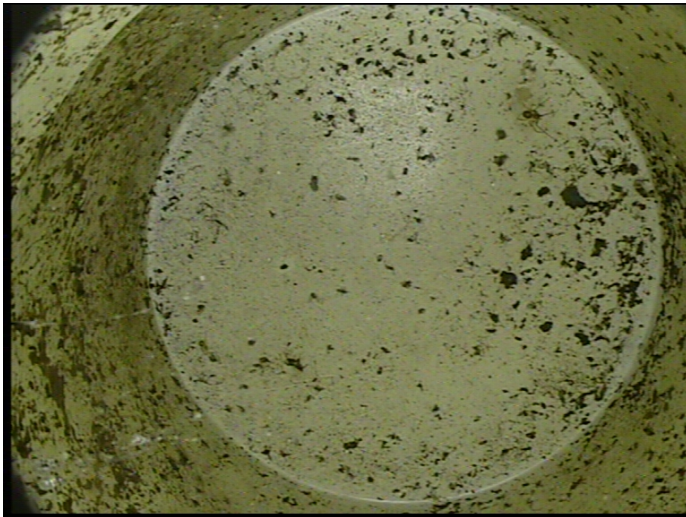
Code: **MWL**
Description: **Water Level**

Distance (ft): **.0**
Structural Grade: **0**
O&M Grade: **0**
Clock Start/From:
Clock To:
1st Value:
2nd Value:
Value Percent: **5.000**
Continuous Index:
Within 8" of Joint: **NO**
Remarks:

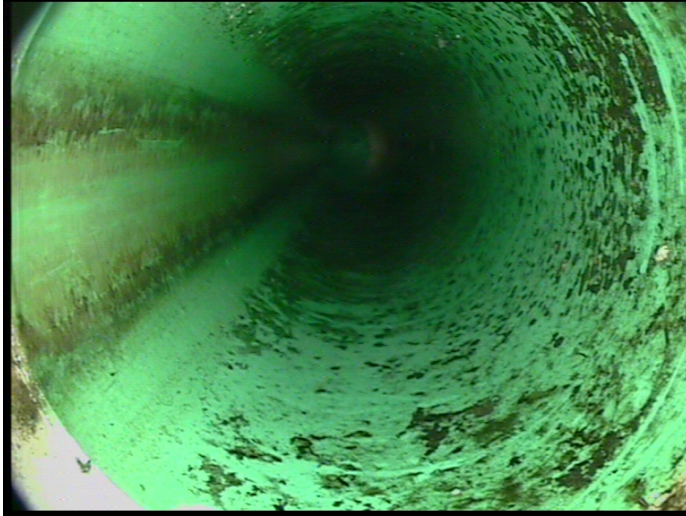
Code: **TFC**
Description: **Tap Factory Capped**

Distance (ft): **10.1**
Structural Grade: **0**
O&M Grade: **0**
Clock Start/From: **10**
Clock To:
1st Value: **4.000**
2nd Value:
Value Percent:
Continuous Index:
Within 8" of Joint: **NO**
Remarks:

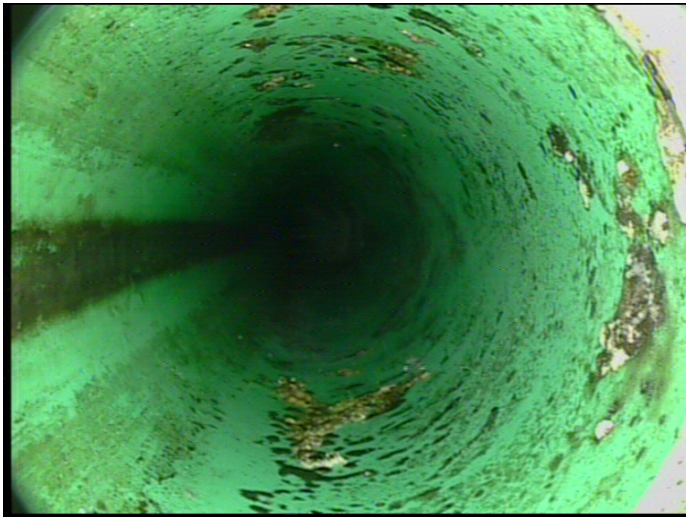
Code: **TF**
Description: **Tap Factory**

Distance (ft): **34.2**
Structural Grade: **0**
O&M Grade: **0**
Clock Start/From: **10**
Clock To:
1st Value: **4.000**
2nd Value:
Value Percent:
Continuous Index:
Within 8" of Joint: **NO**
Remarks:

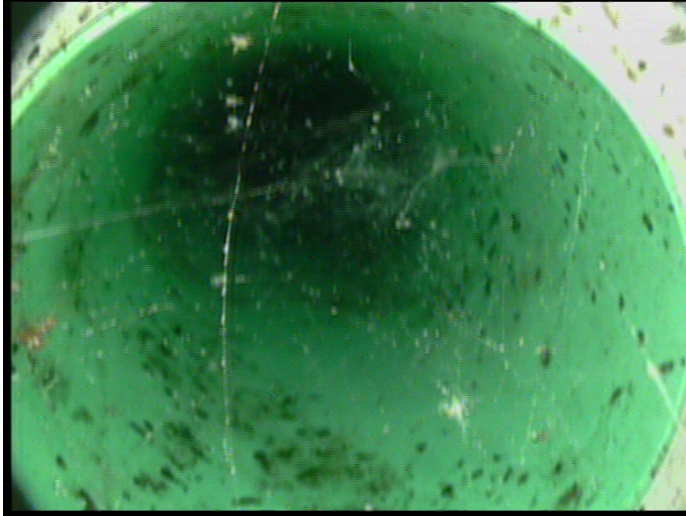
Code: **TF**
Description: **Tap Factory**

Distance (ft): **56.4**
Structural Grade: **0**
O&M Grade: **0**
Clock Start/From: **9**
Clock To:
1st Value: **4.000**
2nd Value:
Value Percent:
Continuous Index:
Within 8" of Joint: **NO**
Remarks:

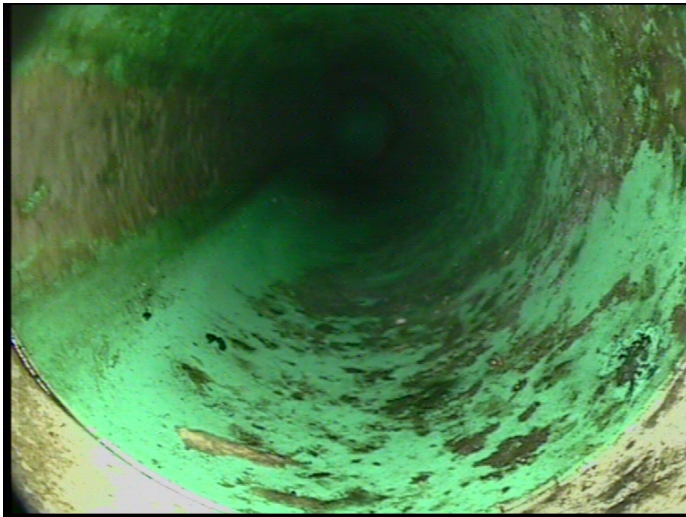
Code: **TF**
Description: **Tap Factory**

Distance (ft): **87.0**
Structural Grade: **0**
O&M Grade: **0**
Clock Start/From: **9**
Clock To:
1st Value: **4.000**
2nd Value:
Value Percent:
Continuous Index:
Within 8" of Joint: **NO**
Remarks:

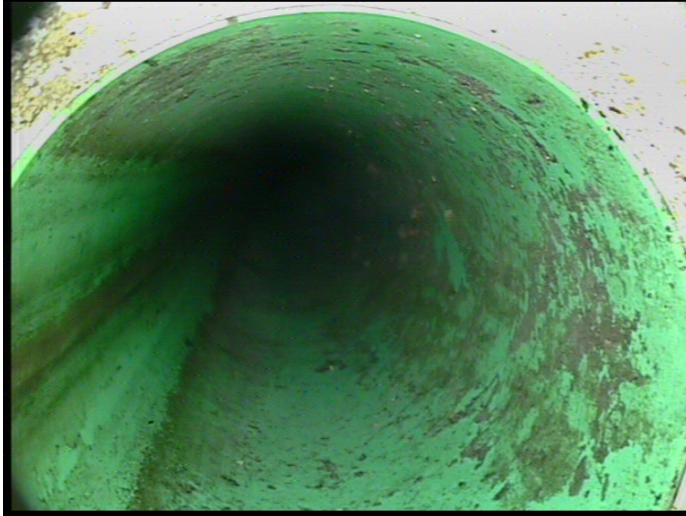
Code: **TF**
Description: **Tap Factory**

Distance (ft): **129.3**
Structural Grade: **0**
O&M Grade: **0**
Clock Start/From: **9**
Clock To:
1st Value: **4.000**
2nd Value:
Value Percent:
Continuous Index:
Within 8" of Joint: **NO**
Remarks:

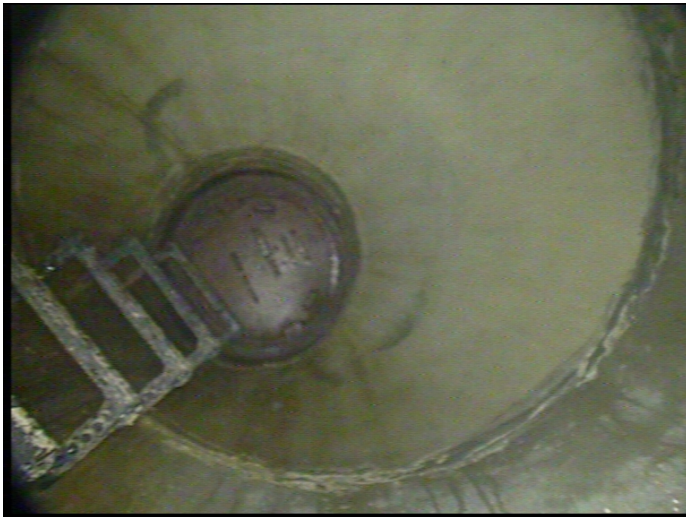
Code: **TF**
Description: **Tap Factory**

Distance (ft): **151.1**
Structural Grade: **0**
O&M Grade: **0**
Clock Start/From: **9**
Clock To:
1st Value: **4.000**
2nd Value:
Value Percent:
Continuous Index:
Within 8" of Joint: **NO**
Remarks:
