Profile/Photo Observation Report

Street:	MCAFEE DR	Flow Control:	Not Controlled
City:	Hobart, IN	Year Renewed:	
Location:	Other	Tape/Media #:	
Purpose:	Not Known	Dia/Height:	8"
Use:	Sanitary	Material:	PVC
Drain Area:	NA	Lining:	
Category:	NA		
Comment:

Location Details:		Direction of Survey:	Downstream
US MH:	M-1004-015	DS MH:	M-1004-014
		Total Length Surveyed (ft):	198.7

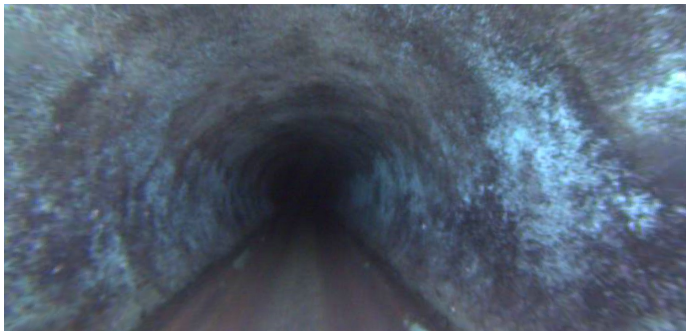
Code: **AMH**
Description: **Manhole**

Distance (ft): **.0**
Structural Grade: **0**
O&M Grade: **0**
Clock Start/From:
Clock To:
1st Value:
2nd Value:
Value Percent:
Continuous Index:
Within 8" of Joint: **NO**
Remarks: **M-1004-015**

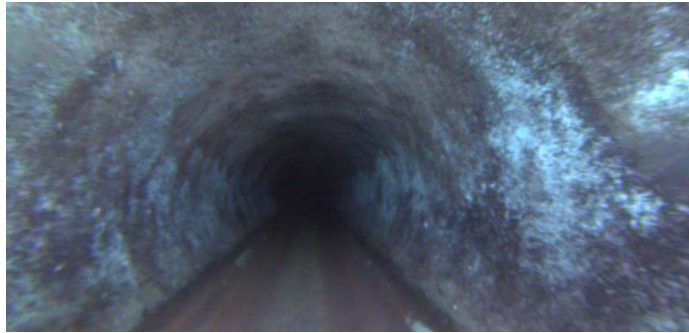
Code:	MWL
Description:	Water Level
Distance (ft):	.0
Structural Grade:	0
O&M Grade:	0
Clock Start/From:	
Clock To:	
1st Value:	
2nd Value:	
Value Percent:	10.000
Continuous Index:	
Within 8" of Joint:	NO
Remarks:

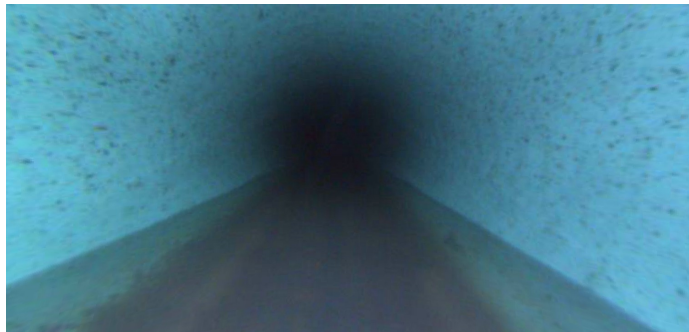
Code:	MWL
Description:	Water Level
Distance (ft):	29.4
Structural Grade:	0
O&M Grade:	0
Clock Start/From:	
Clock To:	
1st Value:	
2nd Value:	
Value Percent:	30.000
Continuous Index:	
Within 8" of Joint:	NO
Remarks:

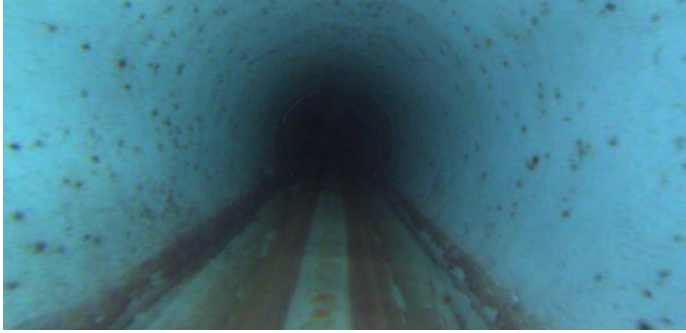
Code: **MWL**
Description: **Water Level**

Distance (ft): **47.3**
Structural Grade: **0**
O&M Grade: **0**
Clock Start/From:
Clock To:
1st Value:
2nd Value:
Value Percent: **5.000**
Continuous Index:
Within 8" of Joint: **NO**
Remarks:

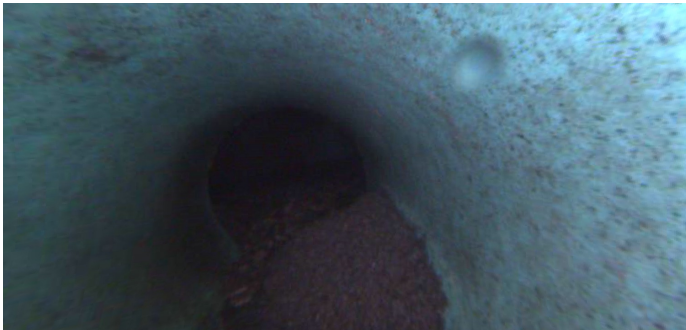
Code: **DSF**
Description: **Deposits Settled Fine**

Distance (ft): **197.0**
Structural Grade: **0**
O&M Grade: **3**
Clock Start/From: **3**
Clock To: **6**
1st Value:
2nd Value:
Value Percent: **20.000**
Continuous Index:
Within 8" of Joint: **NO**
Remarks:

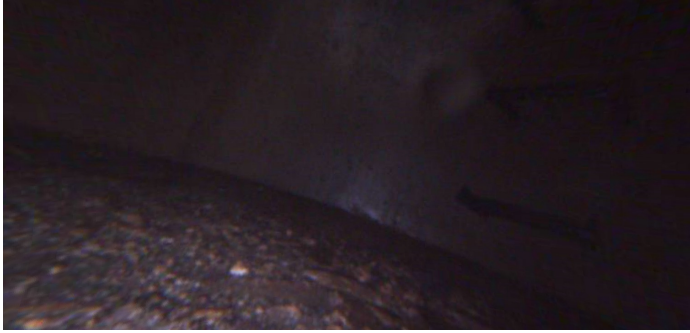
Code:	AMH
Description:	Manhole
Distance (ft):	198.7
Structural Grade:	0
O&M Grade:	0
Clock Start/From:	
Clock To:	
1st Value:	
2nd Value:	
Value Percent:	
Continuous Index:	
Within 8" of Joint:	NO
Remarks:	M-1004-014
