Profile/Photo Observation Report

| Street: | McAfee Dr. | Flow Control: | Not Controlled |
| City: | Hobart, IN | Year Renewed: | |

| US MH: | M-1004-015 | DS MH: | M-1004-014 |

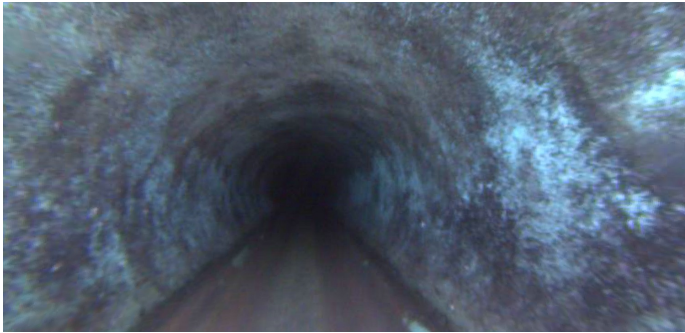
| Code: | MWL |
| Description: | Water Level |

| Distance (ft): | .0 |
| Value Percent: | 10.000 |

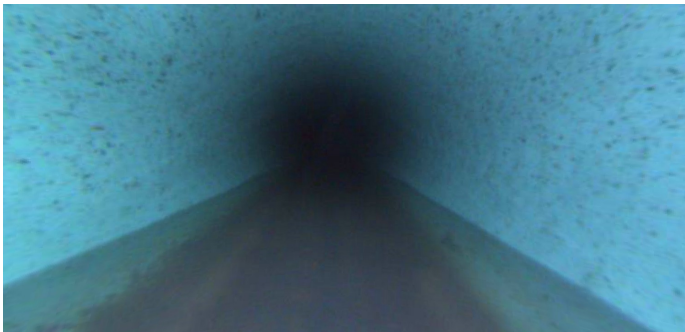
| Code: | MWL |
| Description: | Water Level |

| Distance (ft): | 29.4 |
| Value Percent: | 30.000 |

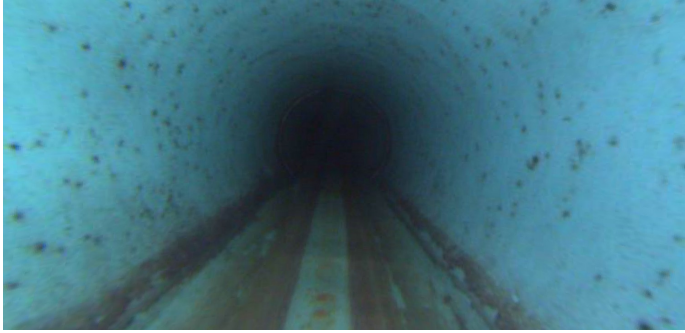
Code: **MWL**
Description: **Water Level**

Distance (ft): **47.3**
Structural Grade: **0**
O&M Grade: **0**
Clock Start/From:
Clock To:
1st Value:
2nd Value:
Value Percent: **5.000**
Continuous Index:
Within 8" of Joint: **NO**
Remarks:

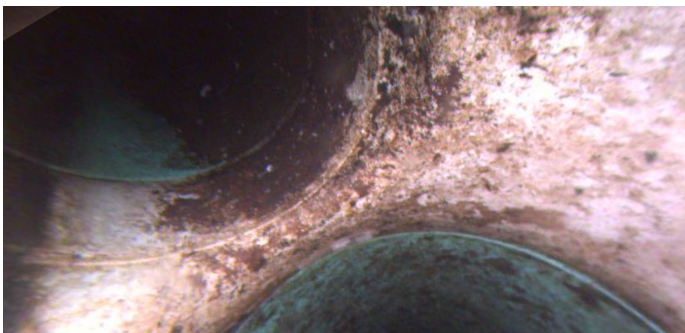
Code: **TF**
Description: **Tap Factory**

Distance (ft): **73.9**
Structural Grade: **0**
O&M Grade: **0**
Clock Start/From: **10**
Clock To:
1st Value: **4.000**
2nd Value:
Value Percent:
Continuous Index:
Within 8" of Joint:
Remarks:

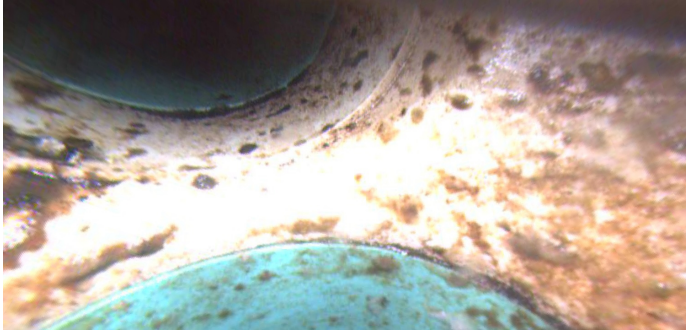
Code: **TF**
Description: **Tap Factory**

Distance (ft): **105.5**
Structural Grade: **0**
O&M Grade: **0**
Clock Start/From: **11**
Clock To:
1st Value: **4.000**
2nd Value:
Value Percent:
Continuous Index:
Within 8" of Joint:
Remarks:

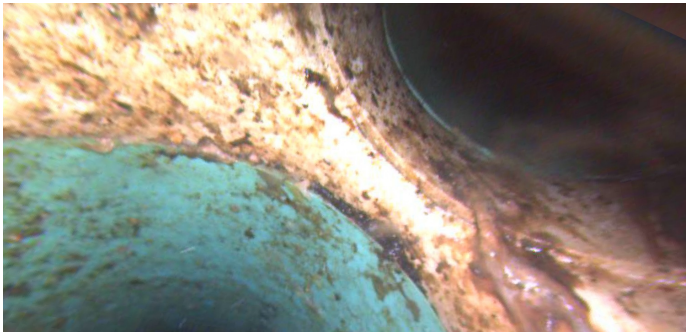
Code: **TF**
Description: **Tap Factory**

Distance (ft): **180.3**
Structural Grade: **0**
O&M Grade: **0**
Clock Start/From: **2**
Clock To:
1st Value: **4.000**
2nd Value:
Value Percent:
Continuous Index:
Within 8" of Joint:
Remarks:

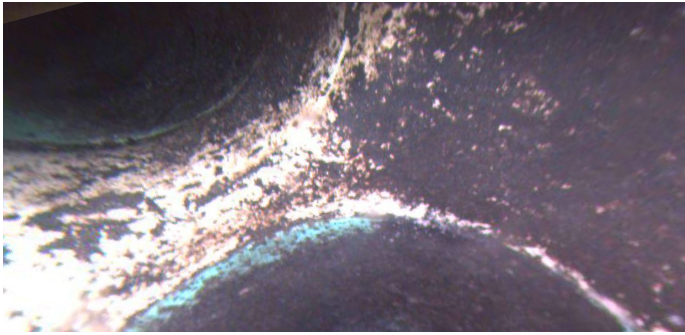
Code: **TF**
Description: **Tap Factory**

Distance (ft): **193.0**
Structural Grade: **0**
O&M Grade: **0**
Clock Start/From: **10**
Clock To:
1st Value: **4.000**
2nd Value:
Value Percent:
Continuous Index:
Within 8" of Joint:
Remarks:

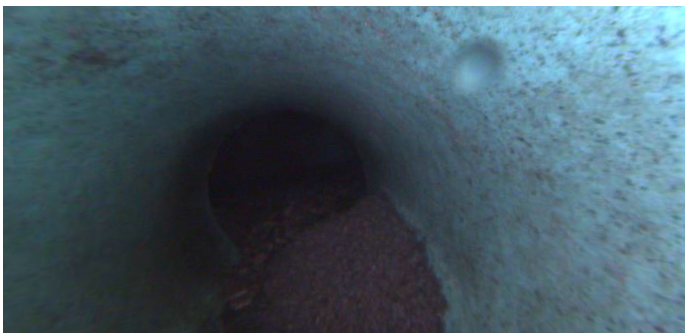
Code: **DSF**
Description: **Deposits Settled Fine**

Distance (ft): **197.0**
Structural Grade: **0**
O&M Grade: **3**
Clock Start/From: **3**
Clock To: **6**
1st Value:
2nd Value:
Value Percent: **20.000**
Continuous Index:
Within 8" of Joint: **NO**
Remarks:

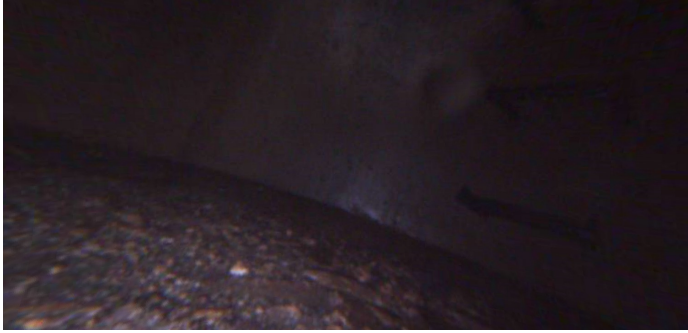
| Code: | AMH |
| Description: | Manhole |
| Distance (ft): | 198.7 |
| Remarks: | M-1004-014 |
