Profile/Photo Observation Report

Date:	10/08/2018	Weather:		Coding:	PACP 6.0
Pipe Length (ft):	221.4	Owner:	NA	Pre Clean:	Not Known
P.O.#:		Surveyor:	Selasie Honu	PSR:	P-1004-014-015
Customer:		Clean Date:	01/01/1900	Shape:	C

Street:	MCAFEE DR	Flow Control:	Not Controlled
City:	Hobart, IN	Year Renewed:	
Location:	Light Highway	Tape/Media #:	
Purpose:	Routine Assessment	Dia/Height:	8"
Use:	Sanitary	Material:	PVC
Drain Area:	NA	Lining:	
Category:	NA		
Comment:

Location Details:		Direction of Survey:	Upstream
US MH:	M-1004-015	DS MH:	M-1004-014
		Total Length Surveyed (ft):	197.8

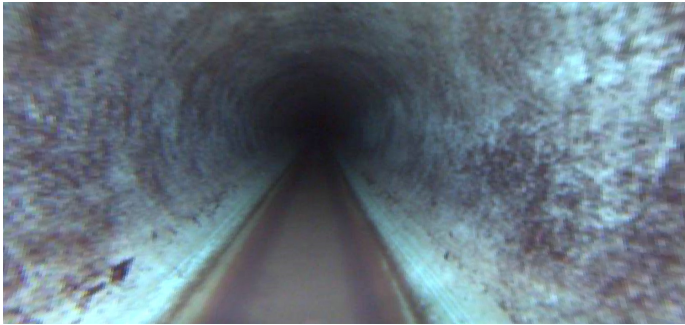
Code:	MWL
Description:	Water Level

Distance (ft):	.0
Structural Grade:	0
O&M Grade:	0
Clock Start/From:	
Clock To:	
1st Value:	
2nd Value:	
Value Percent:	5.000
Continuous Index:	
Within 8" of Joint:	NO
Remarks:

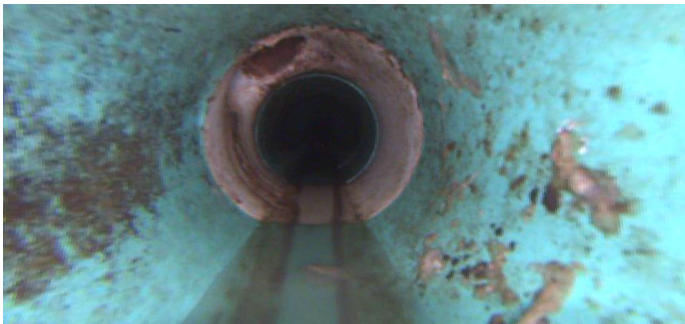
Code:	TF
Description:	Tap Factory

Distance (ft):	72.5
Structural Grade:	0
O&M Grade:	0
Clock Start/From:	11
Clock To:	
1st Value:	4.000
2nd Value:	
Value Percent:	
Continuous Index:	
Within 8" of Joint:	
Remarks:

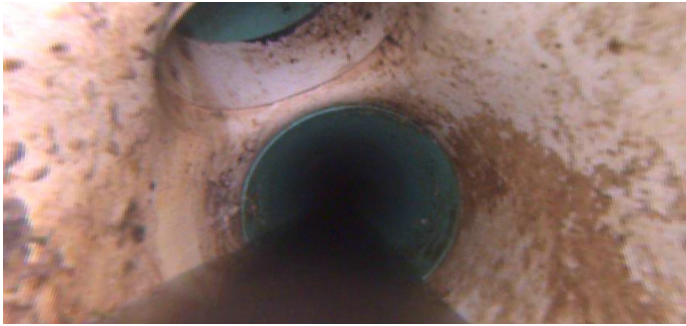
Code: **TF**
Description: **Tap Factory**

Distance (ft): **104.4**
Structural Grade: **0**
O&M Grade: **0**
Clock Start/From: **11**
Clock To:
1st Value: **4.000**
2nd Value:
Value Percent:
Continuous Index:
Within 8" of Joint:
Remarks:

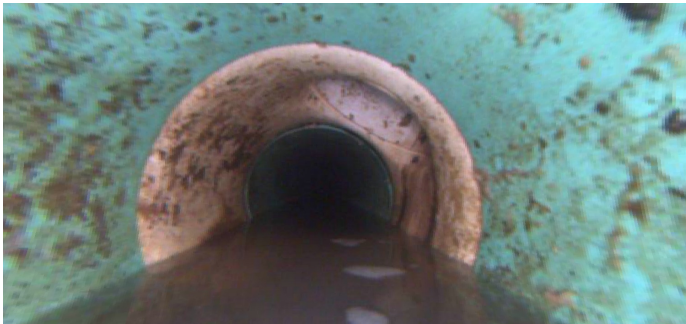
Code: **TF**
Description: **Tap Factory**

Distance (ft): **178.3**
Structural Grade: **0**
O&M Grade: **0**
Clock Start/From: **2**
Clock To:
1st Value: **4.000**
2nd Value:
Value Percent:
Continuous Index:
Within 8" of Joint:
Remarks:

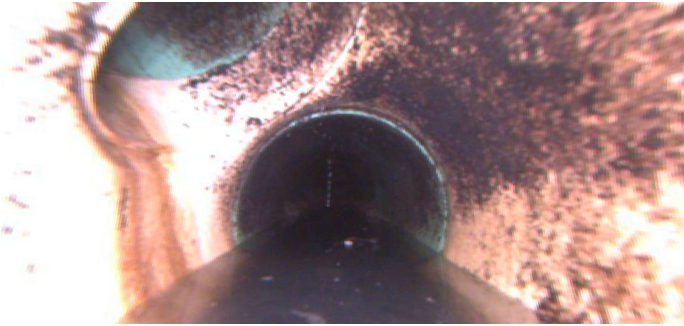
Code: **TF**
Description: **Tap Factory**

Distance (ft): **191.3**
Structural Grade: **0**
O&M Grade: **0**
Clock Start/From: **11**
Clock To:
1st Value: **4.000**
2nd Value:
Value Percent:
Continuous Index:
Within 8" of Joint:
Remarks:

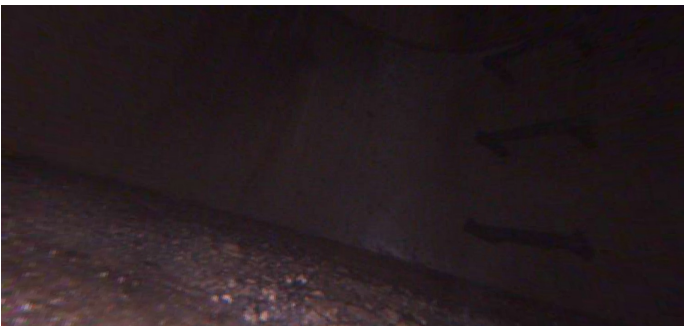
Code: **AMH**
Description: **Manhole**

Distance (ft): **197.8**
Structural Grade: **0**
O&M Grade: **0**
Clock Start/From:
Clock To:
1st Value:
2nd Value:
Value Percent:
Continuous Index:
Within 8" of Joint: **NO**
Remarks: **M-1004-015**
