Profile/Photo Observation Report

Date:	10/08/2018	Weather:		Coding:	PACP 6.0
Pipe Length (ft):	221.4	Owner:	NA	Pre Clean:	Not Known
P.O.#:		Surveyor:	Selasie Honu	PSR:	P-1004-014-015
Customer:		Clean Date:	01/01/1900	Shape:	C

Street:	McAfee Dr.	Flow Control:	Not Controlled
City:	Hobart, IN	Year Renewed:	
Location:	Light Highway	Tape/Media #:	
Purpose:	Routine Assessment	Dia/Height:	8"
Use:	Sanitary	Material:	PVC
Drain Area:	NA	Lining:	
Category:	NA		
Comment:

Location Details:		Direction of Survey:	Upstream
US MH:	M-1004-015	DS MH:	M-1004-014
		Total Length Surveyed (ft):	197.8

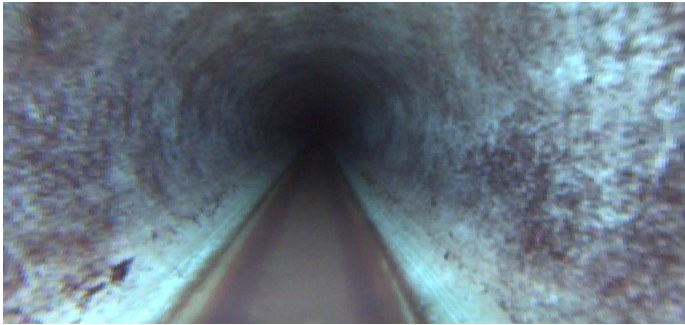
Code:	MWL
Description:	Water Level

Distance (ft):	.0
Structural Grade:	0
O&M Grade:	0
Clock Start/From:	
Clock To:	
1st Value:	
2nd Value:	
Value Percent:	5.000
Continuous Index:	
Within 8" of Joint:	NO
Remarks:

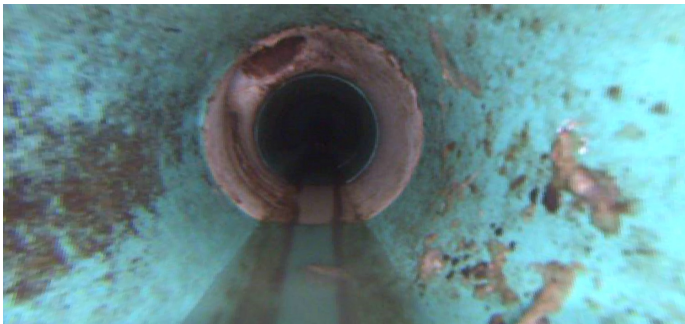
Code:	TF
Description:	Tap Factory

Distance (ft):	72.5
Structural Grade:	0
O&M Grade:	0
Clock Start/From:	11
Clock To:	
1st Value:	4.000
2nd Value:	
Value Percent:	
Continuous Index:	
Within 8" of Joint:	
Remarks:

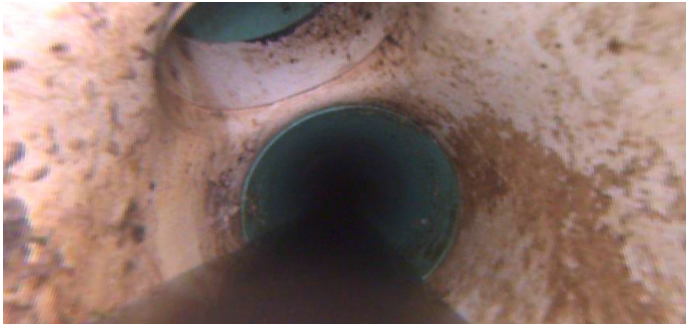
Code: **TF**
Description: **Tap Factory**

Distance (ft): **104.4**
Structural Grade: **0**
O&M Grade: **0**
Clock Start/From: **11**
Clock To:
1st Value: **4.000**
2nd Value:
Value Percent:
Continuous Index:
Within 8" of Joint:
Remarks:

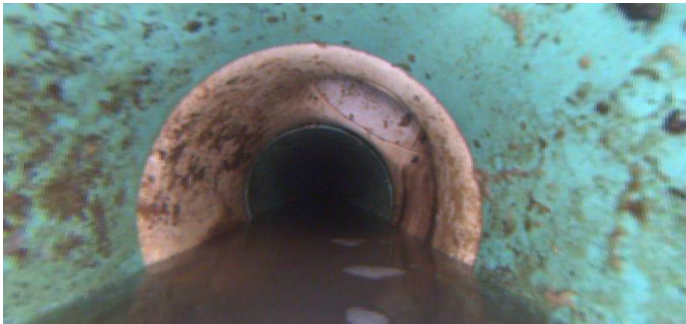
Code: **TF**
Description: **Tap Factory**

Distance (ft): **178.3**
Structural Grade: **0**
O&M Grade: **0**
Clock Start/From: **2**
Clock To:
1st Value: **4.000**
2nd Value:
Value Percent:
Continuous Index:
Within 8" of Joint:
Remarks:

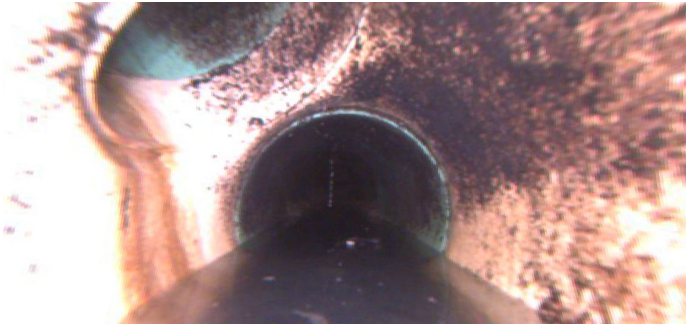
Code: **TF**
Description: **Tap Factory**

Distance (ft): **191.3**
Structural Grade: **0**
O&M Grade: **0**
Clock Start/From: **11**
Clock To:
1st Value: **4.000**
2nd Value:
Value Percent:
Continuous Index:
Within 8" of Joint:
Remarks:

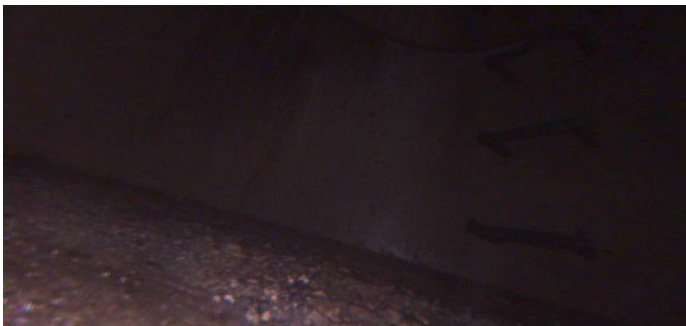
Code: **AMH**
Description: **Manhole**

Distance (ft): **197.8**
Structural Grade: **0**
O&M Grade: **0**
Clock Start/From:
Clock To:
1st Value:
2nd Value:
Value Percent:
Continuous Index:
Within 8" of Joint: **NO**
Remarks: **M-1004-015**
