Profile/Photo Observation Report

Date:	04/19/2018	Weather:		Coding:	PACP 4.2
Pipe Length (ft):	382.2	Owner:	City of Hobart	Pre Clean:	No Pre-Cleaning
P.O.#:	2004	Surveyor:	SAN	PSR:	P-1004-008-016
Customer:	Red Zone	Clean Date:		Shape:	C

Street:	3045 McAfee Dr	Flow Control:	Not Controlled
City:	Hobart In	Year Renewed:	
Location:	Light Highway	Tape/Media #:	Deliverable 1
Purpose:	Routine Assessment	Dia/Height:	15"
Use:	Sanitary	Material:	PVC
Drain Area:	Northeast	Lining:	
Category:	NA		
Comment:	418-1		
Location Details:	Center of street	Direction of Survey:	Downstream
US MH:	M-1004-008	DS MH:	M-1004-016
		Total Length Surveyed (ft):	382.2

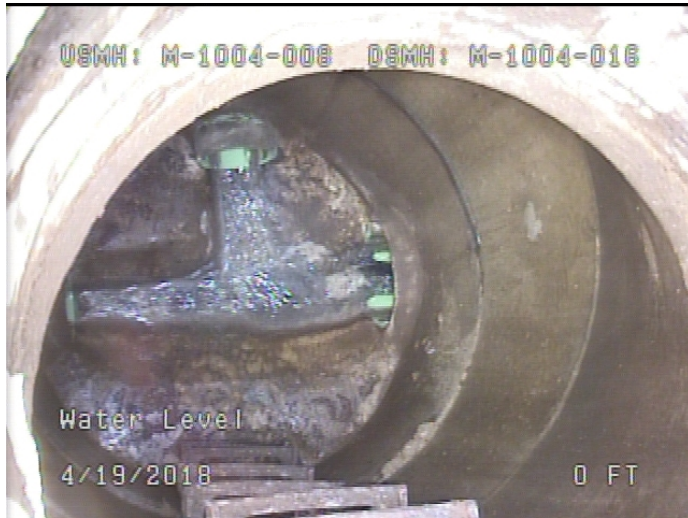
Code:	AMH
Description:	Manhole
Distance (ft):	.0
Structural Grade:	0
O&M Grade:	0
Clock Start/From:	
Clock To:	
1st Value:	
2nd Value:	
Value Percent:	
Continuous Index:	
Within 8" of Joint:	NO
Remarks:	M-1004-008

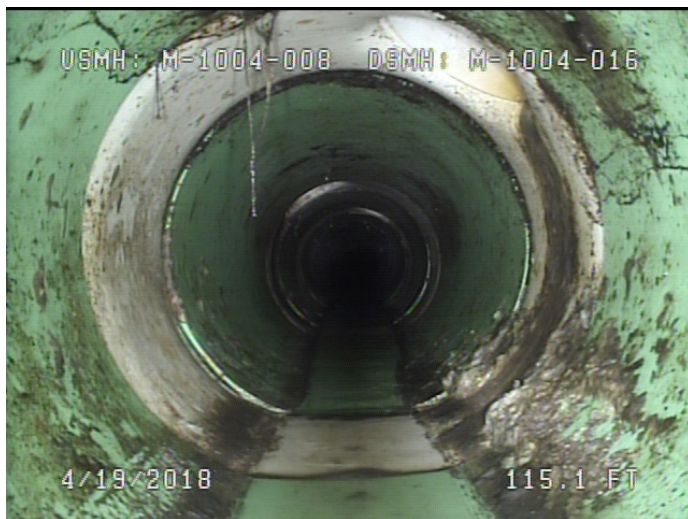
Code:	MWL
Description:	Water Level
Distance (ft):	.0
Structural Grade:	0
O&M Grade:	0
Clock Start/From:	
Clock To:	
1st Value:	
2nd Value:	
Value Percent:	5.000
Continuous Index:	
Within 8" of Joint:	NO
Remarks:

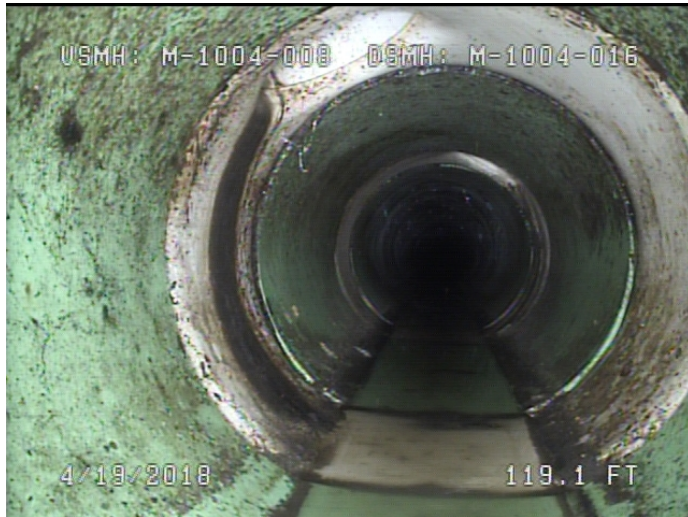
Code:	TF
Description:	Tap Factory
Distance (ft):	115.1
Structural Grade:	0
O&M Grade:	0
Clock Start/From:	2
Clock To:	
1st Value:	6.000
2nd Value:	
Value Percent:	
Continuous Index:	
Within 8" of Joint:	NO
Remarks:

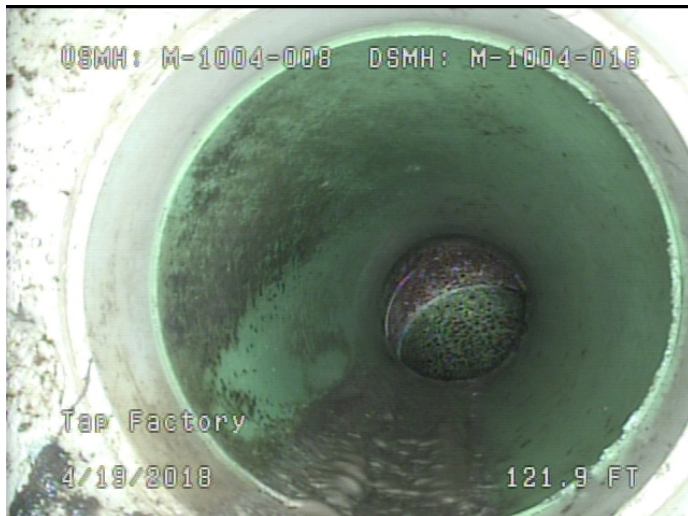
Code:	TF
Description:	Tap Factory
Distance (ft):	119.1
Structural Grade:	0
O&M Grade:	0
Clock Start/From:	11
Clock To:	
1st Value:	4.000
2nd Value:	
Value Percent:	
Continuous Index:	
Within 8" of Joint:	NO
Remarks:

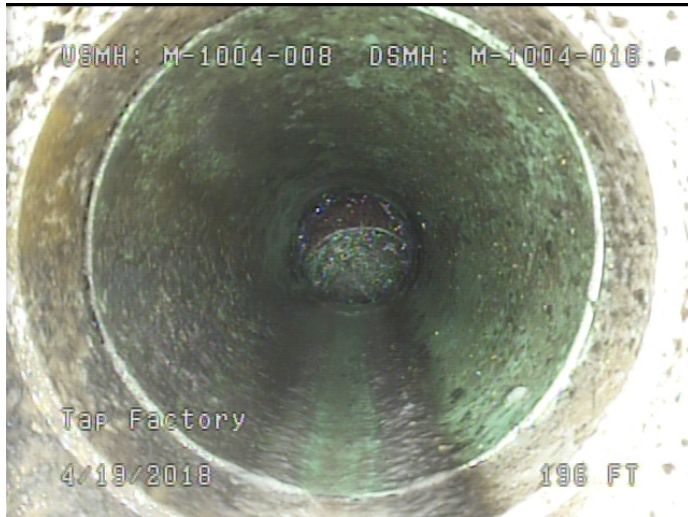
Code:	TF
Description:	Tap Factory
Distance (ft):	121.9
Structural Grade:	0
O&M Grade:	0
Clock Start/From:	1
Clock To:	
1st Value:	4.000
2nd Value:	
Value Percent:	
Continuous Index:	
Within 8" of Joint:	NO
Remarks:

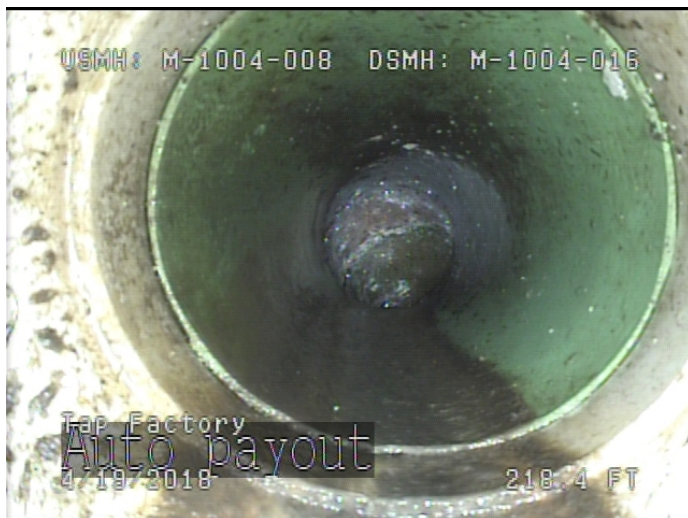
Code:	TF
Description:	Tap Factory
Distance (ft):	196.0
Structural Grade:	0
O&M Grade:	0
Clock Start/From:	11
Clock To:	
1st Value:	4.000
2nd Value:	
Value Percent:	
Continuous Index:	
Within 8" of Joint:	NO
Remarks:

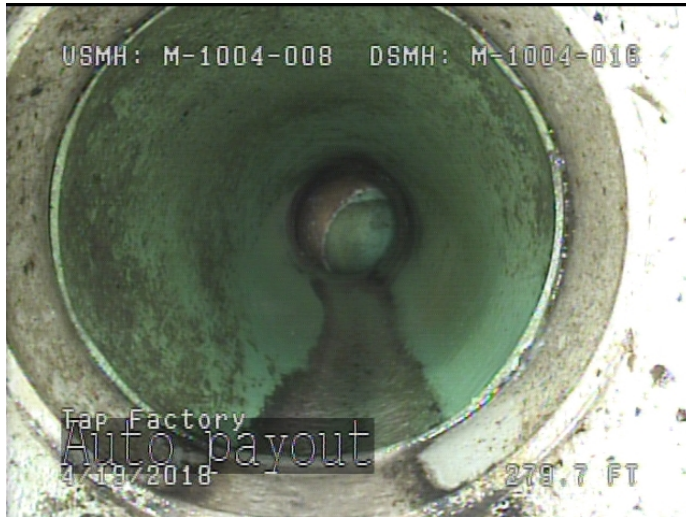
Code:	TF
Description:	Tap Factory
Distance (ft):	218.4
Structural Grade:	0
O&M Grade:	0
Clock Start/From:	1
Clock To:	
1st Value:	4.000
2nd Value:	
Value Percent:	
Continuous Index:	
Within 8" of Joint:	NO
Remarks:

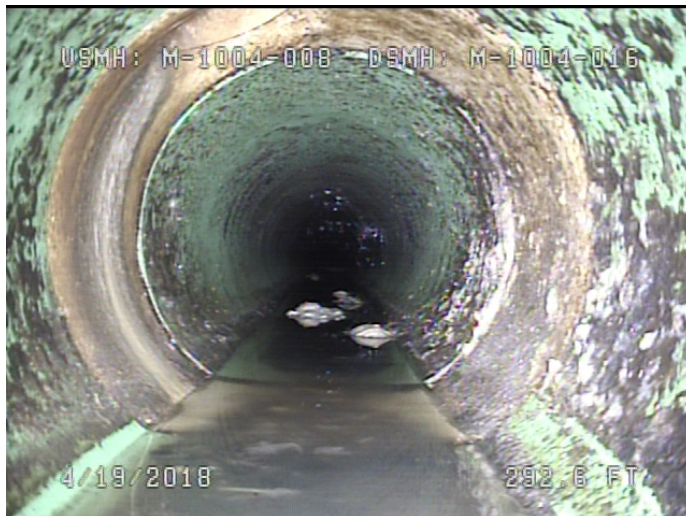
Code: **TF**
Description: **Tap Factory**

Distance (ft): **279.7**
Structural Grade: **0**
O&M Grade: **0**
Clock Start/From: **1**
Clock To:
1st Value: **4.000**
2nd Value:
Value Percent:
Continuous Index:
Within 8" of Joint: **NO**
Remarks:

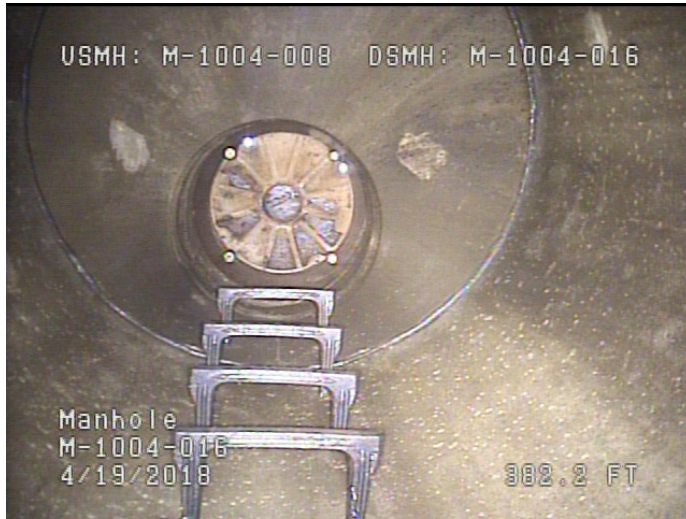
Code: **TF**
Description: **Tap Factory**

Distance (ft): **292.6**
Structural Grade: **0**
O&M Grade: **0**
Clock Start/From: **11**
Clock To:
1st Value: **4.000**
2nd Value:
Value Percent:
Continuous Index:
Within 8" of Joint: **NO**
Remarks:
