# Profile/Photo Observation Report

Date:	<b>10/22/2021</b>	Weather:		Coding:	<b>PACP 6.0</b>
Pipe Length (ft):		Owner:	<b>Hobart, IN</b>	Pre Clean:	<b>Not Known</b>
P.O.#:	<b>965_1</b>	Surveyor:	<b>M. Pielacha</b>	PSR:	<b>M-806-047_M-806-062</b>
Customer:	<b>Hobart, IN</b>	Clean Date:		Shape:	<b>C</b>

Street:	<b>10th Street</b>	Flow Control:	
City:	<b>Hobart, IN</b>	Year Renewed:	
Location:	<b>Light Highway</b>	Tape/Media #:	<b>965</b>
Purpose:	<b>Routine Assessment</b>	Dia/Height:	<b>15"</b>
Use:	<b>Sanitary</b>	Material:	<b>PVC</b>
Drain Area:		Lining:	
Category:	<b>NA</b>		
Comment:			
Location Details:		Direction of Survey:	<b>Downstream</b>
US MH:	<b>M-806-047</b>	DS MH:	<b>M-806-062</b>
		Total Length Surveyed (ft):	<b>346.8</b>

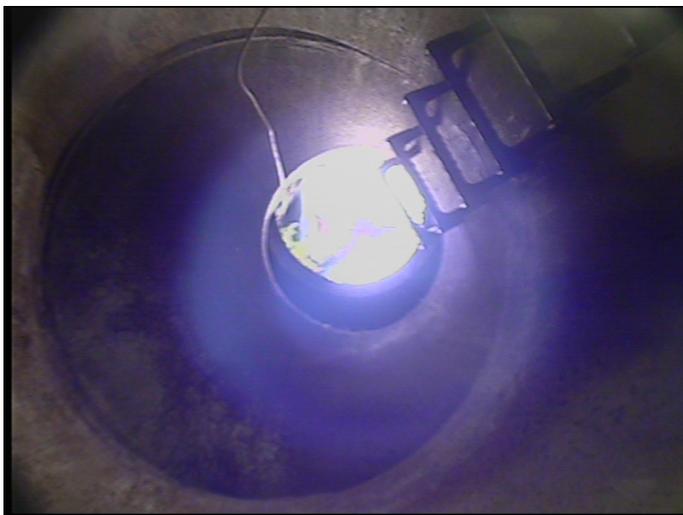
Code: **AMH**  
 Description: **Manhole**  
 Distance (ft): **.0**  
 Structural Grade: **0**  
 O&M Grade: **0**  
 Clock Start/From:  
 Clock To:  
 1st Value:  
 2nd Value:  
 Value Percent:  
 Continuous Index:  
 Within 8" of Joint: **NO**  
 Remarks: **M-806-047**

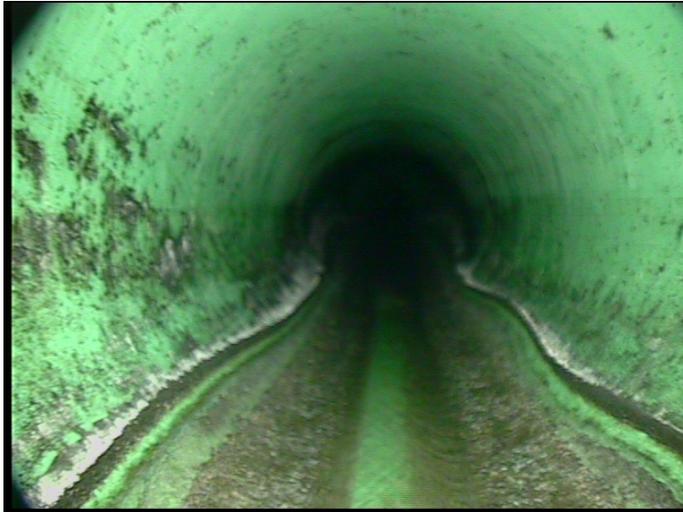
Code: **MWL**  
Description: **Water Level**

Distance (ft): **.0**  
Structural Grade: **0**  
O&M Grade: **0**  
Clock Start/From:  
Clock To:  
1st Value:  
2nd Value:  
Value Percent: **5.000**  
Continuous Index:  
Within 8" of Joint: **NO**  
Remarks:

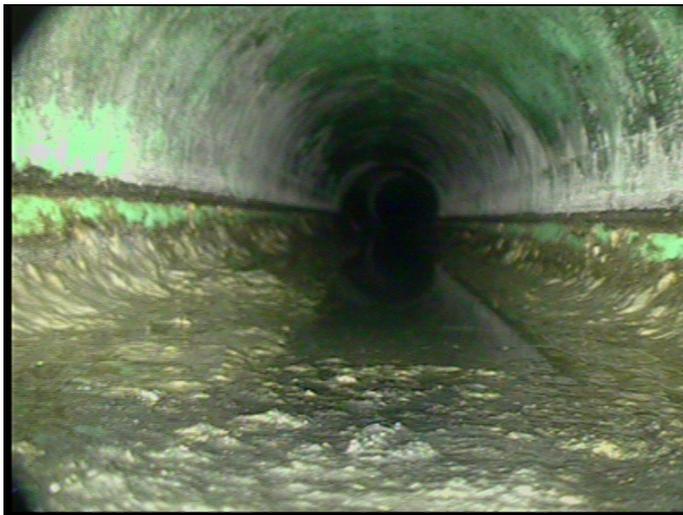
Code: **DSF**  
Description: **Deposits Settled Fine**

Distance (ft): **333.2**  
Structural Grade: **0**  
O&M Grade: **2**  
Clock Start/From: **4**  
Clock To: **8**  
1st Value:  
2nd Value:  
Value Percent: **5.000**  
Continuous Index: **S01**  
Within 8" of Joint: **YES**  
Remarks:

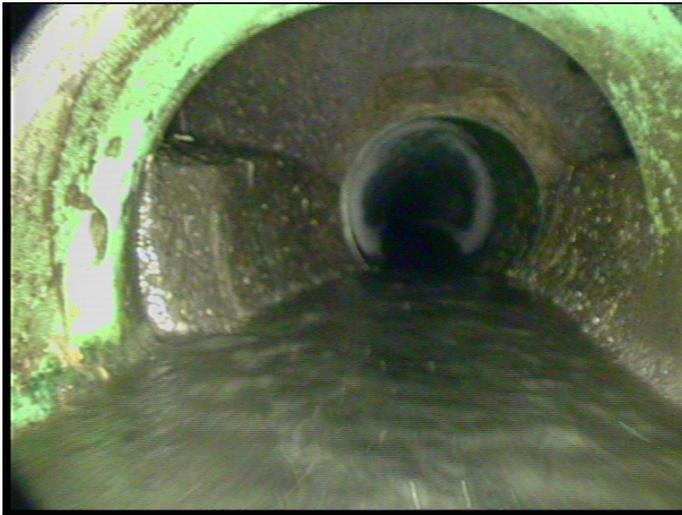
Code: **DSF**  
Description: **Deposits Settled Fine**

Distance (ft): **344.5**  
Structural Grade: **0**  
O&M Grade: **2**  
Clock Start/From: **4**  
Clock To: **8**  
1st Value:  
2nd Value:  
Value Percent: **10.000**  
Continuous Index: **F01**  
Within 8" of Joint: **NO**  
Remarks:

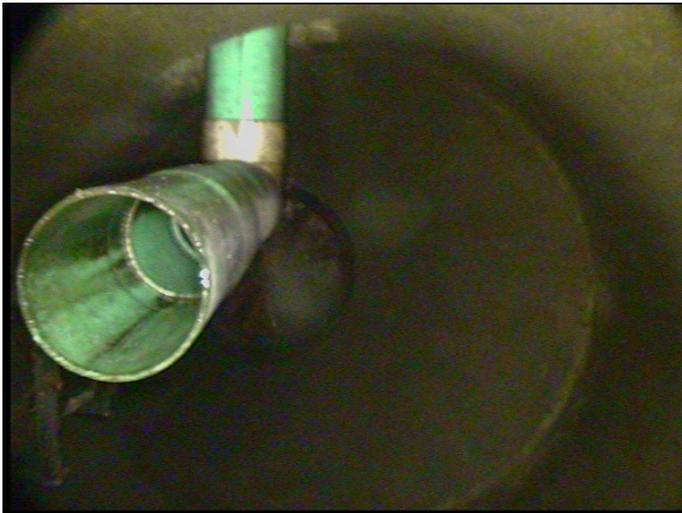
Code: **AMH**  
Description: **Manhole**

Distance (ft): **346.8**  
Structural Grade: **0**  
O&M Grade: **0**  
Clock Start/From:  
Clock To:  
1st Value:  
2nd Value:  
Value Percent:  
Continuous Index:  
Within 8" of Joint: **NO**  
Remarks: **M-806-062**
