Profile/Photo Observation Report

Street:	9521 E Ridge Rd	Flow Control:	Not Controlled
City:	Hobart In	Year Renewed:	
Location:	Yard	Tape/Media #:	Deliverable 1
Purpose:	Routine Assessment	Dia/Height:	8"
Use:	Sanitary	Material:	PVC
Drain Area:	Northeast	Lining:	
Category:	NA		
Comment:	435-2/Manhole 003 does not exist. Configuration differs from provided mapping.		
Location Details:	Grass at car wash	Direction of Survey:	Downstream
US MH:	M-1003-002	DS MH:	LS-025
		Total Length Surveyed (ft):	71.7

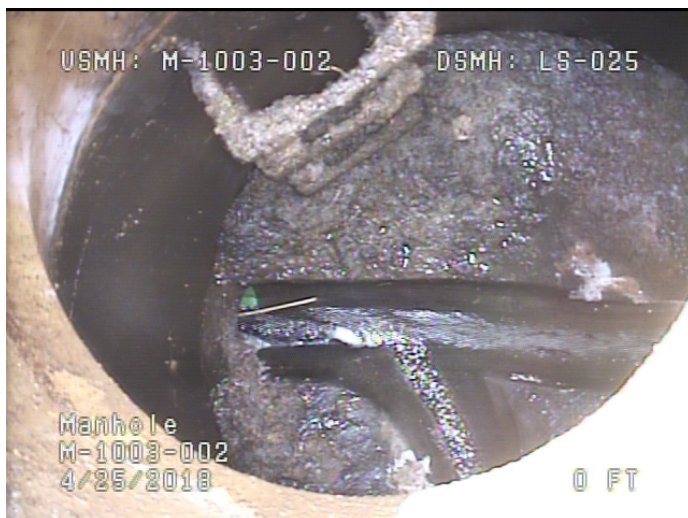
Code: **AMH**
 Description: **Manhole**

Distance (ft): **.0**
 Structural Grade: **0**
 O&M Grade: **0**
 Clock Start/From:
 Clock To:
 1st Value:
 2nd Value:
 Value Percent:
 Continuous Index:
 Within 8" of Joint: **NO**
 Remarks: **M-1003-002**

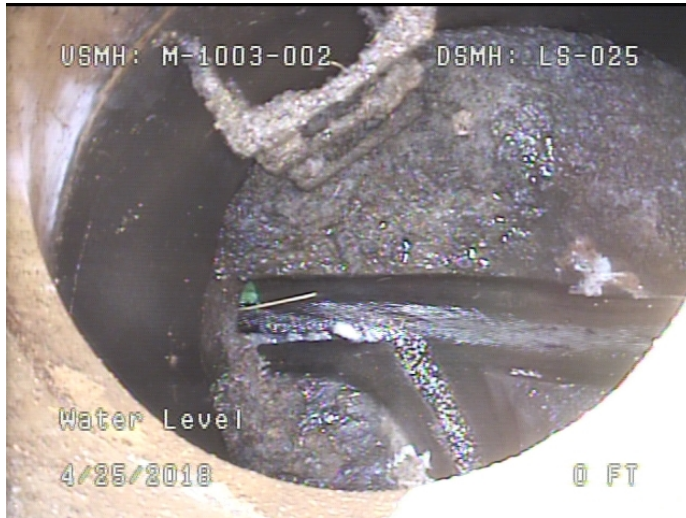
Code:	MWL
Description:	Water Level
Distance (ft):	.0
Structural Grade:	0
O&M Grade:	0
Clock Start/From:	
Clock To:	
1st Value:	
2nd Value:	
Value Percent:	5.000
Continuous Index:	
Within 8" of Joint:	NO
Remarks:

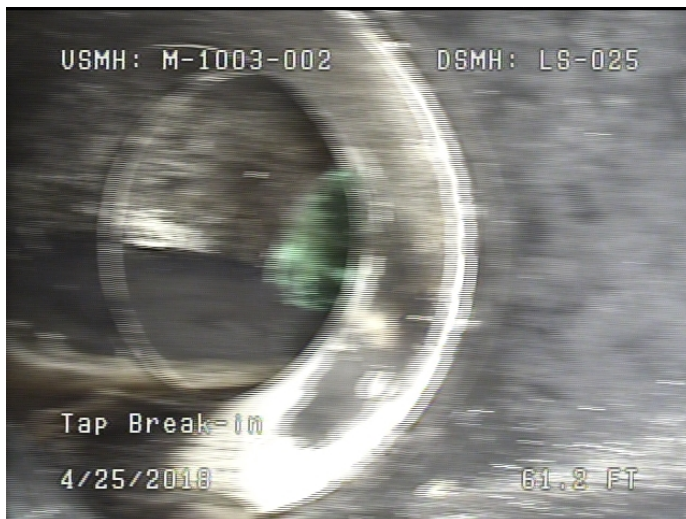
Code:	TB
Description:	Tap Break-in
Distance (ft):	61.2
Structural Grade:	0
O&M Grade:	0
Clock Start/From:	9
Clock To:	
1st Value:	6.000
2nd Value:	
Value Percent:	
Continuous Index:	
Within 8" of Joint:	NO
Remarks:

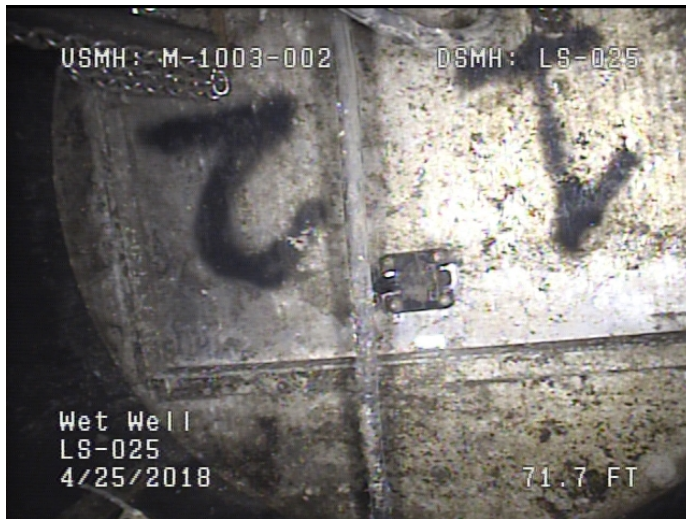
Code:	AWW
Description:	Wet Well
Distance (ft):	71.7
Structural Grade:	0
O&M Grade:	0
Clock Start/From:	
Clock To:	
1st Value:	
2nd Value:	
Value Percent:	
Continuous Index:	
Within 8" of Joint:	NO
Remarks:	LS-025
