Profile/Photo Observation Report

| Street: | DREXEL DR | Flow Control: | Not Controlled |

| US MH: | M-1004-016 | DS MH: | M-1004-017 |

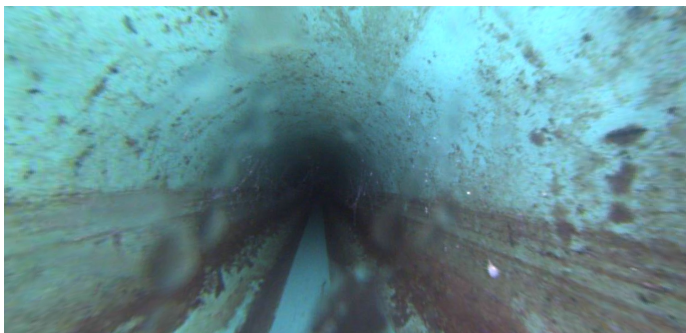
Code: **AMH**
Description: **Manhole**

Distance (ft): **.0**
Structural Grade: **0**
O&M Grade: **0**
Clock Start/From:
Clock To:
1st Value:
2nd Value:
Value Percent:
Continuous Index:
Within 8" of Joint: **NO**
Remarks: **M-1004-016**

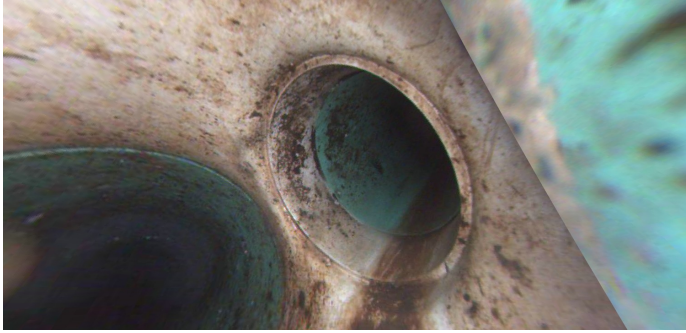
Code: **TF**
Description: **Tap Factory**

Distance (ft): **186.1**
Structural Grade: **0**
O&M Grade: **0**
Clock Start/From: **10**
Clock To:
1st Value: **4.000**
2nd Value:
Value Percent:
Continuous Index:
Within 8" of Joint:
Remarks:

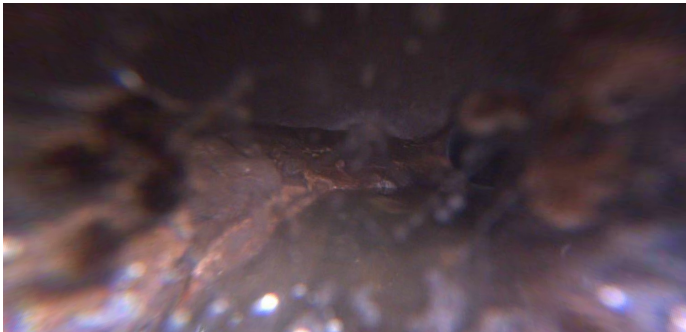
Code: **AMH**
Description: **Manhole**

Distance (ft): **194.5**
Structural Grade: **0**
O&M Grade: **0**
Clock Start/From:
Clock To:
1st Value:
2nd Value:
Value Percent:
Continuous Index:
Within 8" of Joint: **NO**
Remarks: **M-1004-017**
