Profile/Photo Observation Report

Street:	DREXEL DR	Flow Control:	Not Controlled
City:	Hobart, IN	Year Renewed:	
Location:	Other	Tape/Media #:	
Purpose:	Not Known	Dia/Height:	8"
Use:	Sanitary	Material:	PVC
Drain Area:	NA	Lining:	
Category:	NA		
Comment:

Location Details:		Direction of Survey:	Upstream
US MH:	M-1004-017	DS MH:	M-1004-018
		Total Length Surveyed (ft):	96.1

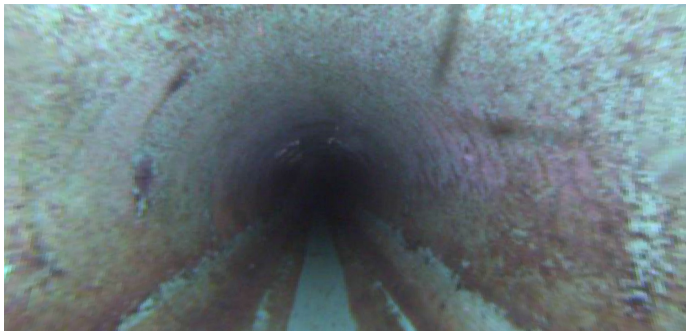
Code: **AMH**
Description: **Manhole**

Distance (ft):	.0
Structural Grade:	0
O&M Grade:	0
Clock Start/From:	
Clock To:	
1st Value:	
2nd Value:	
Value Percent:	
Continuous Index:	
Within 8" of Joint:	NO
Remarks:	M-1004-018

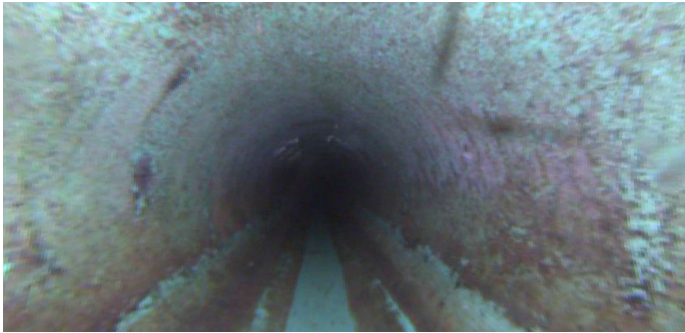
Code:	MWL
Description:	Water Level

Distance (ft):	.0
Structural Grade:	0
O&M Grade:	0
Clock Start/From:	
Clock To:	
1st Value:	
2nd Value:	
Value Percent:	5.000
Continuous Index:	
Within 8" of Joint:	NO
Remarks:

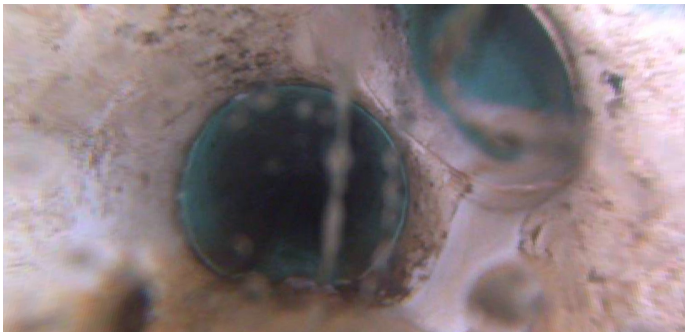
Code:	TF
Description:	Tap Factory

Distance (ft):	57.1
Structural Grade:	0
O&M Grade:	0
Clock Start/From:	2
Clock To:	
1st Value:	4.000
2nd Value:	
Value Percent:	
Continuous Index:	
Within 8" of Joint:	
Remarks:

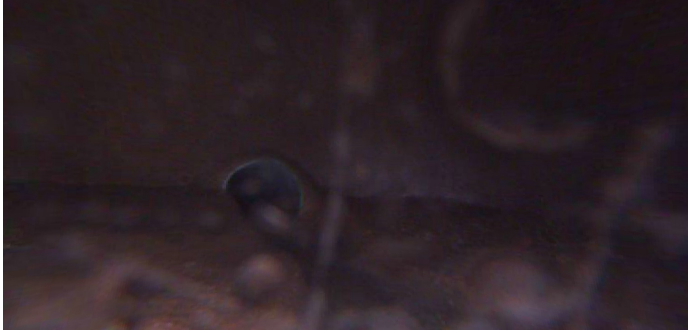
Code:	AMH
Description:	Manhole
Distance (ft):	96.1
Structural Grade:	0
O&M Grade:	0
Clock Start/From:	
Clock To:	
1st Value:	
2nd Value:	
Value Percent:	
Continuous Index:	
Within 8" of Joint:	NO
Remarks:	M-1004-017
