Profile/Photo Observation Report

Street:	Drexel Dr.	Flow Control:	Not Controlled
City:	Hobart, IN	Year Renewed:	
Location:	Other	Tape/Media #:	
Purpose:	Not Known	Dia/Height:	8"
Use:	Sanitary	Material:	PVC
Drain Area:	NA	Lining:	
Category:	NA		
Comment:

Location Details:		Direction of Survey:	Upstream
US MH:	M-1004-017	DS MH:	M-1004-018
		Total Length Surveyed (ft):	96.1

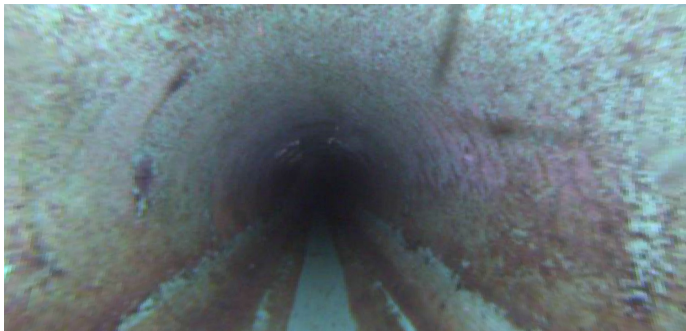
Code: **AMH**
Description: **Manhole**

Distance (ft): **.0**
Structural Grade: **0**
O&M Grade: **0**
Clock Start/From:
Clock To:
1st Value:
2nd Value:
Value Percent:
Continuous Index:
Within 8" of Joint: **NO**
Remarks: **M-1004-018**

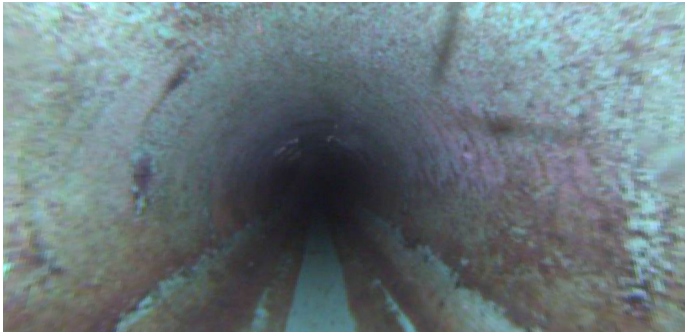
Code:	MWL
Description:	Water Level

Distance (ft):	.0
Structural Grade:	0
O&M Grade:	0
Clock Start/From:	
Clock To:	
1st Value:	
2nd Value:	
Value Percent:	5.000
Continuous Index:	
Within 8" of Joint:	NO
Remarks:

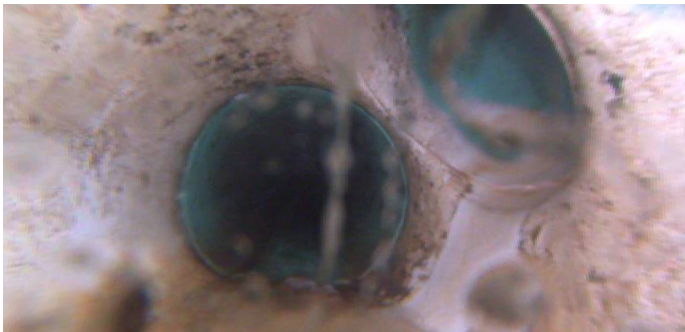
Code:	TF
Description:	Tap Factory

Distance (ft):	57.1
Structural Grade:	0
O&M Grade:	0
Clock Start/From:	2
Clock To:	
1st Value:	4.000
2nd Value:	
Value Percent:	
Continuous Index:	
Within 8" of Joint:	
Remarks:

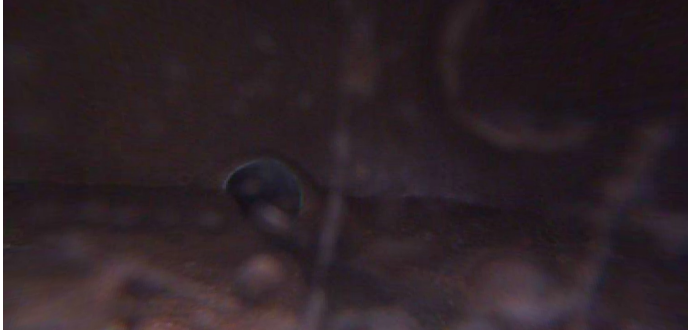
Code:	AMH
Description:	Manhole
Distance (ft):	96.1
Structural Grade:	0
O&M Grade:	0
Clock Start/From:	
Clock To:	
1st Value:	
2nd Value:	
Value Percent:	
Continuous Index:	
Within 8" of Joint:	NO
Remarks:	M-1004-017
