Profile/Photo Observation Report

Date:	10/08/2018	Weather:		Coding:	PACP 6.0
Pipe Length (ft):	101.4	Owner:	NA	Pre Clean:	Not Known
P.O.#:		Surveyor:	Selasie Honu	PSR:	P-1004-018-017
Customer:		Clean Date:	01/01/1900	Shape:	C

Location Details:		Direction of Survey:	Downstream
US MH:	M-1004-017	DS MH:	M-1004-018
		Total Length Surveyed (ft):	100.0

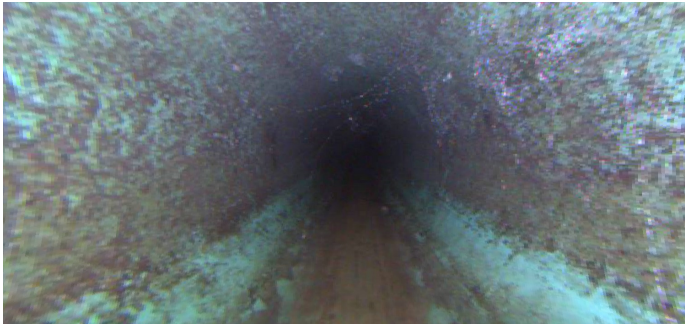
Code:	MWL
Description:	Water Level

Distance (ft):	.0
Structural Grade:	0
O&M Grade:	0
Clock Start/From:	
Clock To:	
1st Value:	
2nd Value:	
Value Percent:	5.000
Continuous Index:	
Within 8" of Joint:	NO
Remarks:

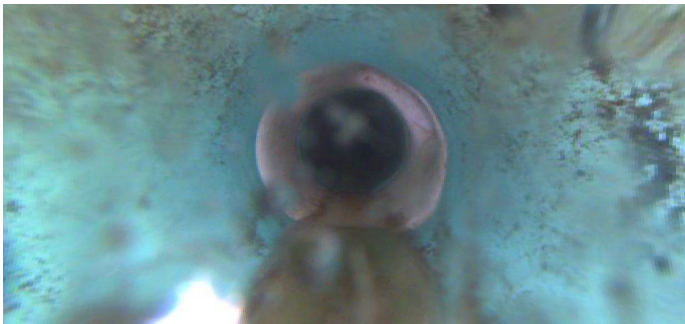
Code:	TF
Description:	Tap Factory

Distance (ft):	58.5
Structural Grade:	0
O&M Grade:	0
Clock Start/From:	2
Clock To:	
1st Value:	4.000
2nd Value:	
Value Percent:	
Continuous Index:	
Within 8" of Joint:	
Remarks:

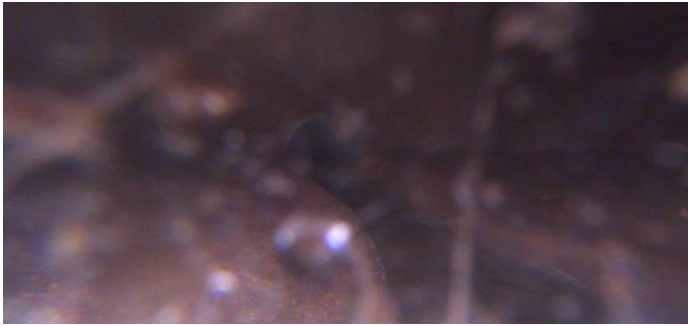
Code:	AMH
Description:	Manhole
Distance (ft):	100.0
Structural Grade:	0
O&M Grade:	0
Clock Start/From:	
Clock To:	
1st Value:	
2nd Value:	
Value Percent:	
Continuous Index:	
Within 8" of Joint:	NO
Remarks:	M-1004-018
