Profile/Photo Observation Report

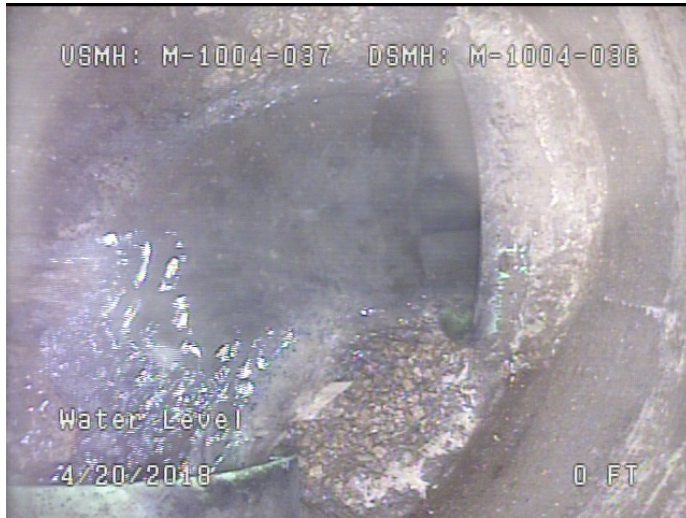
Code:	MWL
Description:	Water Level
Distance (ft):	.0
Structural Grade:	0
O&M Grade:	0
Clock Start/From:	
Clock To:	
1st Value:	
2nd Value:	
Value Percent:	15.000
Continuous Index:	
Within 8" of Joint:	NO
Remarks:

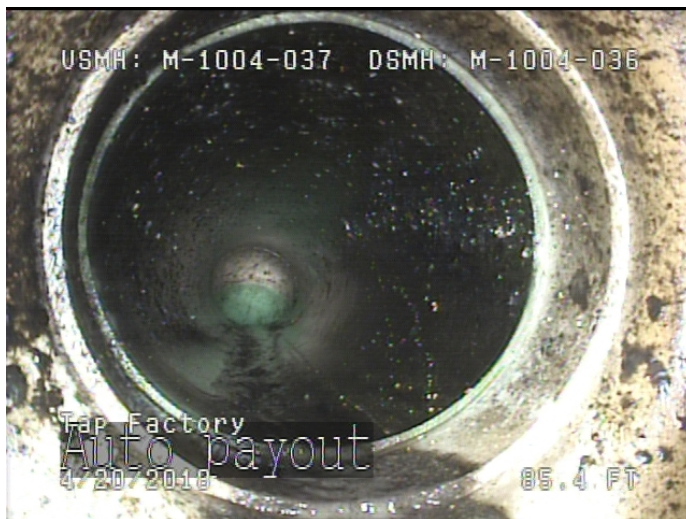
Code:	TF
Description:	Tap Factory
Distance (ft):	85.4
Structural Grade:	0
O&M Grade:	0
Clock Start/From:	11
Clock To:	
1st Value:	4.000
2nd Value:	
Value Percent:	
Continuous Index:	
Within 8" of Joint:	NO
Remarks:

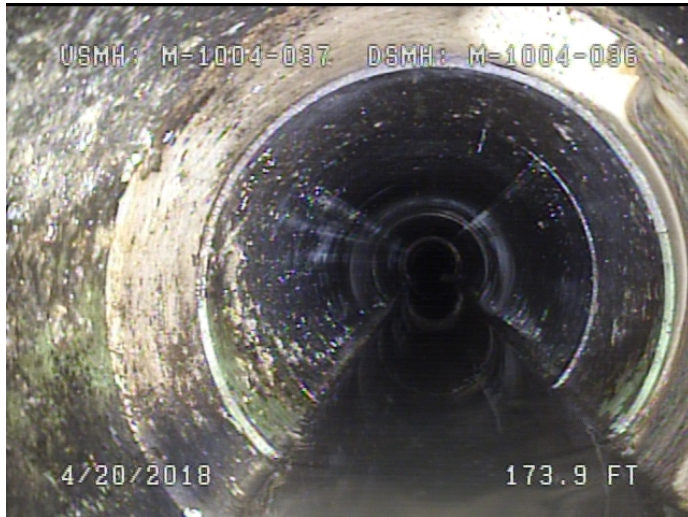
Code:	TF
Description:	Tap Factory
Distance (ft):	173.9
Structural Grade:	0
O&M Grade:	0
Clock Start/From:	1
Clock To:	
1st Value:	4.000
2nd Value:	
Value Percent:	
Continuous Index:	
Within 8" of Joint:	NO
Remarks:

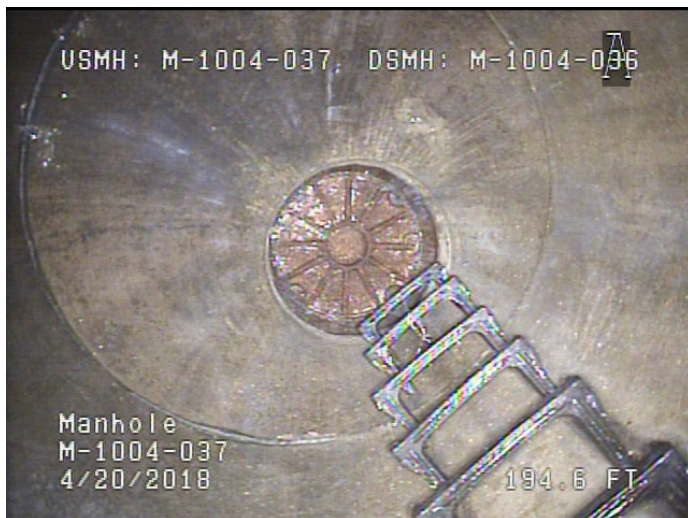
Code:	AMH
Description:	Manhole
Distance (ft):	194.6
Structural Grade:	0
O&M Grade:	0
Clock Start/From:	
Clock To:	
1st Value:	
2nd Value:	
Value Percent:	
Continuous Index:	
Within 8" of Joint:	NO
Remarks:	M-1004-037
