## Profile/Photo Observation Report

Street:	<b>DREXEL DR</b>	Flow Control:	<b>Not Controlled</b>
City:	<b>Hobart, IN</b>	Year Renewed:	
Location:	<b>Other</b>	Tape/Media #:	
Purpose:	<b>Not Known</b>	Dia/Height:	<b>8"</b>
Use:	<b>Sanitary</b>	Material:	<b>PVC</b>
Drain Area:	<b>NA</b>	Lining:	
Category:	<b>NA</b>		
Comment:

Location Details:		Direction of Survey:	<b>Downstream</b>
US MH:	<b>M-1004-021</b>	DS MH:	<b>M-1004-020</b>
		Total Length Surveyed (ft):	<b>211.7</b>

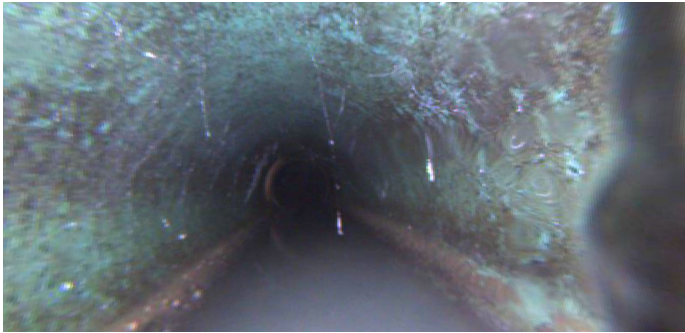
Code:	<b>MWL</b>
Description:	<b>Water Level</b>

Distance (ft):	<b>.0</b>
Structural Grade:	<b>0</b>
O&M Grade:	<b>0</b>
Clock Start/From:	
Clock To:	
1st Value:	
2nd Value:	
Value Percent:	<b>5.000</b>
Continuous Index:	
Within 8" of Joint:	<b>NO</b>
Remarks:

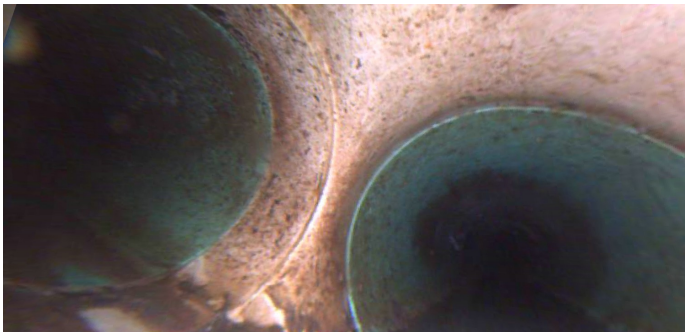
Code:	<b>TFA</b>
Description:	<b>Tap Factory Active</b>

Distance (ft):	<b>3.4</b>
Structural Grade:	<b>0</b>
O&M Grade:	<b>0</b>
Clock Start/From:	<b>9</b>
Clock To:	
1st Value:	<b>4.000</b>
2nd Value:	
Value Percent:	
Continuous Index:	
Within 8" of Joint:	
Remarks:

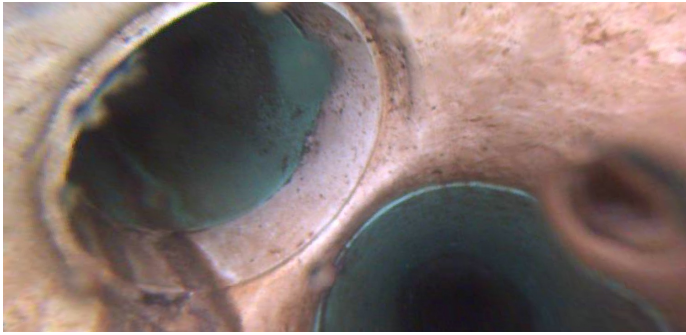
Code: **TF**  
Description: **Tap Factory**

Distance (ft): **77.5**  
Structural Grade: **0**  
O&M Grade: **0**  
Clock Start/From: **10**  
Clock To:  
1st Value: **4.000**  
2nd Value:  
Value Percent:  
Continuous Index:  
Within 8" of Joint:  
Remarks:

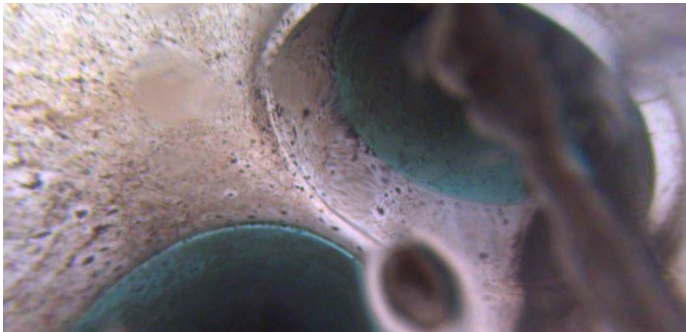
Code: **TF**  
Description: **Tap Factory**

Distance (ft): **92.9**  
Structural Grade: **0**  
O&M Grade: **0**  
Clock Start/From: **2**  
Clock To:  
1st Value: **4.000**  
2nd Value:  
Value Percent:  
Continuous Index:  
Within 8" of Joint:  
Remarks:

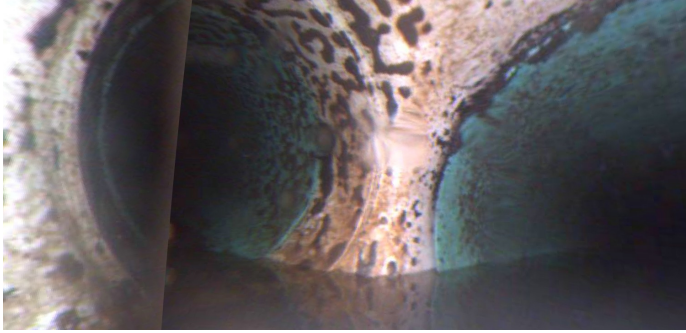
Code: **TFA**  
Description: **Tap Factory Active**

Distance (ft): **130.5**  
Structural Grade: **0**  
O&M Grade: **0**  
Clock Start/From: **9**  
Clock To:  
1st Value: **4.000**  
2nd Value:  
Value Percent:  
Continuous Index:  
Within 8" of Joint:  
Remarks:

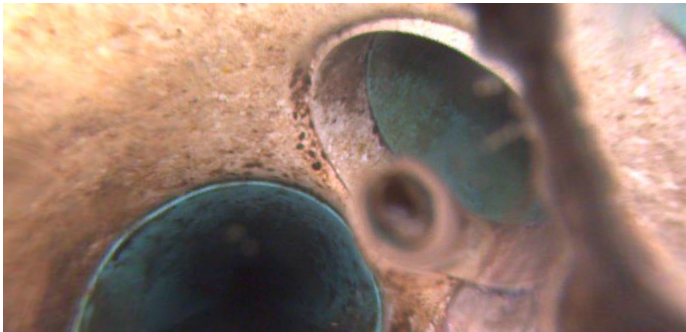
Code: **TFA**  
Description: **Tap Factory Active**

Distance (ft): **167.6**  
Structural Grade: **0**  
O&M Grade: **0**  
Clock Start/From: **2**  
Clock To:  
1st Value: **4.000**  
2nd Value:  
Value Percent:  
Continuous Index:  
Within 8" of Joint:  
Remarks:

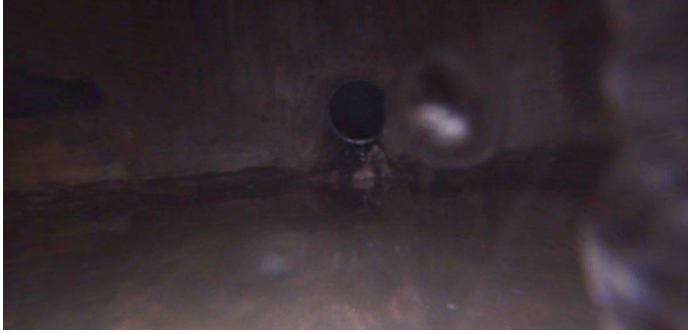
Code:	AMH
Description:	Manhole
Distance (ft):	211.7
Structural Grade:	0
O&M Grade:	0
Clock Start/From:	
Clock To:	
1st Value:	
2nd Value:	
Value Percent:	
Continuous Index:	
Within 8" of Joint:	NO
Remarks:	M-1004-020
