## Profile/Photo Observation Report

Date:	<b>04/15/2018</b>	Weather:		Coding:	<b>PACP 6.0</b>
Pipe Length (ft):	<b>218.8</b>	Owner:	<b>NA</b>	Pre Clean:	<b>Not Known</b>
P.O.#:		Surveyor:	<b>Selasie Honu</b>	PSR:	<b>P-1004-020-021</b>
Customer:		Clean Date:	<b>01/01/1900</b>	Shape:	<b>C</b>

Street:	<b>Drexel Dr.</b>	Flow Control:	<b>Not Controlled</b>
City:	<b>Hobart, IN</b>	Year Renewed:	
Location:	<b>Other</b>	Tape/Media #:	
Purpose:	<b>Not Known</b>	Dia/Height:	<b>8"</b>
Use:	<b>Sanitary</b>	Material:	<b>PVC</b>
Drain Area:	<b>NA</b>	Lining:	
Category:	<b>NA</b>		
Comment:

Location Details:		Direction of Survey:	<b>Downstream</b>
US MH:	<b>M-1004-021</b>	DS MH:	<b>M-1004-020</b>
		Total Length Surveyed (ft):	<b>211.7</b>

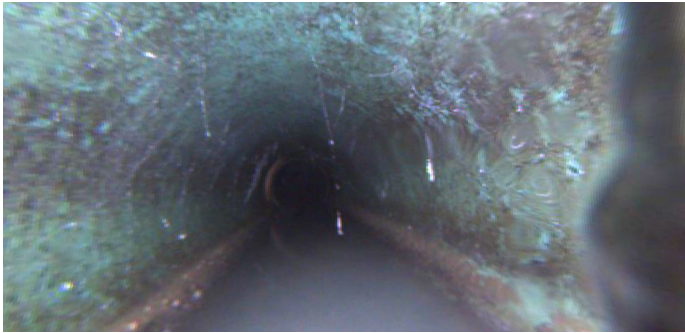
Code:	<b>MWL</b>
Description:	<b>Water Level</b>

Distance (ft):	<b>.0</b>
Structural Grade:	<b>0</b>
O&M Grade:	<b>0</b>
Clock Start/From:	
Clock To:	
1st Value:	
2nd Value:	
Value Percent:	<b>5.000</b>
Continuous Index:	
Within 8" of Joint:	<b>NO</b>
Remarks:

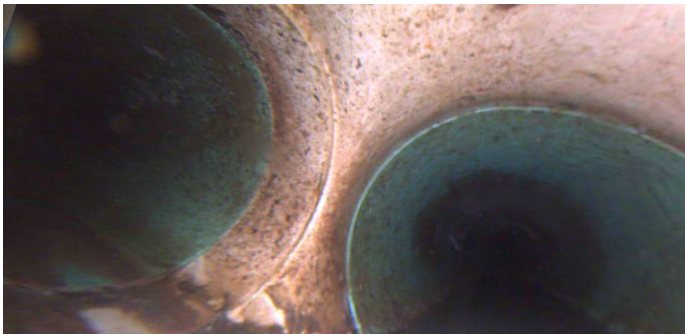
Code:	<b>TFA</b>
Description:	<b>Tap Factory Active</b>

Distance (ft):	<b>3.4</b>
Structural Grade:	<b>0</b>
O&M Grade:	<b>0</b>
Clock Start/From:	<b>9</b>
Clock To:	
1st Value:	<b>4.000</b>
2nd Value:	
Value Percent:	
Continuous Index:	
Within 8" of Joint:	
Remarks:

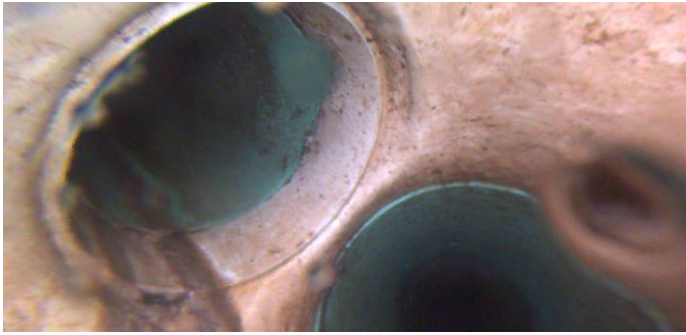
Code: **TF**  
Description: **Tap Factory**

Distance (ft): **77.5**  
Structural Grade: **0**  
O&M Grade: **0**  
Clock Start/From: **10**  
Clock To:  
1st Value: **4.000**  
2nd Value:  
Value Percent:  
Continuous Index:  
Within 8" of Joint:  
Remarks:

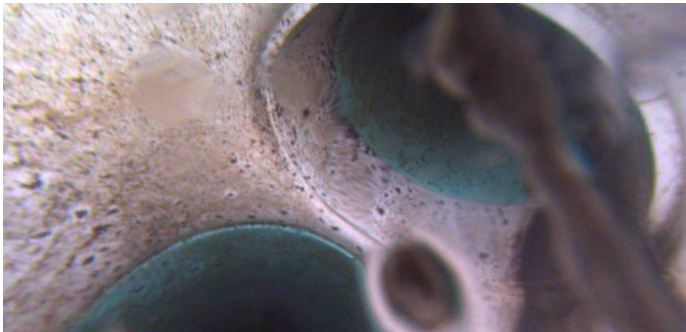
Code: **TF**  
Description: **Tap Factory**

Distance (ft): **92.9**  
Structural Grade: **0**  
O&M Grade: **0**  
Clock Start/From: **2**  
Clock To:  
1st Value: **4.000**  
2nd Value:  
Value Percent:  
Continuous Index:  
Within 8" of Joint:  
Remarks:

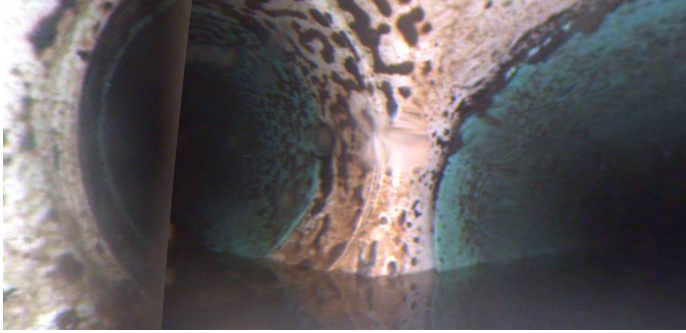
Code: **TFA**  
Description: **Tap Factory Active**

Distance (ft): **130.5**  
Structural Grade: **0**  
O&M Grade: **0**  
Clock Start/From: **9**  
Clock To:  
1st Value: **4.000**  
2nd Value:  
Value Percent:  
Continuous Index:  
Within 8" of Joint:  
Remarks:

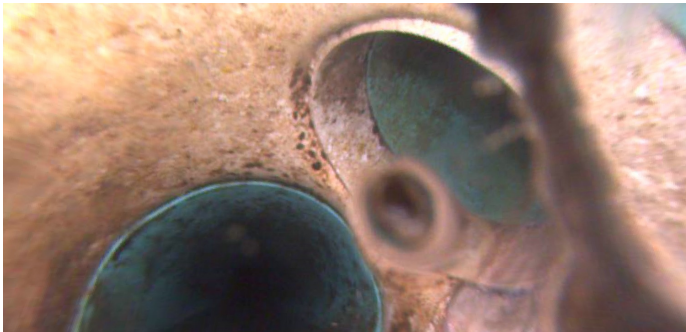
Code: **TFA**  
Description: **Tap Factory Active**

Distance (ft): **167.6**  
Structural Grade: **0**  
O&M Grade: **0**  
Clock Start/From: **2**  
Clock To:  
1st Value: **4.000**  
2nd Value:  
Value Percent:  
Continuous Index:  
Within 8" of Joint:  
Remarks:

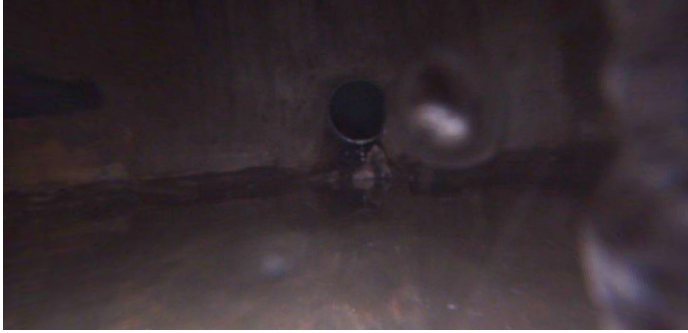
Code:	AMH
Description:	Manhole
Distance (ft):	211.7
Structural Grade:	0
O&M Grade:	0
Clock Start/From:	
Clock To:	
1st Value:	
2nd Value:	
Value Percent:	
Continuous Index:	
Within 8" of Joint:	NO
Remarks:	M-1004-020
