Profile/Photo Observation Report

Street:	DREXEL DR	Flow Control:	Not Controlled
City:	Hobart, IN	Year Renewed:	
Location:	Other	Tape/Media #:	
Purpose:	Not Known	Dia/Height:	8"
Use:	Sanitary	Material:	PVC
Drain Area:	NA	Lining:	
Category:	NA		
Comment:

Location Details:		Direction of Survey:	Upstream
US MH:	M-1004-022	DS MH:	M-1004-021
		Total Length Surveyed (ft):	243.3

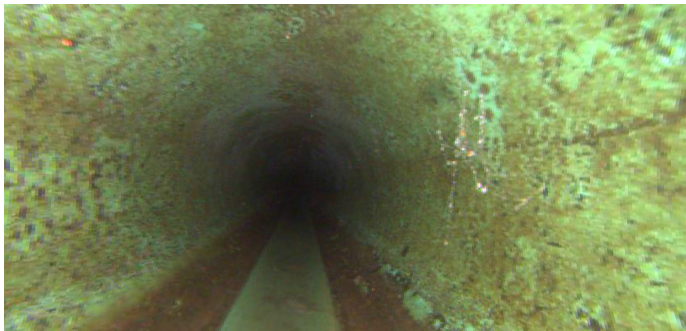
Code: **AMH**
Description: **Manhole**

Distance (ft): **.0**
Structural Grade: **0**
O&M Grade: **0**
Clock Start/From:
Clock To:
1st Value:
2nd Value:
Value Percent:
Continuous Index:
Within 8" of Joint: **NO**
Remarks: **M-1004-021**

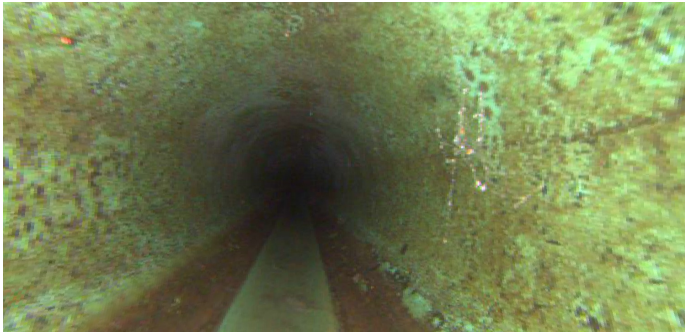
Code:	MWL
Description:	Water Level

Distance (ft):	.0
Structural Grade:	0
O&M Grade:	0
Clock Start/From:	
Clock To:	
1st Value:	
2nd Value:	
Value Percent:	5.000
Continuous Index:	
Within 8" of Joint:	NO
Remarks:

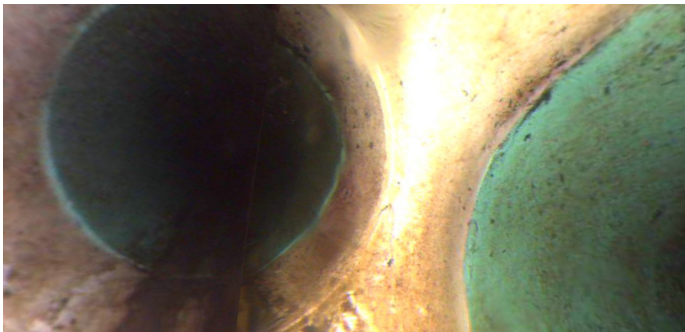
Code:	TF
Description:	Tap Factory

Distance (ft):	31.5
Structural Grade:	0
O&M Grade:	0
Clock Start/From:	10
Clock To:	
1st Value:	4.000
2nd Value:	
Value Percent:	
Continuous Index:	
Within 8" of Joint:	
Remarks:

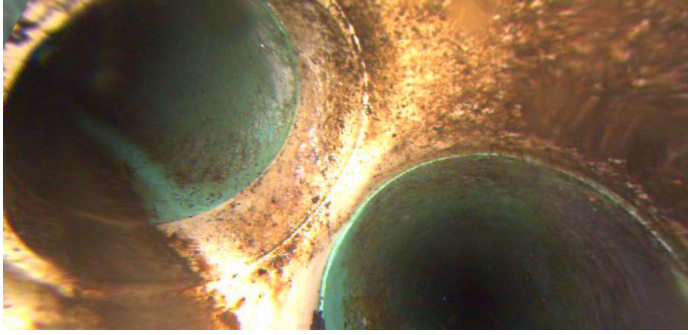
Code: **TFA**
Description: **Tap Factory Active**

Distance (ft): **46.6**
Structural Grade: **0**
O&M Grade: **0**
Clock Start/From: **10**
Clock To:
1st Value: **4.000**
2nd Value:
Value Percent:
Continuous Index:
Within 8" of Joint:
Remarks:

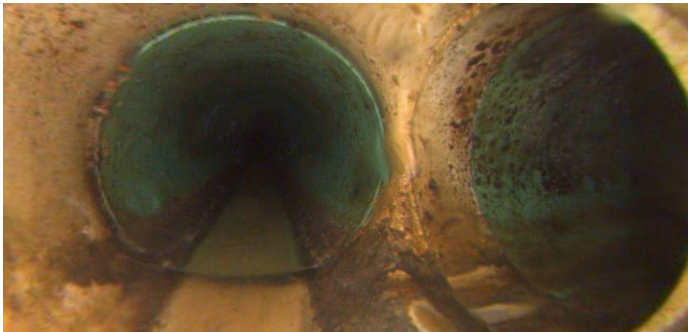
Code: **TFA**
Description: **Tap Factory Active**

Distance (ft): **69.0**
Structural Grade: **0**
O&M Grade: **0**
Clock Start/From: **3**
Clock To:
1st Value: **4.000**
2nd Value:
Value Percent:
Continuous Index:
Within 8" of Joint:
Remarks:

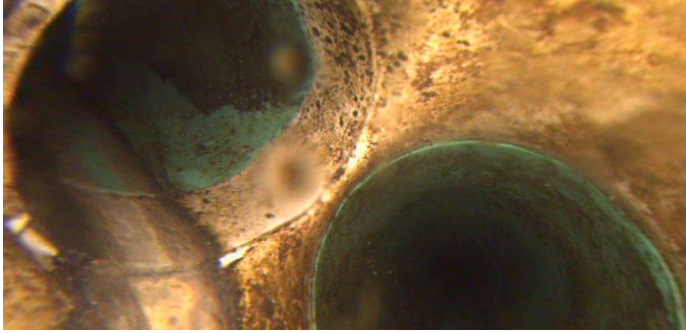
Code: **TFA**
Description: **Tap Factory Active**

Distance (ft): **126.8**
Structural Grade: **0**
O&M Grade: **0**
Clock Start/From: **10**
Clock To:
1st Value: **4.000**
2nd Value:
Value Percent:
Continuous Index:
Within 8" of Joint:
Remarks:

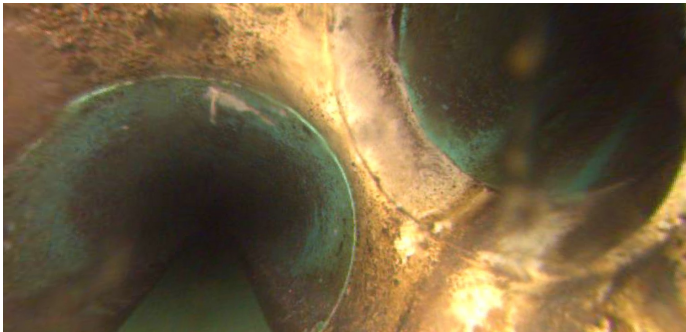
Code: **TFA**
Description: **Tap Factory Active**

Distance (ft): **148.1**
Structural Grade: **0**
O&M Grade: **0**
Clock Start/From: **2**
Clock To:
1st Value: **4.000**
2nd Value:
Value Percent:
Continuous Index:
Within 8" of Joint:
Remarks:

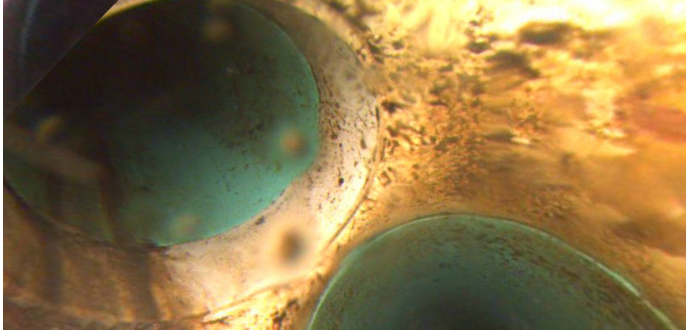
Code: **TF**
Description: **Tap Factory**

Distance (ft): **198.0**
Structural Grade: **0**
O&M Grade: **0**
Clock Start/From: **10**
Clock To:
1st Value: **4.000**
2nd Value:
Value Percent:
Continuous Index:
Within 8" of Joint:
Remarks:

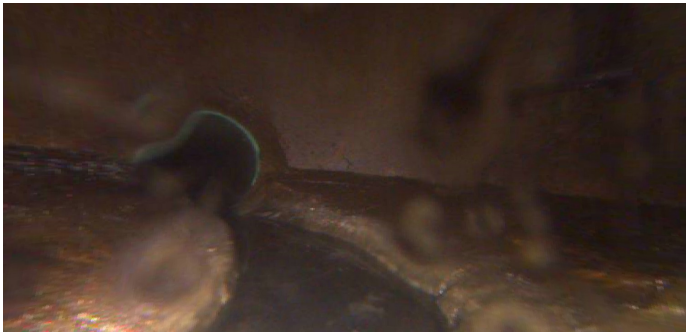
Code: **AMH**
Description: **Manhole**

Distance (ft): **243.3**
Structural Grade: **0**
O&M Grade: **0**
Clock Start/From:
Clock To:
1st Value:
2nd Value:
Value Percent:
Continuous Index:
Within 8" of Joint: **NO**
Remarks: **M-1004-022**
