Profile/Photo Observation Report

Date:	04/15/2018	Weather:		Coding:	PACP 6.0
Pipe Length (ft):	250.1	Owner:	NA	Pre Clean:	Not Known
P.O.#:		Surveyor:	Selasie Honu	PSR:	P-1004-021-022
Customer:		Clean Date:	01/01/1900	Shape:	C

Street:	Drexel Dr.	Flow Control:	Not Controlled
City:	Hobart, IN	Year Renewed:	
Location:	Other	Tape/Media #:	
Purpose:	Not Known	Dia/Height:	8"
Use:	Sanitary	Material:	PVC
Drain Area:	NA	Lining:	
Category:	NA		
Comment:

Location Details:		Direction of Survey:	Upstream
US MH:	M-1004-022	DS MH:	M-1004-021
		Total Length Surveyed (ft):	243.3

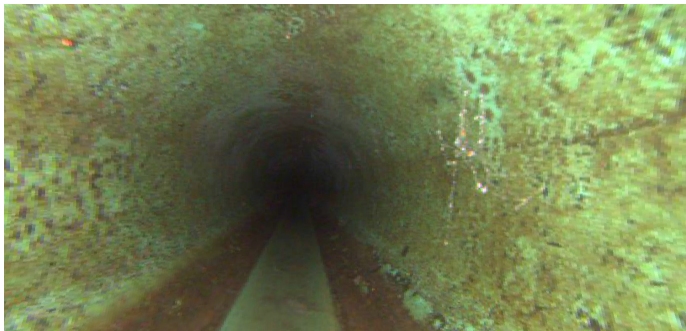
Code: **AMH**
Description: **Manhole**

Distance (ft): **.0**
Structural Grade: **0**
O&M Grade: **0**
Clock Start/From:
Clock To:
1st Value:
2nd Value:
Value Percent:
Continuous Index:
Within 8" of Joint: **NO**
Remarks: **M-1004-021**

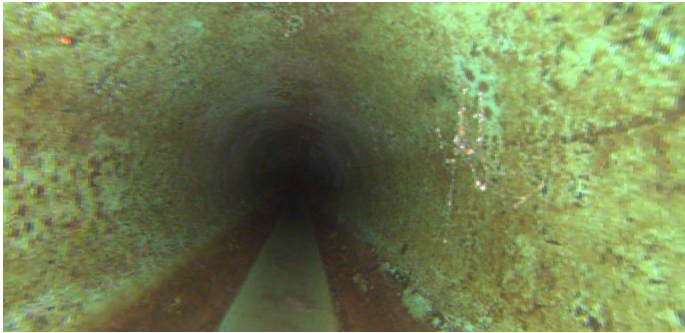
Code:	MWL
Description:	Water Level

Distance (ft):	.0
Structural Grade:	0
O&M Grade:	0
Clock Start/From:	
Clock To:	
1st Value:	
2nd Value:	
Value Percent:	5.000
Continuous Index:	
Within 8" of Joint:	NO
Remarks:

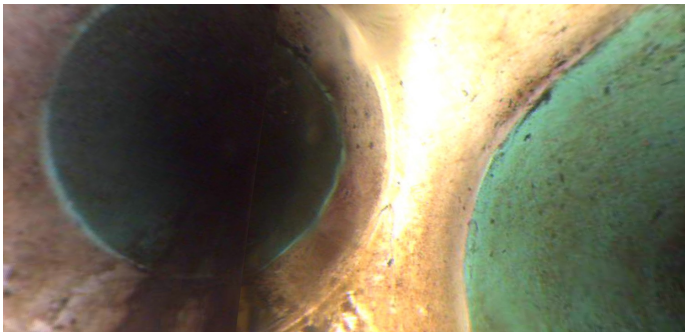
Code:	TF
Description:	Tap Factory

Distance (ft):	31.5
Structural Grade:	0
O&M Grade:	0
Clock Start/From:	10
Clock To:	
1st Value:	4.000
2nd Value:	
Value Percent:	
Continuous Index:	
Within 8" of Joint:	
Remarks:

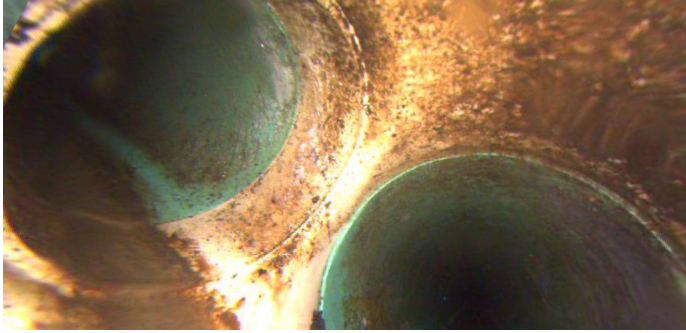
Code: **TFA**
Description: **Tap Factory Active**

Distance (ft): **46.6**
Structural Grade: **0**
O&M Grade: **0**
Clock Start/From: **10**
Clock To:
1st Value: **4.000**
2nd Value:
Value Percent:
Continuous Index:
Within 8" of Joint:
Remarks:

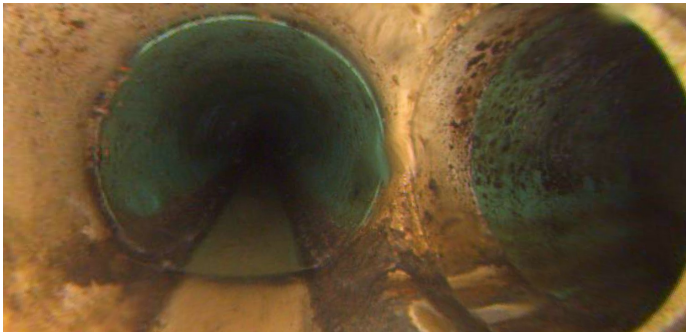
Code: **TFA**
Description: **Tap Factory Active**

Distance (ft): **69.0**
Structural Grade: **0**
O&M Grade: **0**
Clock Start/From: **3**
Clock To:
1st Value: **4.000**
2nd Value:
Value Percent:
Continuous Index:
Within 8" of Joint:
Remarks:

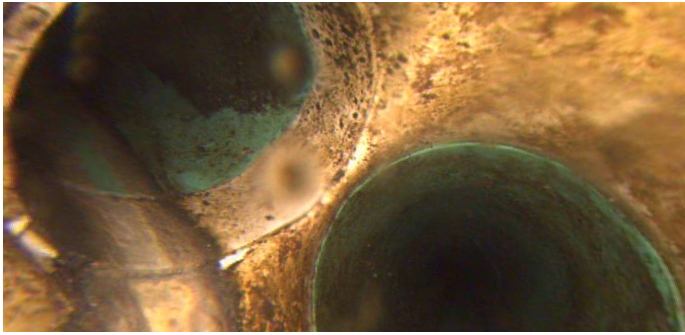
Code: **TFA**
Description: **Tap Factory Active**

Distance (ft): **126.8**
Structural Grade: **0**
O&M Grade: **0**
Clock Start/From: **10**
Clock To:
1st Value: **4.000**
2nd Value:
Value Percent:
Continuous Index:
Within 8" of Joint:
Remarks:

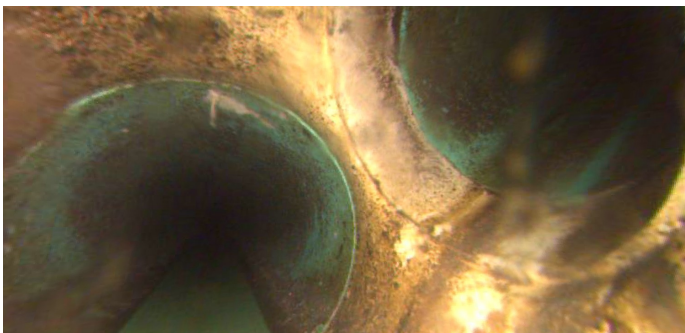
Code: **TFA**
Description: **Tap Factory Active**

Distance (ft): **148.1**
Structural Grade: **0**
O&M Grade: **0**
Clock Start/From: **2**
Clock To:
1st Value: **4.000**
2nd Value:
Value Percent:
Continuous Index:
Within 8" of Joint:
Remarks:

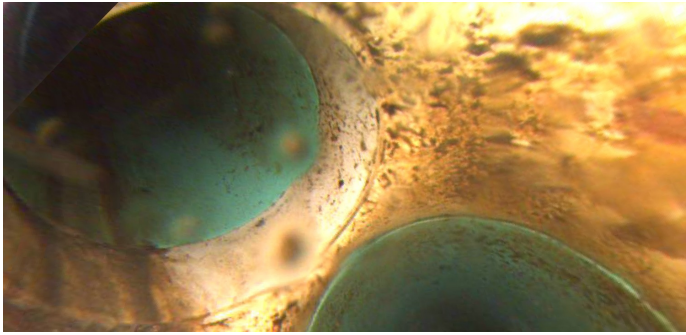
Code: **TF**
Description: **Tap Factory**

Distance (ft): **198.0**
Structural Grade: **0**
O&M Grade: **0**
Clock Start/From: **10**
Clock To:
1st Value: **4.000**
2nd Value:
Value Percent:
Continuous Index:
Within 8" of Joint:
Remarks:

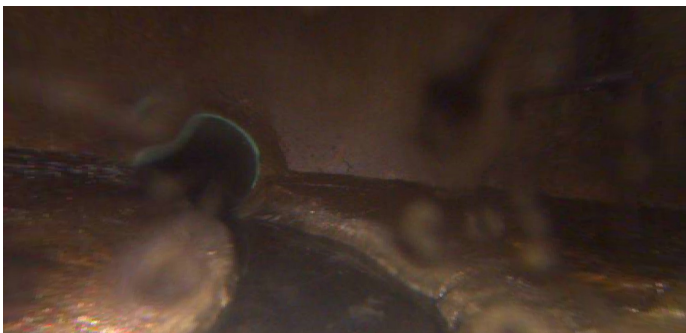
Code: **AMH**
Description: **Manhole**

Distance (ft): **243.3**
Structural Grade: **0**
O&M Grade: **0**
Clock Start/From:
Clock To:
1st Value:
2nd Value:
Value Percent:
Continuous Index:
Within 8" of Joint: **NO**
Remarks: **M-1004-022**
