Profile/Photo Observation Report

Date:	04/15/2018	Weather:		Coding:	PACP 6.0
Pipe Length (ft):	168.8	Owner:	NA	Pre Clean:	Not Known
P.O.#:		Surveyor:	Mark Ruby	PSR:	P-1004-022-023
Customer:		Clean Date:	01/01/1900	Shape:	C

Street:	DREXEL DR	Flow Control:	Not Controlled
City:	Hobart, IN	Year Renewed:	
Location:	Other	Tape/Media #:	
Purpose:	Not Known	Dia/Height:	8"
Use:	Sanitary	Material:	PVC
Drain Area:	NA	Lining:	
Category:	NA		
Comment:

Location Details:		Direction of Survey:	Upstream
US MH:	M-1004-023	DS MH:	M-1004-022
		Total Length Surveyed (ft):	165.5

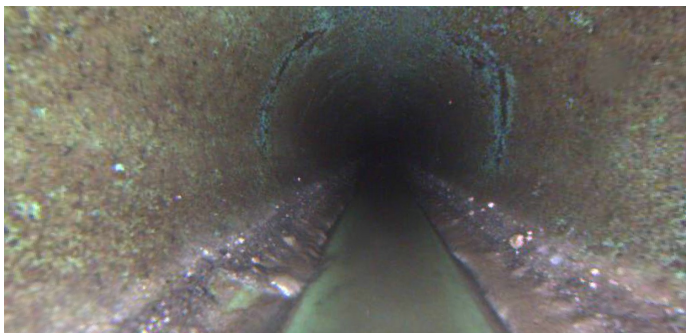
Code: **AMH**
Description: **Manhole**

Distance (ft): **.0**
Structural Grade: **0**
O&M Grade: **0**
Clock Start/From:
Clock To:
1st Value:
2nd Value:
Value Percent:
Continuous Index:
Within 8" of Joint: **NO**
Remarks: **M-1004-022**

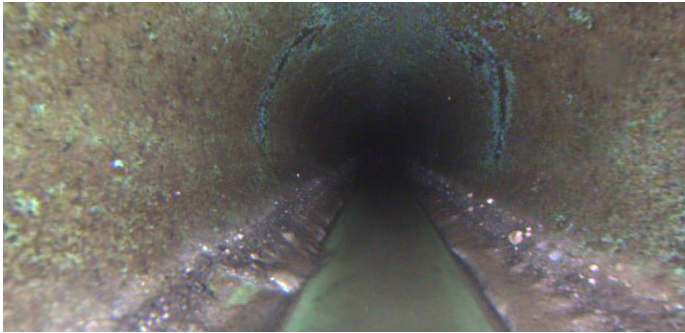
Code: **MWL**
Description: **Water Level**

Distance (ft): **.0**
Structural Grade: **0**
O&M Grade: **0**
Clock Start/From:
Clock To:
1st Value:
2nd Value:
Value Percent: **10.000**
Continuous Index:
Within 8" of Joint: **NO**
Remarks:

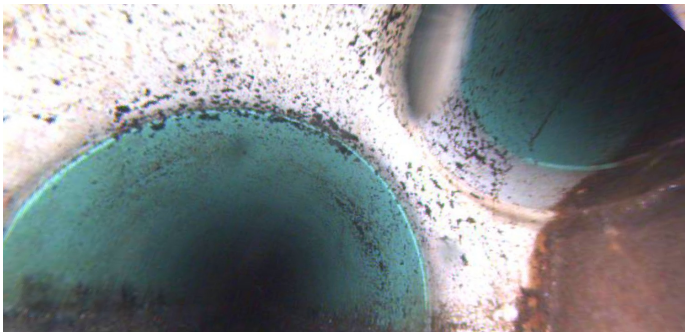
Code: **TF**
Description: **Tap Factory**

Distance (ft): **23.3**
Structural Grade: **0**
O&M Grade: **0**
Clock Start/From: **2**
Clock To:
1st Value: **4.000**
2nd Value:
Value Percent:
Continuous Index:
Within 8" of Joint:
Remarks:

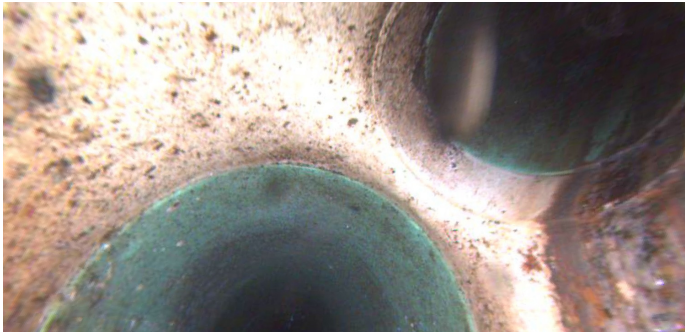
Code: **TF**
Description: **Tap Factory**

Distance (ft): **33.4**
Structural Grade: **0**
O&M Grade: **0**
Clock Start/From: **2**
Clock To:
1st Value: **4.000**
2nd Value:
Value Percent:
Continuous Index:
Within 8" of Joint:
Remarks:

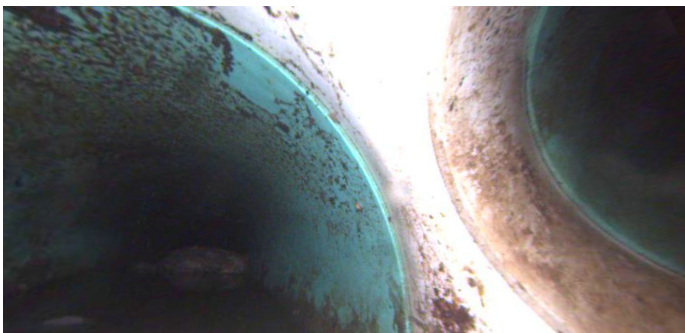
Code: **TF**
Description: **Tap Factory**

Distance (ft): **107.1**
Structural Grade: **0**
O&M Grade: **0**
Clock Start/From: **3**
Clock To:
1st Value: **4.000**
2nd Value:
Value Percent:
Continuous Index:
Within 8" of Joint:
Remarks:

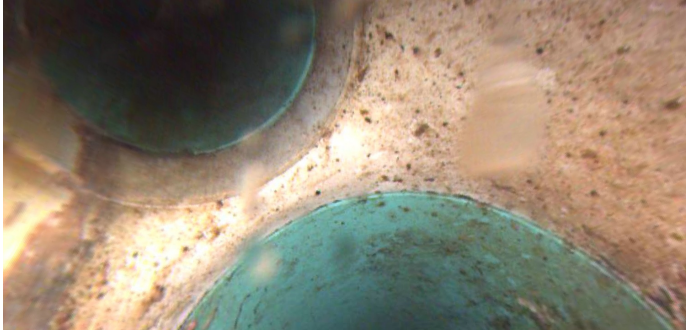
Code: **TF**
Description: **Tap Factory**

Distance (ft): **116.8**
Structural Grade: **0**
O&M Grade: **0**
Clock Start/From: **10**
Clock To:
1st Value: **4.000**
2nd Value:
Value Percent:
Continuous Index:
Within 8" of Joint:
Remarks:

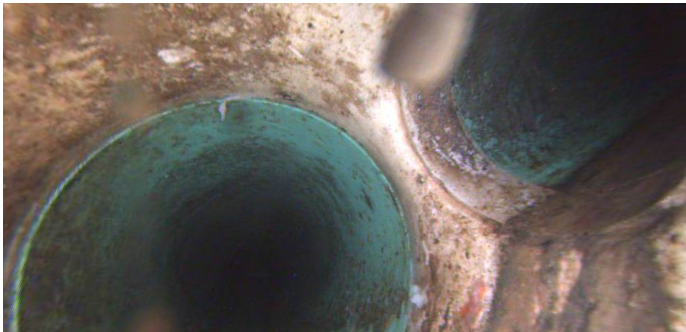
Code: **TF**
Description: **Tap Factory**

Distance (ft): **156.4**
Structural Grade: **0**
O&M Grade: **0**
Clock Start/From: **2**
Clock To:
1st Value: **4.000**
2nd Value:
Value Percent:
Continuous Index:
Within 8" of Joint:
Remarks:

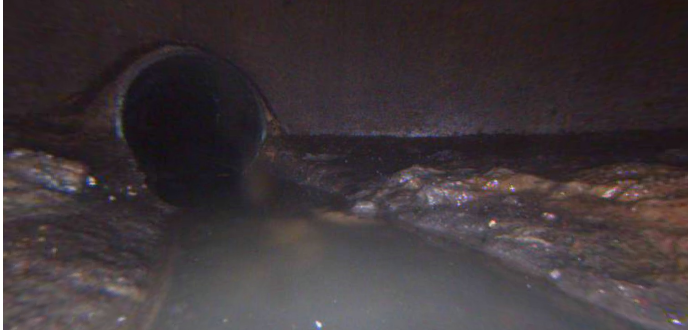
Code:	AMH
Description:	Manhole
Distance (ft):	165.5
Structural Grade:	0
O&M Grade:	0
Clock Start/From:	
Clock To:	
1st Value:	
2nd Value:	
Value Percent:	
Continuous Index:	
Within 8" of Joint:	NO
Remarks:	M-1004-023
