Profile/Photo Observation Report

Street:	Drexel Dr.	Flow Control:	Not Controlled
City:	Hobart, IN	Year Renewed:	
Location:	Other	Tape/Media #:	
Purpose:	Not Known	Dia/Height:	8"
Use:	Sanitary	Material:	PVC
Drain Area:	NA	Lining:	
Category:	NA		
Comment:

Location Details:		Direction of Survey:	Upstream
US MH:	M-1004-023	DS MH:	M-1004-022
		Total Length Surveyed (ft):	165.5

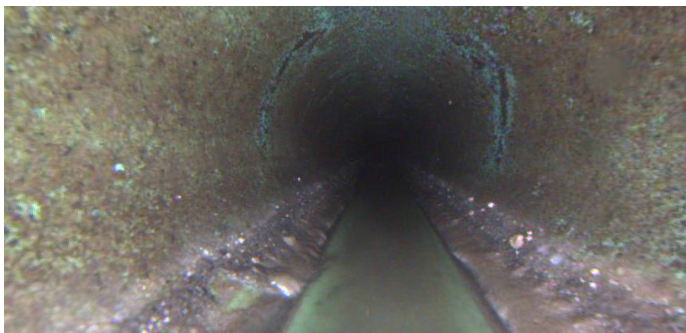
Code: **AMH**
Description: **Manhole**

Distance (ft): **.0**
Structural Grade: **0**
O&M Grade: **0**
Clock Start/From:
Clock To:
1st Value:
2nd Value:
Value Percent:
Continuous Index:
Within 8" of Joint: **NO**
Remarks: **M-1004-022**

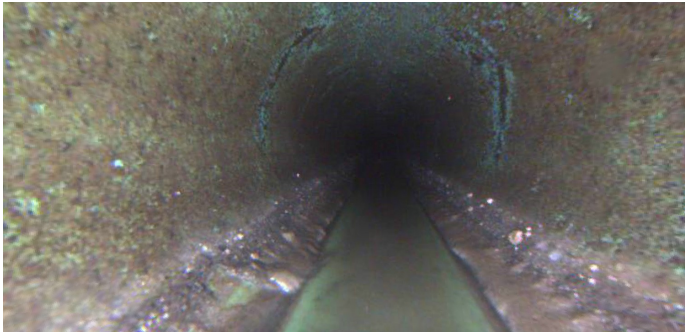
Code: **MWL**
Description: **Water Level**

Distance (ft): **.0**
Structural Grade: **0**
O&M Grade: **0**
Clock Start/From:
Clock To:
1st Value:
2nd Value:
Value Percent: **10.000**
Continuous Index:
Within 8" of Joint: **NO**
Remarks:

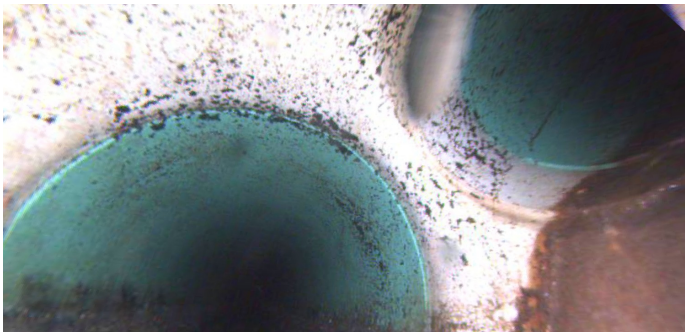
Code: **TF**
Description: **Tap Factory**

Distance (ft): **23.3**
Structural Grade: **0**
O&M Grade: **0**
Clock Start/From: **2**
Clock To:
1st Value: **4.000**
2nd Value:
Value Percent:
Continuous Index:
Within 8" of Joint:
Remarks:

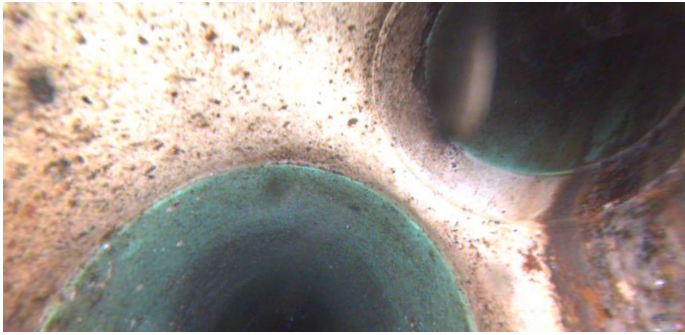
Code: **TF**
Description: **Tap Factory**

Distance (ft): **33.4**
Structural Grade: **0**
O&M Grade: **0**
Clock Start/From: **2**
Clock To:
1st Value: **4.000**
2nd Value:
Value Percent:
Continuous Index:
Within 8" of Joint:
Remarks:

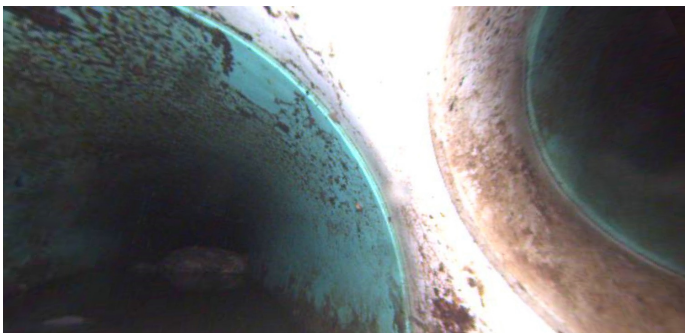
Code: **TF**
Description: **Tap Factory**

Distance (ft): **107.1**
Structural Grade: **0**
O&M Grade: **0**
Clock Start/From: **3**
Clock To:
1st Value: **4.000**
2nd Value:
Value Percent:
Continuous Index:
Within 8" of Joint:
Remarks:

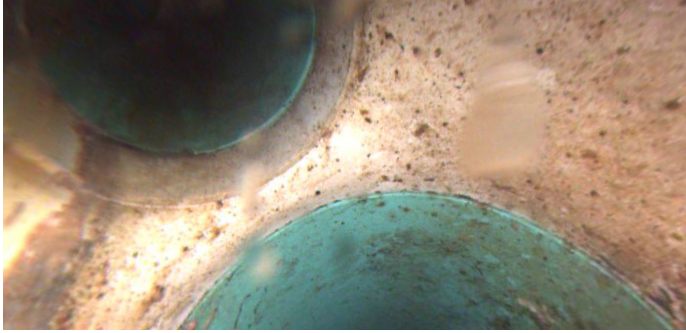
Code: **TF**
Description: **Tap Factory**

Distance (ft): **116.8**
Structural Grade: **0**
O&M Grade: **0**
Clock Start/From: **10**
Clock To:
1st Value: **4.000**
2nd Value:
Value Percent:
Continuous Index:
Within 8" of Joint:
Remarks:

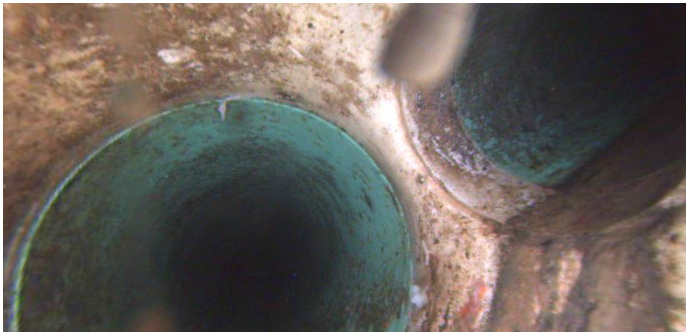
Code: **TF**
Description: **Tap Factory**

Distance (ft): **156.4**
Structural Grade: **0**
O&M Grade: **0**
Clock Start/From: **2**
Clock To:
1st Value: **4.000**
2nd Value:
Value Percent:
Continuous Index:
Within 8" of Joint:
Remarks:

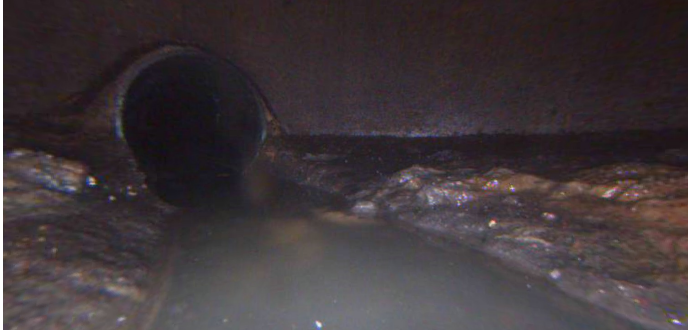
Code:	AMH
Description:	Manhole
Distance (ft):	165.5
Structural Grade:	0
O&M Grade:	0
Clock Start/From:	
Clock To:	
1st Value:	
2nd Value:	
Value Percent:	
Continuous Index:	
Within 8" of Joint:	NO
Remarks:	M-1004-023
