## Profile/Photo Observation Report

Street:	<b>Drexel Dr.</b>	Flow Control:	<b>Not Controlled</b>
City:	<b>Hobart, IN</b>	Year Renewed:	
Location:	<b>Other</b>	Tape/Media #:	
Purpose:	<b>Not Known</b>	Dia/Height:	<b>10"</b>
Use:	<b>Sanitary</b>	Material:	<b>PVC</b>
Drain Area:	<b>NA</b>	Lining:	
Category:	<b>NA</b>		
Comment:

Location Details:		Direction of Survey:	<b>Downstream</b>
US MH:	<b>M-1004-024</b>	DS MH:	<b>M-1004-023</b>
		Total Length Surveyed (ft):	<b>319.1</b>

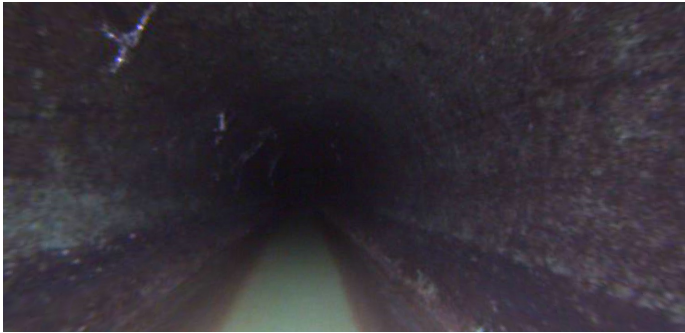
Code:	<b>MWL</b>
Description:	<b>Water Level</b>

Distance (ft):	<b>.0</b>
Structural Grade:	<b>0</b>
O&M Grade:	<b>0</b>
Clock Start/From:	
Clock To:	
1st Value:	
2nd Value:	
Value Percent:	<b>5.000</b>
Continuous Index:	
Within 8" of Joint:	<b>NO</b>
Remarks:

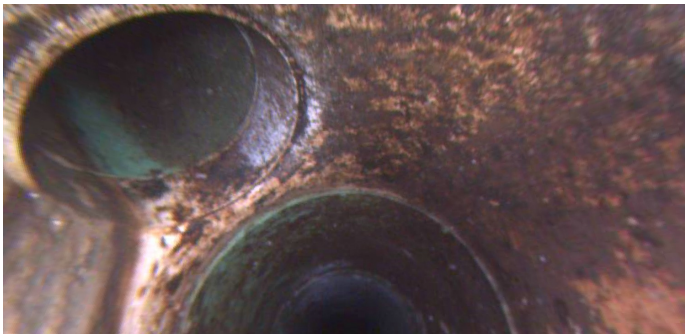
Code:	<b>TF</b>
Description:	<b>Tap Factory</b>

Distance (ft):	<b>59.3</b>
Structural Grade:	<b>0</b>
O&M Grade:	<b>0</b>
Clock Start/From:	<b>11</b>
Clock To:	
1st Value:	<b>4.000</b>
2nd Value:	
Value Percent:	
Continuous Index:	
Within 8" of Joint:	
Remarks:

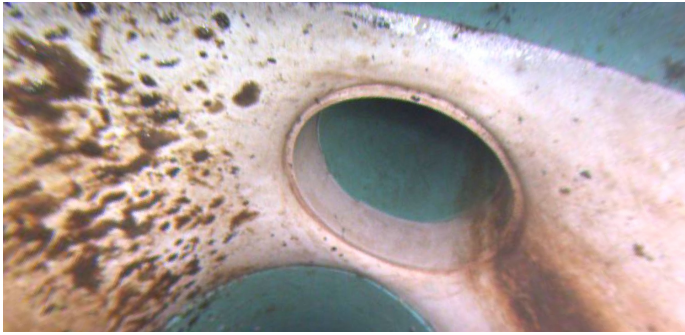
Code: **TF**  
Description: **Tap Factory**

Distance (ft): **101.6**  
Structural Grade: **0**  
O&M Grade: **0**  
Clock Start/From: **1**  
Clock To:  
1st Value: **4.000**  
2nd Value:  
Value Percent:  
Continuous Index:  
Within 8" of Joint:  
Remarks:

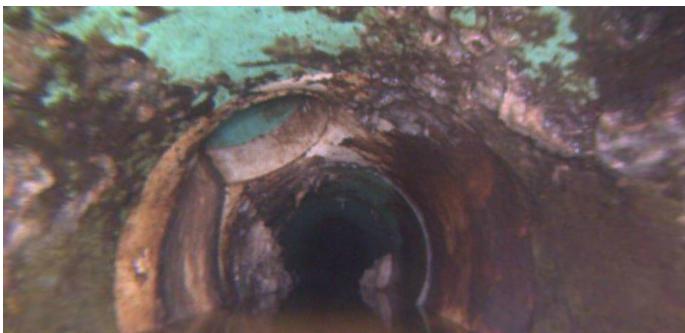
Code: **DAGS**  
Description: **Deposits Attached Grease**

Distance (ft): **140.4**  
Structural Grade: **0**  
O&M Grade: **2**  
Clock Start/From: **8**  
Clock To: **4**  
1st Value:  
2nd Value:  
Value Percent: **5.000**  
Continuous Index:  
Within 8" of Joint: **NO**  
Remarks:

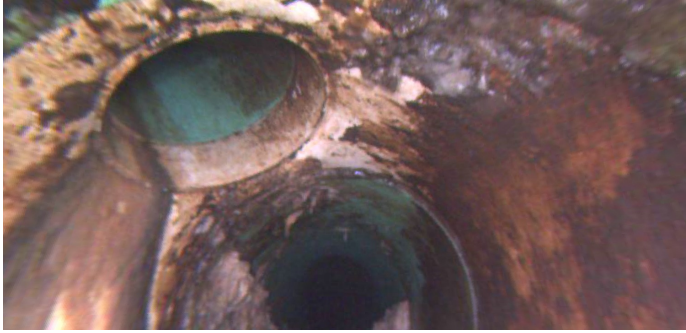
Code: **TF**  
Description: **Tap Factory**

Distance (ft): **140.8**  
Structural Grade: **0**  
O&M Grade: **0**  
Clock Start/From: **11**  
Clock To:  
1st Value: **4.000**  
2nd Value:  
Value Percent:  
Continuous Index:  
Within 8" of Joint:  
Remarks:

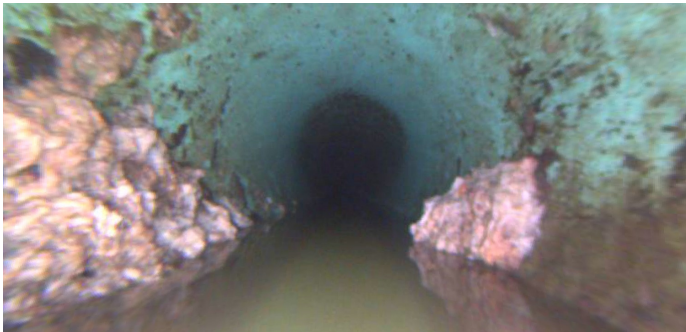
Code: **DAGS**  
Description: **Deposits Attached Grease**

Distance (ft): **142.0**  
Structural Grade: **0**  
O&M Grade: **2**  
Clock Start/From: **8**  
Clock To: **4**  
1st Value:  
2nd Value:  
Value Percent: **10.000**  
Continuous Index:  
Within 8" of Joint: **NO**  
Remarks:

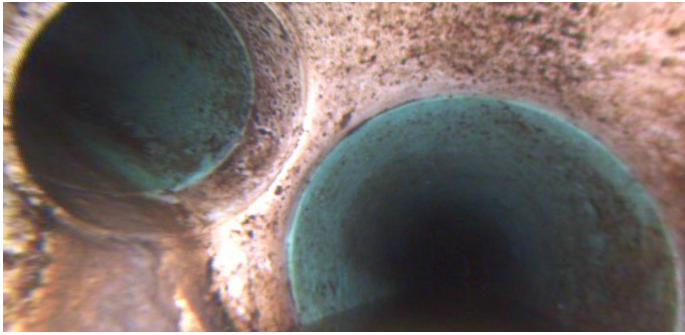
Code: **TF**  
Description: **Tap Factory**

Distance (ft): **241.3**  
Structural Grade: **0**  
O&M Grade: **0**  
Clock Start/From: **10**  
Clock To:  
1st Value: **4.000**  
2nd Value:  
Value Percent:  
Continuous Index:  
Within 8" of Joint:  
Remarks:

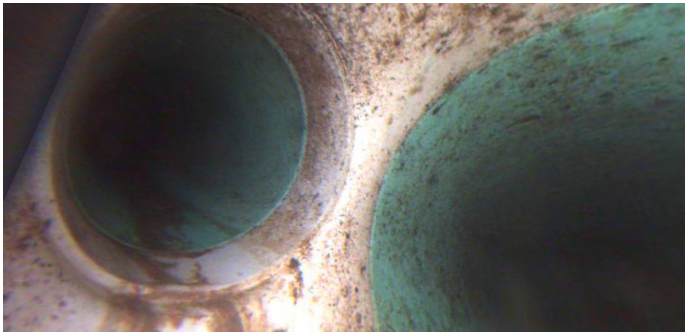
Code: **TF**  
Description: **Tap Factory**

Distance (ft): **310.7**  
Structural Grade: **0**  
O&M Grade: **0**  
Clock Start/From: **2**  
Clock To:  
1st Value: **4.000**  
2nd Value:  
Value Percent:  
Continuous Index:  
Within 8" of Joint:  
Remarks:

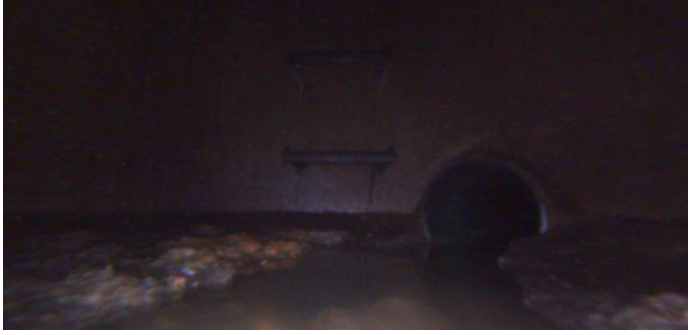
Code:	AMH
Description:	Manhole
Distance (ft):	319.1
Structural Grade:	0
O&M Grade:	0
Clock Start/From:	
Clock To:	
1st Value:	
2nd Value:	
Value Percent:	
Continuous Index:	
Within 8" of Joint:	NO
Remarks:	M-1004-023
