Profile/Photo Observation Report

Street:	2648 McAfee Dr	Flow Control:	Not Controlled
City:	Hobart In	Year Renewed:	
Location:	Light Highway	Tape/Media #:	Deliverable 1
Purpose:	Routine Assessment	Dia/Height:	14"
Use:	Sanitary	Material:	PVC
Drain Area:	Northeast	Lining:	
Category:	NA		
Comment:	453-3		
Location Details:	Edge of street	Direction of Survey:	Downstream
US MH:	M-1004-025	DS MH:	M-1004-024
		Total Length Surveyed (ft):	160.0

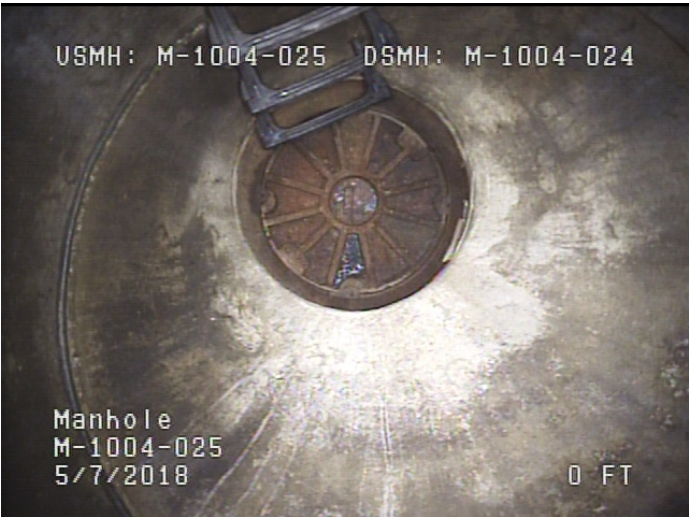
Code:	AMH
Description:	Manhole
Distance (ft):	.0
Structural Grade:	0
O&M Grade:	0
Clock Start/From:	
Clock To:	
1st Value:	
2nd Value:	
Value Percent:	
Continuous Index:	
Within 8" of Joint:	NO
Remarks:	M-1004-025

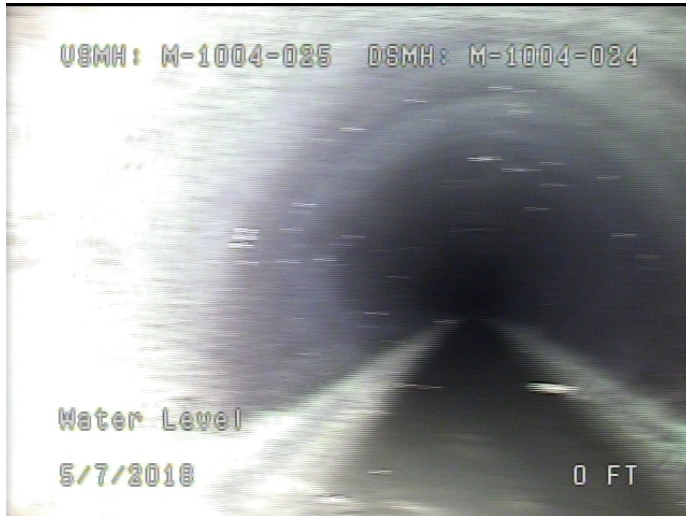
Code:	MWL
Description:	Water Level
Distance (ft):	.0
Structural Grade:	0
O&M Grade:	0
Clock Start/From:	
Clock To:	
1st Value:	
2nd Value:	
Value Percent:	5.000
Continuous Index:	
Within 8" of Joint:	NO
Remarks:

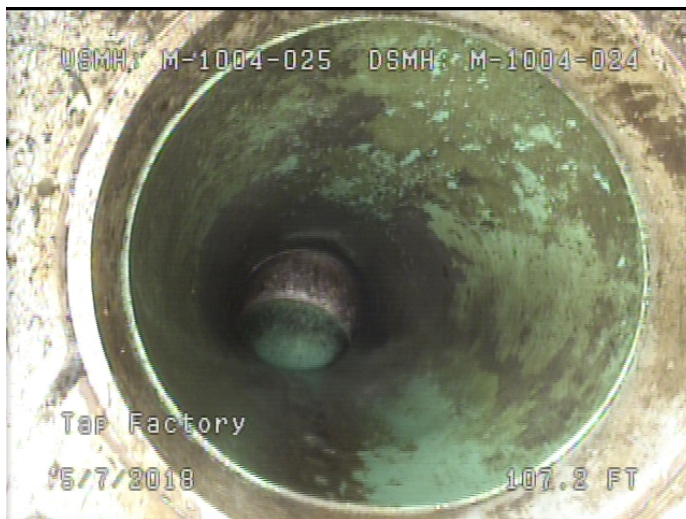
Code:	TF
Description:	Tap Factory
Distance (ft):	107.2
Structural Grade:	0
O&M Grade:	0
Clock Start/From:	11
Clock To:	
1st Value:	4.000
2nd Value:	
Value Percent:	
Continuous Index:	
Within 8" of Joint:	NO
Remarks:

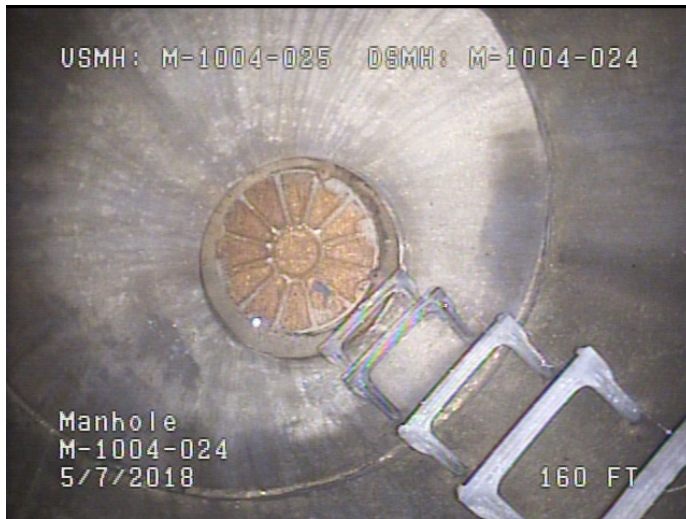
Code:	AMH
Description:	Manhole
Distance (ft):	160.0
Structural Grade:	0
O&M Grade:	0
Clock Start/From:	
Clock To:	
1st Value:	
2nd Value:	
Value Percent:	
Continuous Index:	
Within 8" of Joint:	NO
Remarks:	M-1004-024
