## Profile/Photo Observation Report

Date:	<b>05/07/2018</b>	Weather:		Coding:	<b>PACP 4.2</b>
Pipe Length (ft):	<b>394.2</b>	Owner:	<b>City of Hobart</b>	Pre Clean:	<b>No Pre-Cleaning</b>
P.O.#:	<b>2004</b>	Surveyor:	<b>SAN</b>	PSR:	<b>P-1004-015-026</b>
Customer:	<b>Red Zone</b>	Clean Date:		Shape:	<b>C</b>

Street:	<b>2913 McAfee Dr</b>	Flow Control:	<b>Not Controlled</b>
City:	<b>Hobart In</b>	Year Renewed:	
Location:	<b>Light Highway</b>	Tape/Media #:	<b>Deliverable 1</b>
Purpose:	<b>Routine Assessment</b>	Dia/Height:	<b>14"</b>
Use:	<b>Sanitary</b>	Material:	<b>PVC</b>
Drain Area:	<b>Northeast</b>	Lining:	
Category:	<b>NA</b>		
Comment:	<b>453-1</b>		
Location Details:	<b>Edge of street</b>	Direction of Survey:	<b>Downstream</b>
US MH:	<b>M-1004-015</b>	DS MH:	<b>M-1004-026</b>
		Total Length Surveyed (ft):	<b>394.2</b>

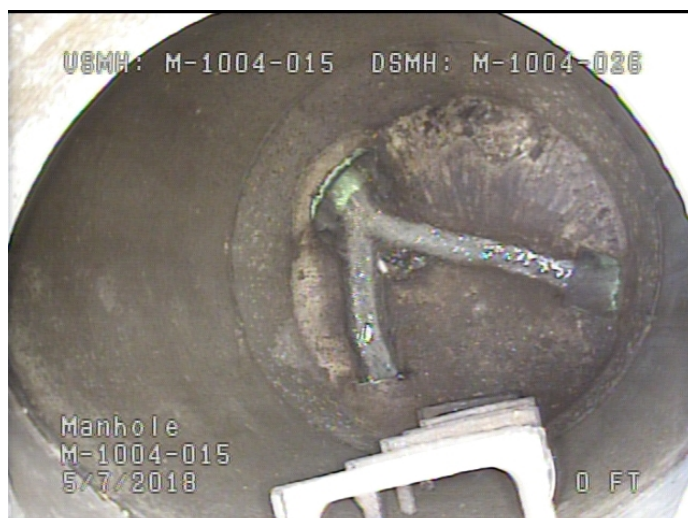
Code: **AMH**  
Description: **Manhole**

Distance (ft): **.0**  
Structural Grade: **0**  
O&M Grade: **0**  
Clock Start/From:  
Clock To:  
1st Value:  
2nd Value:  
Value Percent:  
Continuous Index:  
Within 8" of Joint: **NO**  
Remarks: **M-1004-015**

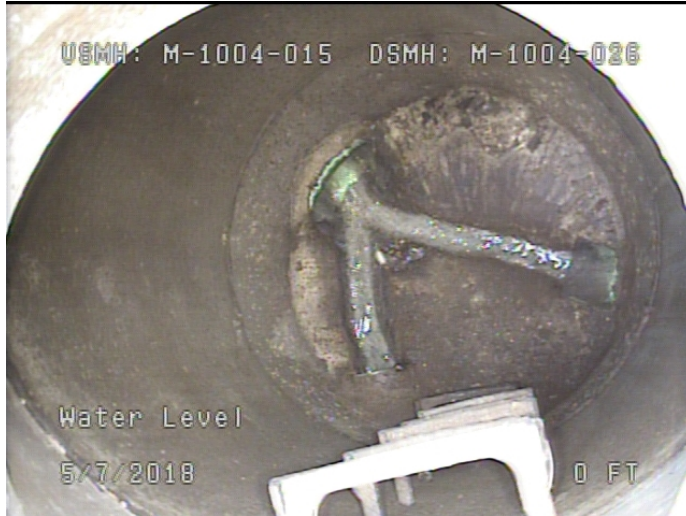
Code:	<b>MWL</b>
Description:	<b>Water Level</b>
Distance (ft):	<b>.0</b>
Structural Grade:	<b>0</b>
O&M Grade:	<b>0</b>
Clock Start/From:	
Clock To:	
1st Value:	
2nd Value:	
Value Percent:	<b>5.000</b>
Continuous Index:	
Within 8" of Joint:	<b>NO</b>
Remarks:

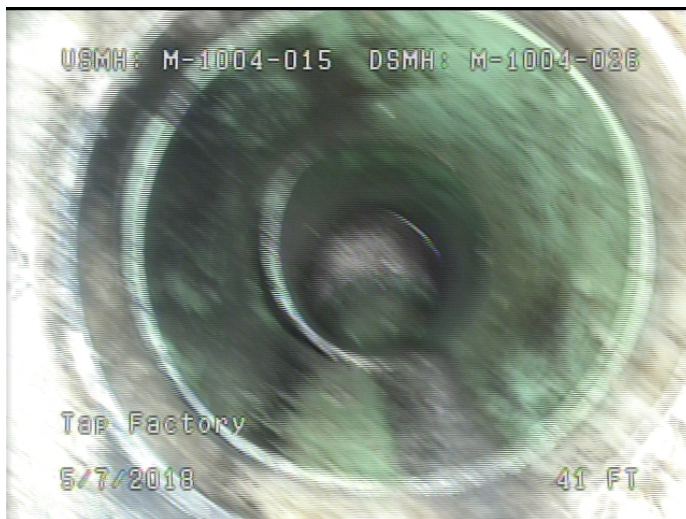
Code:	<b>TF</b>
Description:	<b>Tap Factory</b>
Distance (ft):	<b>41.0</b>
Structural Grade:	<b>0</b>
O&M Grade:	<b>0</b>
Clock Start/From:	<b>11</b>
Clock To:	
1st Value:	<b>4.000</b>
2nd Value:	
Value Percent:	
Continuous Index:	
Within 8" of Joint:	<b>NO</b>
Remarks:

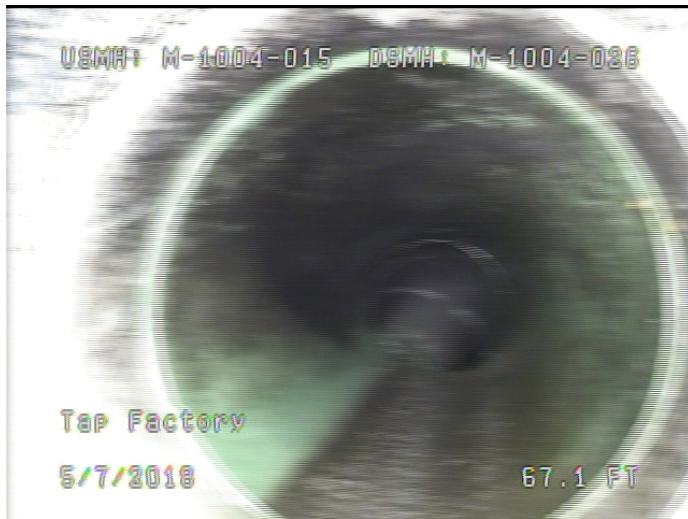
Code:	<b>TF</b>
Description:	<b>Tap Factory</b>
Distance (ft):	<b>67.1</b>
Structural Grade:	<b>0</b>
O&M Grade:	<b>0</b>
Clock Start/From:	<b>1</b>
Clock To:	
1st Value:	<b>4.000</b>
2nd Value:	
Value Percent:	
Continuous Index:	
Within 8" of Joint:	<b>NO</b>
Remarks:

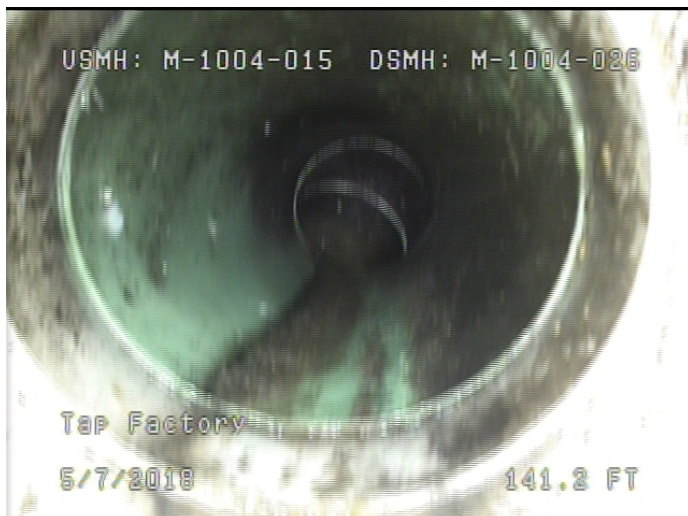
Code:	<b>TF</b>
Description:	<b>Tap Factory</b>
Distance (ft):	<b>141.2</b>
Structural Grade:	<b>0</b>
O&M Grade:	<b>0</b>
Clock Start/From:	<b>1</b>
Clock To:	
1st Value:	<b>4.000</b>
2nd Value:	
Value Percent:	
Continuous Index:	
Within 8" of Joint:	<b>NO</b>
Remarks:

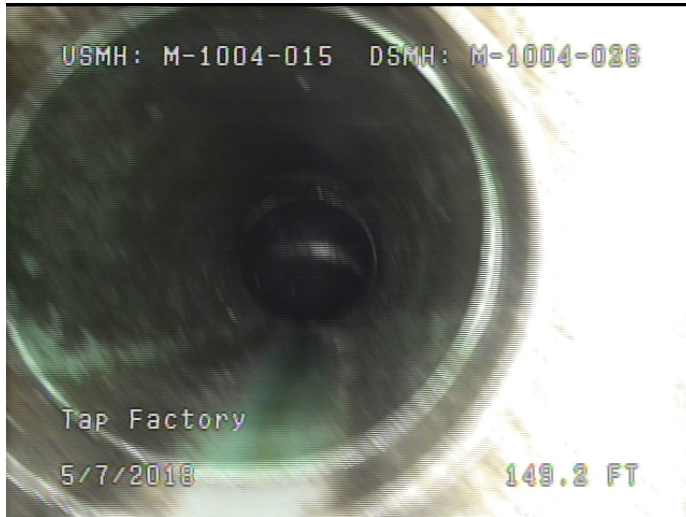
Code:	<b>TF</b>
Description:	<b>Tap Factory</b>
Distance (ft):	<b>149.2</b>
Structural Grade:	<b>0</b>
O&M Grade:	<b>0</b>
Clock Start/From:	<b>11</b>
Clock To:	
1st Value:	<b>4.000</b>
2nd Value:	
Value Percent:	
Continuous Index:	
Within 8" of Joint:	<b>NO</b>
Remarks:

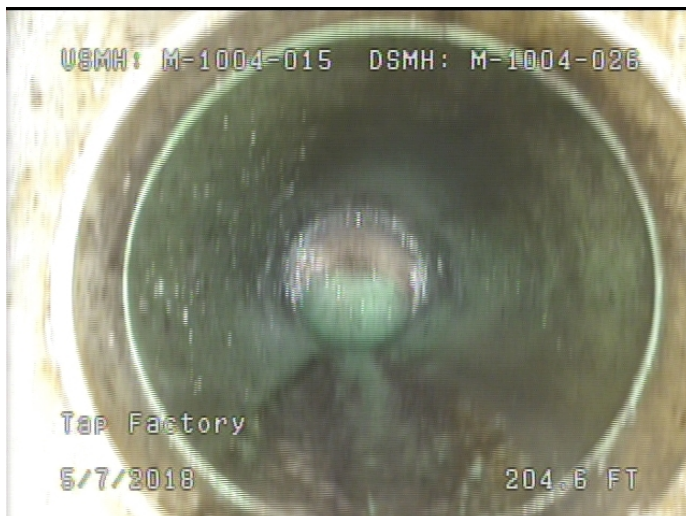
Code:	<b>TF</b>
Description:	<b>Tap Factory</b>
Distance (ft):	<b>204.6</b>
Structural Grade:	<b>0</b>
O&M Grade:	<b>0</b>
Clock Start/From:	<b>11</b>
Clock To:	
1st Value:	<b>4.000</b>
2nd Value:	
Value Percent:	
Continuous Index:	
Within 8" of Joint:	<b>NO</b>
Remarks:

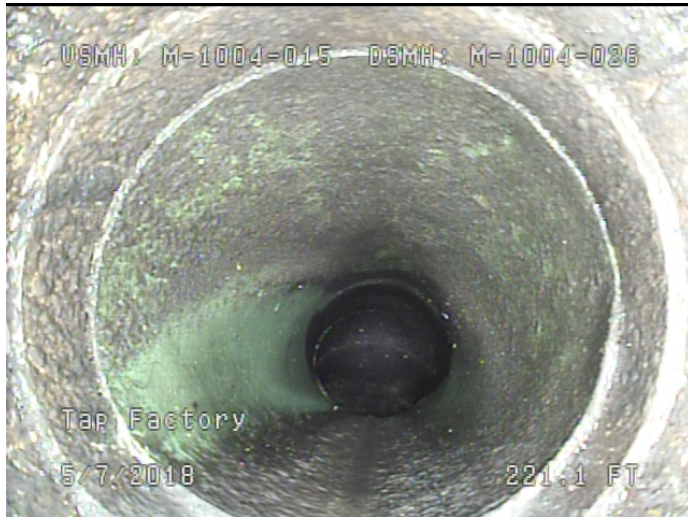
Code: **TF**  
 Description: **Tap Factory**

Distance (ft): **221.1**  
 Structural Grade: **0**  
 O&M Grade: **0**  
 Clock Start/From: **1**  
 Clock To:  
 1st Value: **4.000**  
 2nd Value:  
 Value Percent:  
 Continuous Index:  
 Within 8" of Joint: **NO**  
 Remarks:

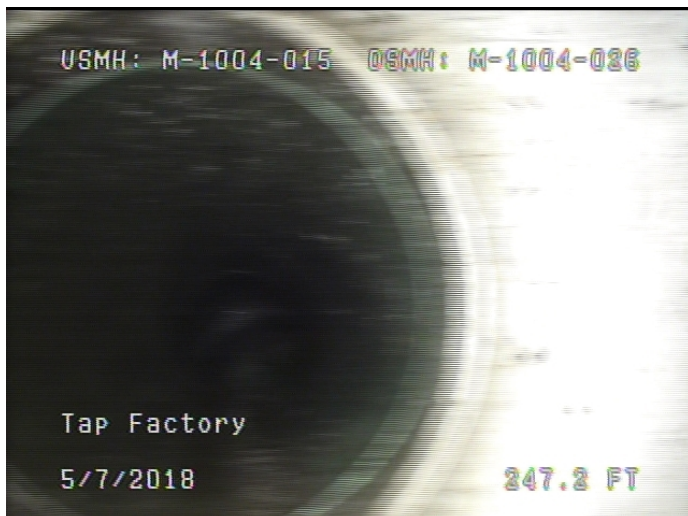
Code: **TF**  
 Description: **Tap Factory**

Distance (ft): **247.2**  
 Structural Grade: **0**  
 O&M Grade: **0**  
 Clock Start/From: **11**  
 Clock To:  
 1st Value: **4.000**  
 2nd Value:  
 Value Percent:  
 Continuous Index:  
 Within 8" of Joint: **NO**  
 Remarks:

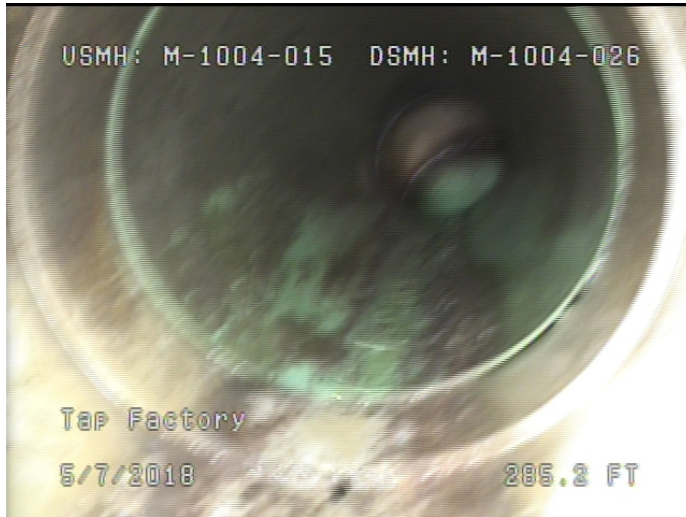
Code: **TF**  
Description: **Tap Factory**

Distance (ft): **285.2**  
Structural Grade: **0**  
O&M Grade: **0**  
Clock Start/From: **1**  
Clock To:  
1st Value: **4.000**  
2nd Value:  
Value Percent:  
Continuous Index:  
Within 8" of Joint: **NO**  
Remarks:

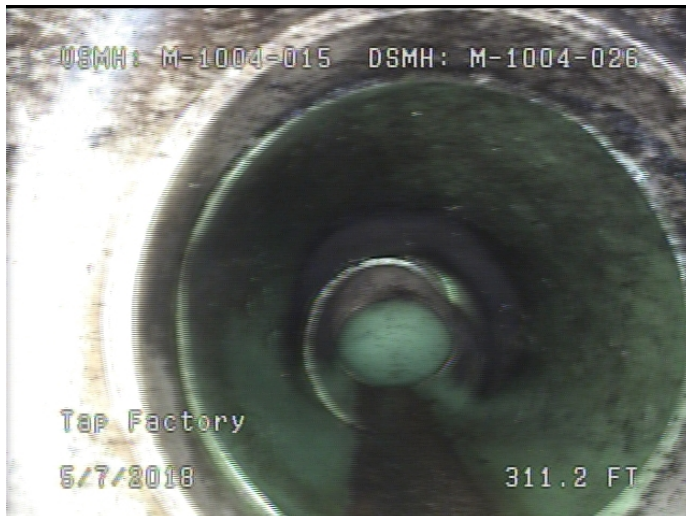
Code: **TF**  
Description: **Tap Factory**

Distance (ft): **311.2**  
Structural Grade: **0**  
O&M Grade: **0**  
Clock Start/From: **1**  
Clock To:  
1st Value: **4.000**  
2nd Value:  
Value Percent:  
Continuous Index:  
Within 8" of Joint: **NO**  
Remarks:

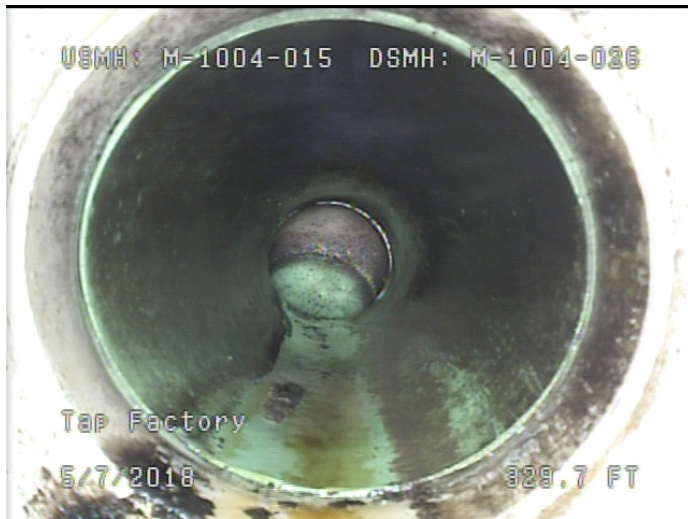
Code: **TF**  
Description: **Tap Factory**

Distance (ft): **329.7**  
Structural Grade: **0**  
O&M Grade: **0**  
Clock Start/From: **11**  
Clock To:  
1st Value: **4.000**  
2nd Value:  
Value Percent:  
Continuous Index:  
Within 8" of Joint: **NO**  
Remarks:

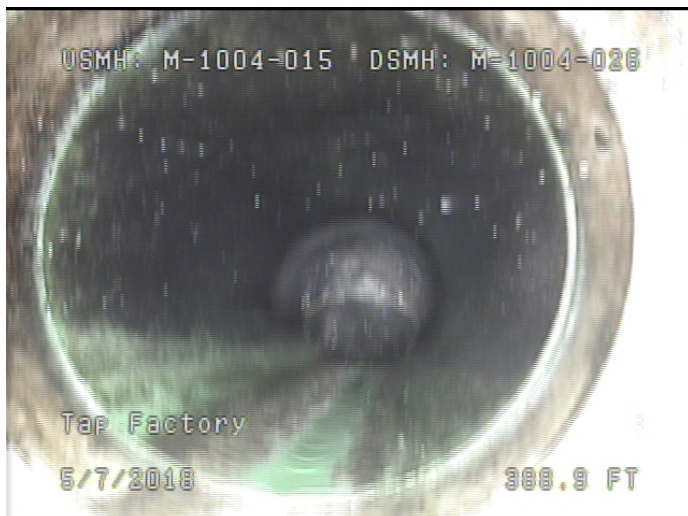
Code: **TF**  
Description: **Tap Factory**

Distance (ft): **388.9**  
Structural Grade: **0**  
O&M Grade: **0**  
Clock Start/From: **11**  
Clock To:  
1st Value: **4.000**  
2nd Value:  
Value Percent:  
Continuous Index:  
Within 8" of Joint: **NO**  
Remarks:

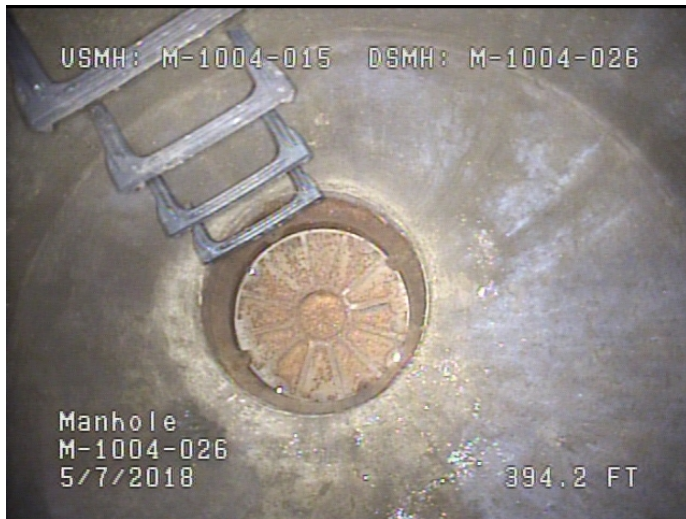
Code:	AMH
Description:	Manhole
Distance (ft):	394.2
Structural Grade:	0
O&M Grade:	0
Clock Start/From:	
Clock To:	
1st Value:	
2nd Value:	
Value Percent:	
Continuous Index:	
Within 8" of Joint:	NO
Remarks:	M-1004-026
