Profile/Photo Observation Report

Date:	04/14/2018	Weather:		Coding:	PACP 6.0
Pipe Length (ft):	306.9	Owner:	NA	Pre Clean:	Not Known
P.O.#:		Surveyor:	Jen Costello	PSR:	P-1004-027-028
Customer:		Clean Date:	01/01/1900	Shape:	C

Street:	E Cleveland Ave.	Flow Control:	Not Controlled
City:	Hobart, IN	Year Renewed:	
Location:	Other	Tape/Media #:	
Purpose:	Not Known	Dia/Height:	8"
Use:	Sanitary	Material:	PVC
Drain Area:	NA	Lining:	
Category:	NA		
Comment:

Location Details:		Direction of Survey:	Upstream
US MH:	M-1004-027	DS MH:	M-1004-028
		Total Length Surveyed (ft):	292.1

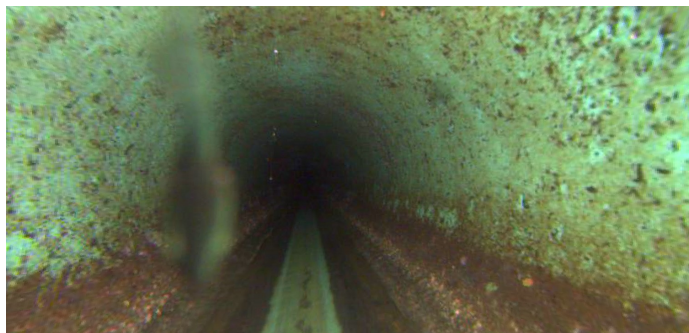
Code: **AMH**
Description: **Manhole**

Distance (ft): **.0**
Structural Grade: **0**
O&M Grade: **0**
Clock Start/From:
Clock To:
1st Value:
2nd Value:
Value Percent:
Continuous Index:
Within 8" of Joint: **NO**
Remarks: **M-1004-028**

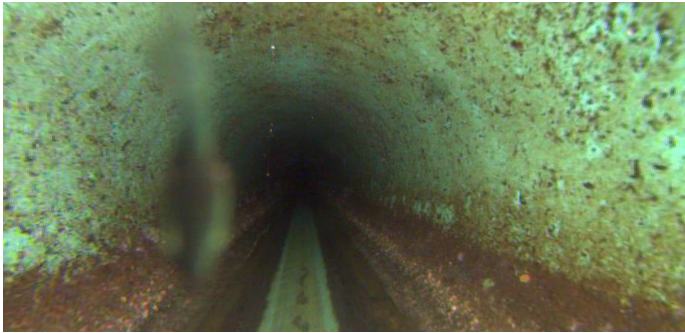
Code:	MWL
Description:	Water Level

Distance (ft):	.0
Structural Grade:	0
O&M Grade:	0
Clock Start/From:	
Clock To:	
1st Value:	
2nd Value:	
Value Percent:	5.000
Continuous Index:	
Within 8" of Joint:	NO
Remarks:

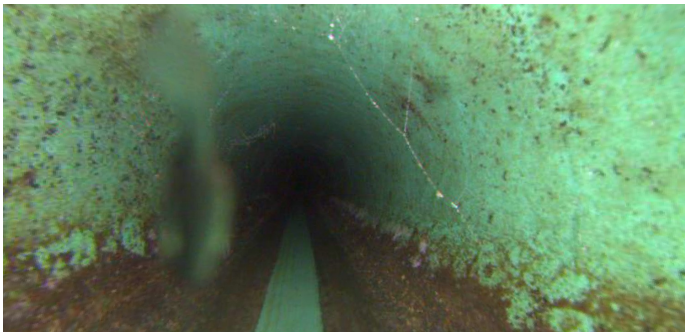
Code:	DAZ
Description:	Deposits Attached Other

Distance (ft):	4.7
Structural Grade:	0
O&M Grade:	2
Clock Start/From:	4
Clock To:	8
1st Value:	
2nd Value:	
Value Percent:	5.000
Continuous Index:	S01
Within 8" of Joint:	NO
Remarks:

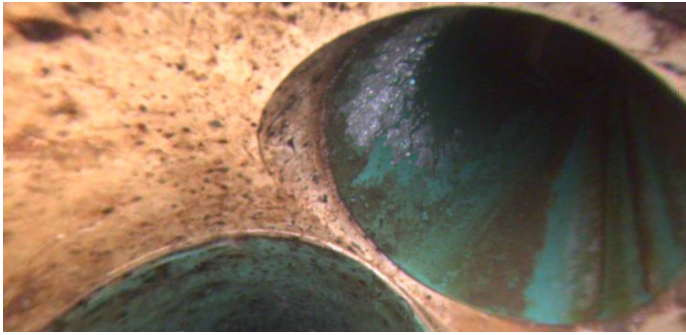
Code: **TF**
Description: **Tap Factory**

Distance (ft): **38.3**
Structural Grade: **0**
O&M Grade: **0**
Clock Start/From: **11**
Clock To:
1st Value: **4.000**
2nd Value:
Value Percent:
Continuous Index:
Within 8" of Joint:
Remarks:

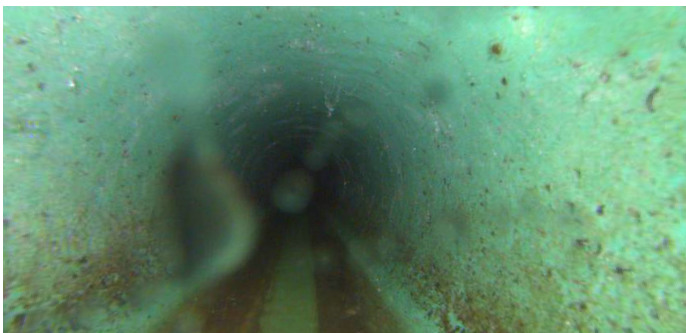
Code: **DAZ**
Description: **Deposits Attached Other**

Distance (ft): **86.9**
Structural Grade: **0**
O&M Grade: **2**
Clock Start/From: **4**
Clock To: **8**
1st Value:
2nd Value:
Value Percent: **5.000**
Continuous Index: **F01**
Within 8" of Joint: **NO**
Remarks:

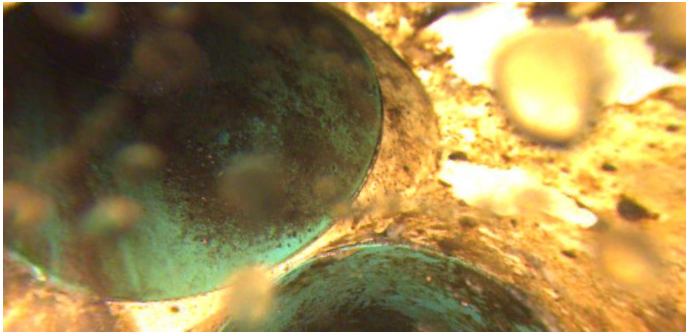
Code: **TF**
Description: **Tap Factory**

Distance (ft): **120.9**
Structural Grade: **0**
O&M Grade: **0**
Clock Start/From: **11**
Clock To:
1st Value: **4.000**
2nd Value:
Value Percent:
Continuous Index:
Within 8" of Joint:
Remarks:

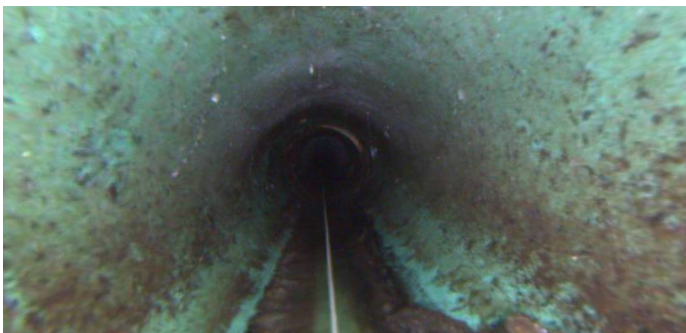
Code: **MGO**
Description: **General Observation**

Distance (ft): **123.8**
Structural Grade: **0**
O&M Grade: **0**
Clock Start/From:
Clock To:
1st Value:
2nd Value:
Value Percent:
Continuous Index:
Within 8" of Joint: **NO**
Remarks: **REAR CAMERA**

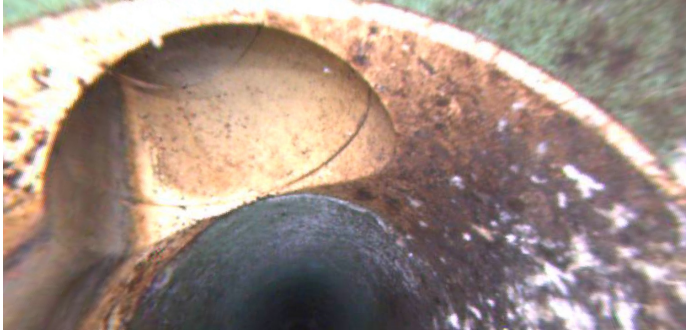
Code: **TF**
Description: **Tap Factory**

Distance (ft): **159.1**
Structural Grade: **0**
O&M Grade: **0**
Clock Start/From: **1**
Clock To:
1st Value: **4.000**
2nd Value:
Value Percent:
Continuous Index:
Within 8" of Joint:
Remarks:

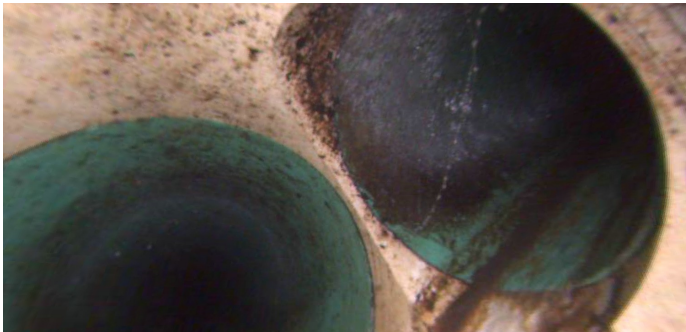
Code: **TFA**
Description: **Tap Factory Active**

Distance (ft): **192.2**
Structural Grade: **0**
O&M Grade: **0**
Clock Start/From: **10**
Clock To:
1st Value: **4.000**
2nd Value:
Value Percent:
Continuous Index:
Within 8" of Joint:
Remarks:

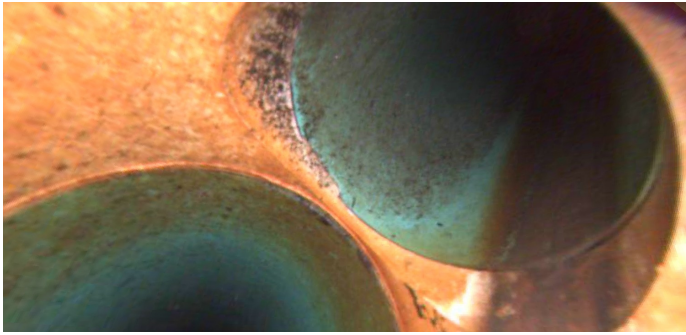
Code: **TF**
Description: **Tap Factory**

Distance (ft): **214.7**
Structural Grade: **0**
O&M Grade: **0**
Clock Start/From: **11**
Clock To:
1st Value: **4.000**
2nd Value:
Value Percent:
Continuous Index:
Within 8" of Joint:
Remarks:

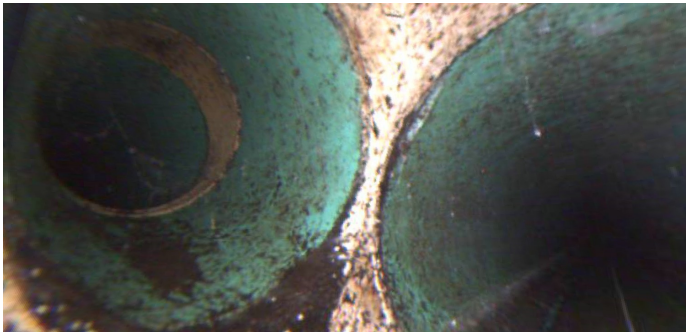
Code: **TF**
Description: **Tap Factory**

Distance (ft): **278.2**
Structural Grade: **0**
O&M Grade: **0**
Clock Start/From: **2**
Clock To:
1st Value: **4.000**
2nd Value:
Value Percent:
Continuous Index:
Within 8" of Joint:
Remarks:

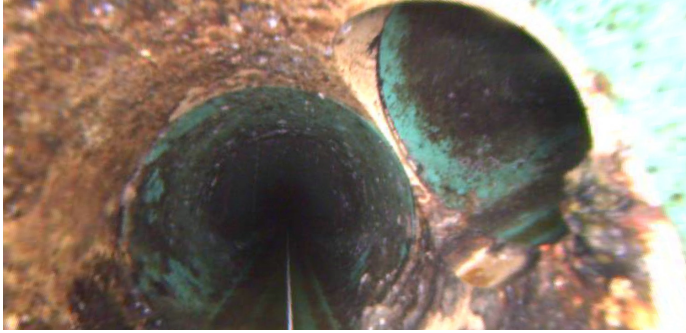
Code: **TF**
Description: **Tap Factory**

Distance (ft): **288.7**
Structural Grade: **0**
O&M Grade: **0**
Clock Start/From: **10**
Clock To:
1st Value: **4.000**
2nd Value:
Value Percent:
Continuous Index:
Within 8" of Joint:
Remarks:

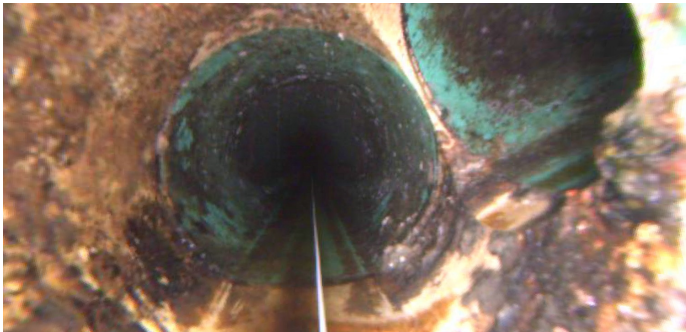
Code: **DAGS**
Description: **Deposits Attached Grease**

Distance (ft): **288.7**
Structural Grade: **0**
O&M Grade: **2**
Clock Start/From: **8**
Clock To: **4**
1st Value:
2nd Value:
Value Percent: **5.000**
Continuous Index:
Within 8" of Joint: **NO**
Remarks:

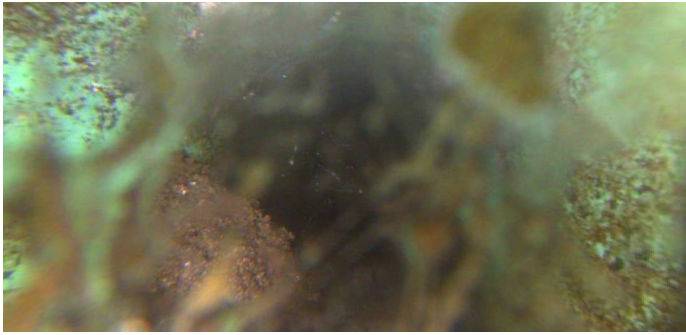
Code: **DAZ**
Description: **Deposits Attached Other**

Distance (ft): **291.2**
Structural Grade: **0**
O&M Grade: **2**
Clock Start/From: **6**
Clock To: **9**
1st Value:
2nd Value:
Value Percent: **10.000**
Continuous Index:
Within 8" of Joint: **YES**
Remarks:

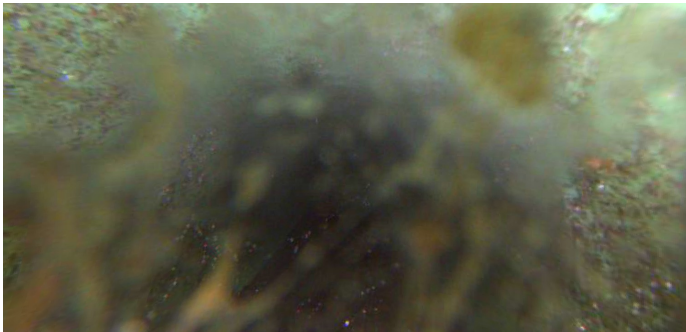
Code: **MSA**
Description: **Abandoned Survey**

Distance (ft): **292.1**
Structural Grade: **0**
O&M Grade: **0**
Clock Start/From:
Clock To:
1st Value:
2nd Value:
Value Percent:
Continuous Index:
Within 8" of Joint: **NO**
Remarks: **DAZ**
