Profile/Photo Observation Report

Date:	10/08/2018	Weather:		Coding:	PACP 6.0
Pipe Length (ft):	306.9	Owner:	NA	Pre Clean:	Not Known
P.O.#:		Surveyor:	Selasie Honu	PSR:	P-1004-027-028
Customer:		Clean Date:	01/01/1900	Shape:	C

Street:	E CLEVELAND AVE	Flow Control:	Not Controlled
City:	Hobart, IN	Year Renewed:	
Location:	Light Highway	Tape/Media #:	
Purpose:	Routine Assessment	Dia/Height:	10"
Use:	Sanitary	Material:	PVC
Drain Area:	NA	Lining:	
Category:	NA		
Comment:

Location Details:		Direction of Survey:	Downstream
US MH:	M-1004-027	DS MH:	M-1004-028
		Total Length Surveyed (ft):	298.3

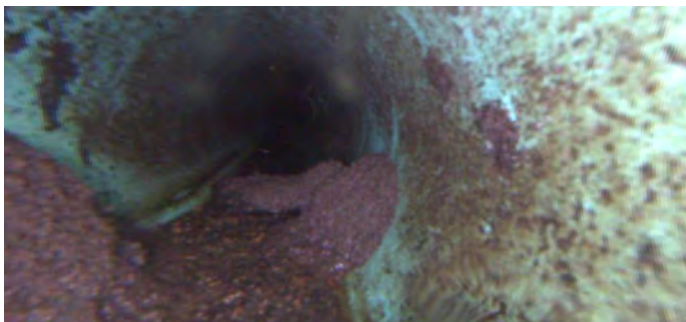
Code: **AMH**
Description: **Manhole**

Distance (ft): **.0**
Structural Grade: **0**
O&M Grade: **0**
Clock Start/From:
Clock To:
1st Value:
2nd Value:
Value Percent:
Continuous Index:
Within 8" of Joint: **NO**
Remarks: **M-1004-027**

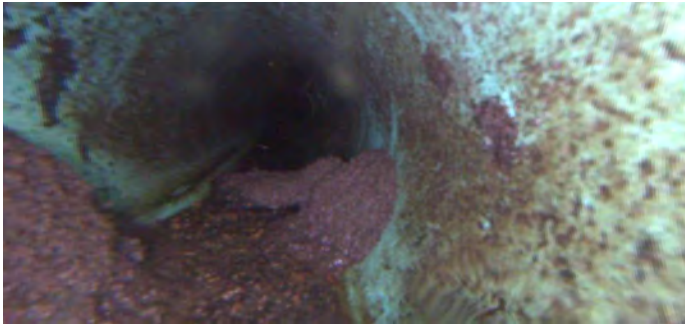
Code:	MWL
Description:	Water Level

Distance (ft):	.0
Structural Grade:	0
O&M Grade:	0
Clock Start/From:	
Clock To:	
1st Value:	
2nd Value:	
Value Percent:	5.000
Continuous Index:	
Within 8" of Joint:	NO
Remarks:

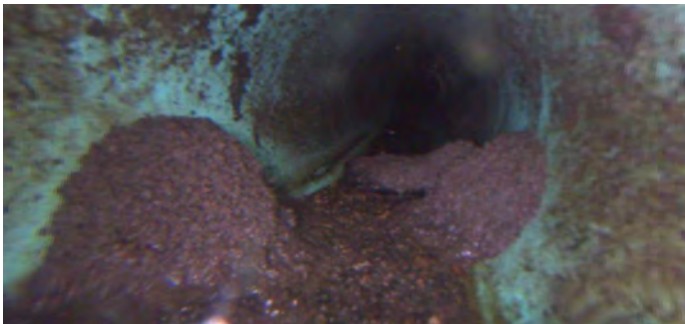
Code:	RMJ
Description:	Roots Medium Joint

Distance (ft):	.0
Structural Grade:	0
O&M Grade:	3
Clock Start/From:	3
Clock To:	9
1st Value:	
2nd Value:	
Value Percent:	20.000
Continuous Index:	
Within 8" of Joint:	YES
Remarks:

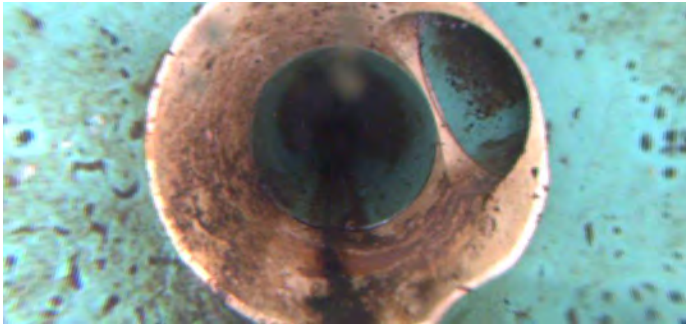
Code: **TF**
Description: **Tap Factory**

Distance (ft): **5.0**
Structural Grade: **0**
O&M Grade: **0**
Clock Start/From: **2**
Clock To:
1st Value: **4.000**
2nd Value:
Value Percent:
Continuous Index:
Within 8" of Joint:
Remarks:

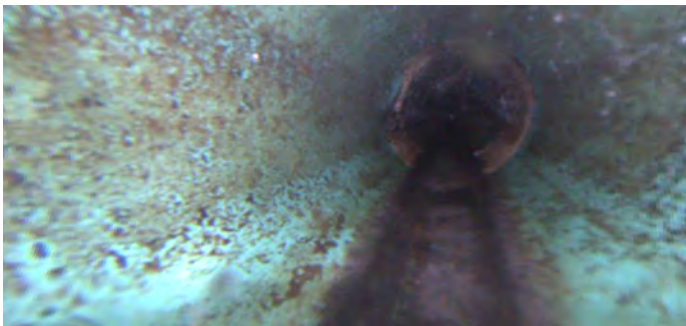
Code: **TF**
Description: **Tap Factory**

Distance (ft): **14.1**
Structural Grade: **0**
O&M Grade: **0**
Clock Start/From: **9**
Clock To:
1st Value: **4.000**
2nd Value:
Value Percent:
Continuous Index:
Within 8" of Joint:
Remarks:

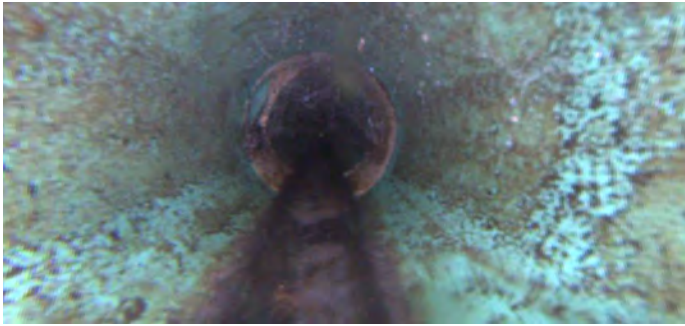
Code: **TF**
Description: **Tap Factory**

Distance (ft): **14.4**
Structural Grade: **0**
O&M Grade: **0**
Clock Start/From: **10**
Clock To:
1st Value: **4.000**
2nd Value:
Value Percent:
Continuous Index:
Within 8" of Joint:
Remarks:

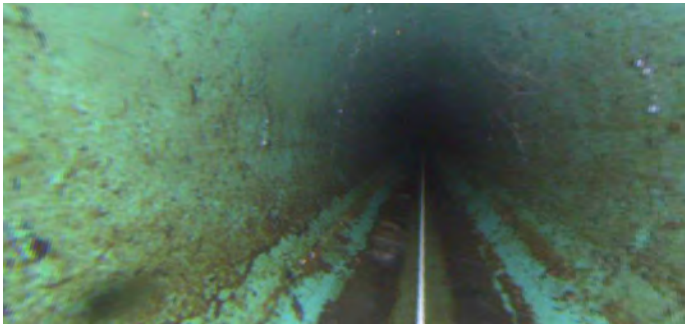
Code: **MGO**
Description: **General Observation**

Distance (ft): **30.6**
Structural Grade: **0**
O&M Grade: **0**
Clock Start/From:
Clock To:
1st Value:
2nd Value:
Value Percent:
Continuous Index:
Within 8" of Joint: **NO**
Remarks: **switching to rear view**

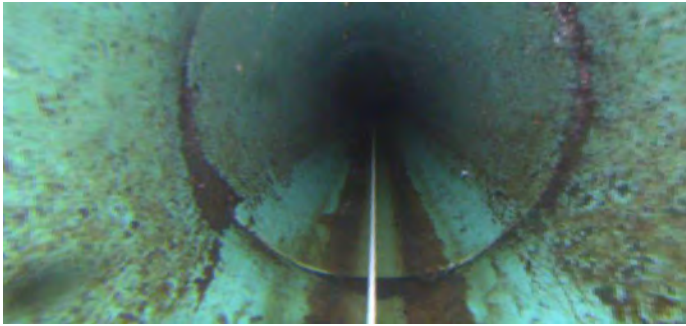
Code: **RFJ**
Description: **Roots Fine Joint**

Distance (ft): **37.9**
Structural Grade: **0**
O&M Grade: **1**
Clock Start/From: **8**
Clock To: **4**
1st Value:
2nd Value:
Value Percent:
Continuous Index:
Within 8" of Joint: **YES**
Remarks:

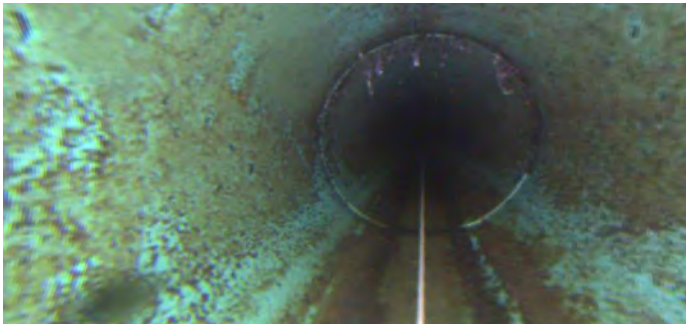
Code: **RFJ**
Description: **Roots Fine Joint**

Distance (ft): **63.0**
Structural Grade: **0**
O&M Grade: **1**
Clock Start/From: **9**
Clock To: **4**
1st Value:
2nd Value:
Value Percent:
Continuous Index:
Within 8" of Joint: **YES**
Remarks:

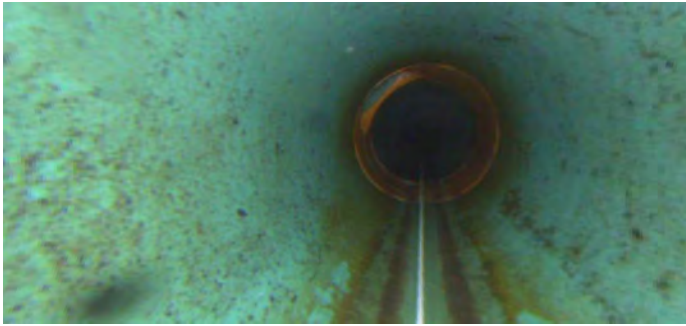
Code: **TF**
Description: **Tap Factory**

Distance (ft): **80.6**
Structural Grade: **0**
O&M Grade: **0**
Clock Start/From: **10**
Clock To:
1st Value: **4.000**
2nd Value:
Value Percent:
Continuous Index:
Within 8" of Joint:
Remarks:

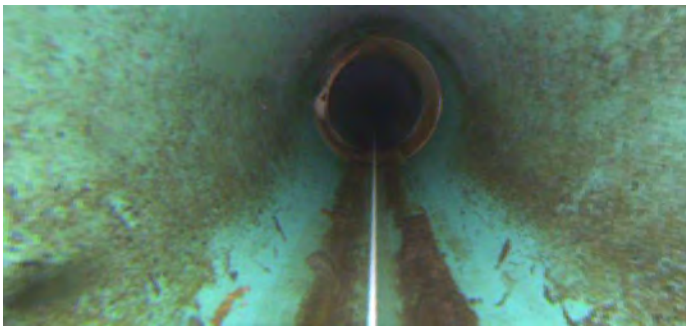
Code: **TF**
Description: **Tap Factory**

Distance (ft): **106.5**
Structural Grade: **0**
O&M Grade: **0**
Clock Start/From: **10**
Clock To:
1st Value: **4.000**
2nd Value:
Value Percent:
Continuous Index:
Within 8" of Joint:
Remarks:

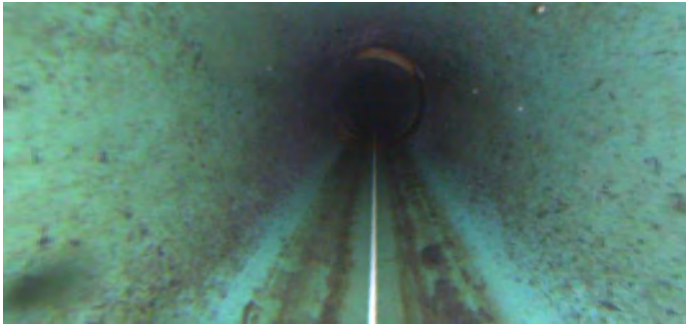
Code: **TF**
Description: **Tap Factory**

Distance (ft): **139.8**
Structural Grade: **0**
O&M Grade: **0**
Clock Start/From: **1**
Clock To:
1st Value: **4.000**
2nd Value:
Value Percent:
Continuous Index:
Within 8" of Joint:
Remarks:

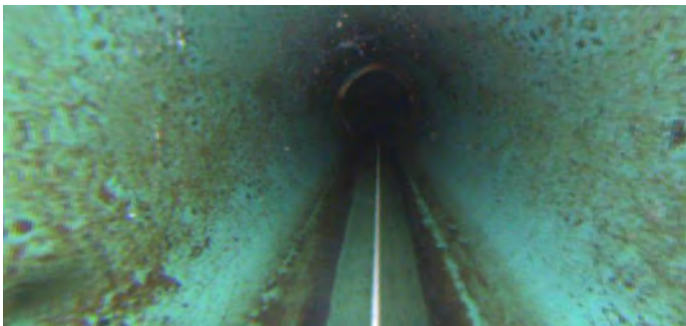
Code: **TF**
Description: **Tap Factory**

Distance (ft): **180.2**
Structural Grade: **0**
O&M Grade: **0**
Clock Start/From: **11**
Clock To:
1st Value: **4.000**
2nd Value:
Value Percent:
Continuous Index:
Within 8" of Joint:
Remarks:

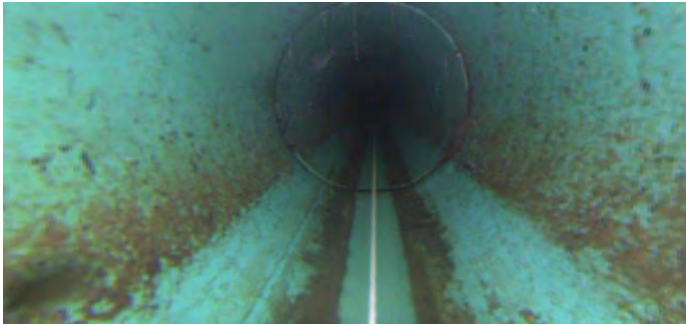
Code: **RFJ**
Description: **Roots Fine Joint**

Distance (ft): **200.2**
Structural Grade: **0**
O&M Grade: **1**
Clock Start/From: **8**
Clock To: **4**
1st Value:
2nd Value:
Value Percent:
Continuous Index:
Within 8" of Joint: **YES**
Remarks:

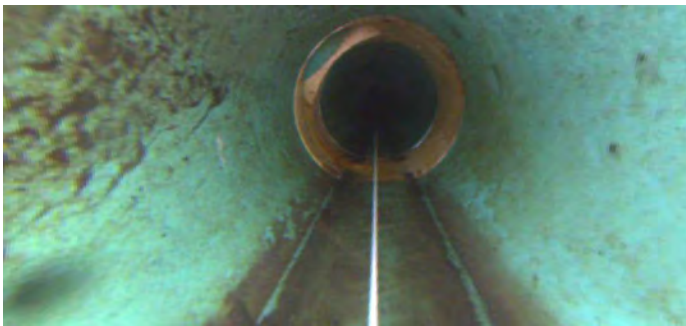
Code: **TF**
Description: **Tap Factory**

Distance (ft): **260.9**
Structural Grade: **0**
O&M Grade: **0**
Clock Start/From: **10**
Clock To:
1st Value: **4.000**
2nd Value:
Value Percent:
Continuous Index:
Within 8" of Joint:
Remarks:

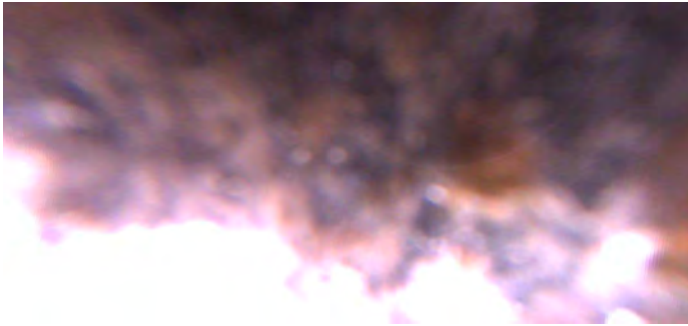
Code:	AMH
Description:	Manhole
Distance (ft):	298.3
Structural Grade:	0
O&M Grade:	0
Clock Start/From:	
Clock To:	
1st Value:	
2nd Value:	
Value Percent:	
Continuous Index:	
Within 8" of Joint:	NO
Remarks:	M-1004-028
